STAR ONLINE PUBLICATION

Case Number: S2008000132 Rev. E

Release Date: August 2023

Symptom/Vehicle Issue: Malfunction Indicator Lamp Illuminated. U11E9 Lost Communication With AGS. Ambient Air Temp Incorrectly Displayed. P0070 And P0073 Set for Ambient Air Temp Sensor

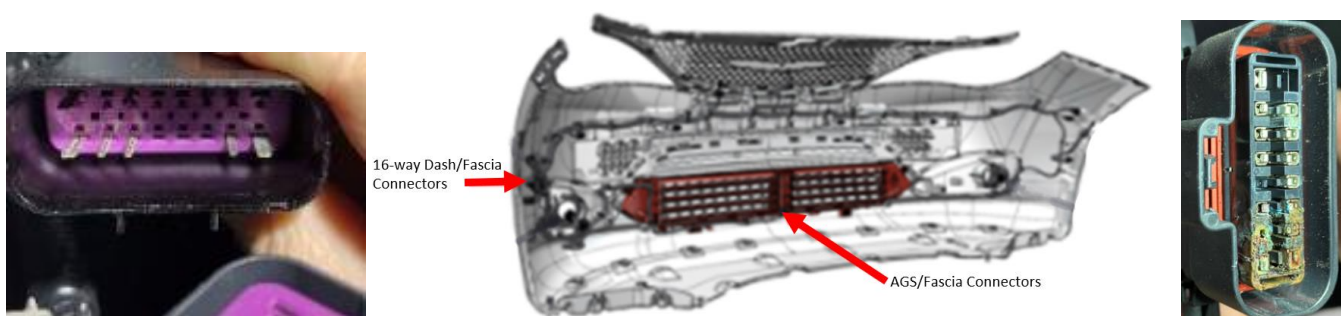
1. Inspect the wiring near the 16-way XY101A Dash to Fascia Connector for nicks and cuts. Disconnect the connector, remove the purple terminal retainer (dash side only), inspect for corrosion and terminal pushout on both sides (fascia/dash).

1. If corrosion, damage, or terminal pushout is present at the XY101A connector. Use connector kit 68497543AB to repair the 16-way Dash side connector and replace the Fascia side harness. A connector repair kit 68500834AA for the fascia side connector is also available. But due to the various possible issues described, fascia harness replacement is recommended.
