CAMPAIGN BULLETIN

Seat Frame Weld

Reference: PC987

PC987 – 2023-2024 PATHFINDER, ROGUE FRONT POWER SEAT FRAME WELD

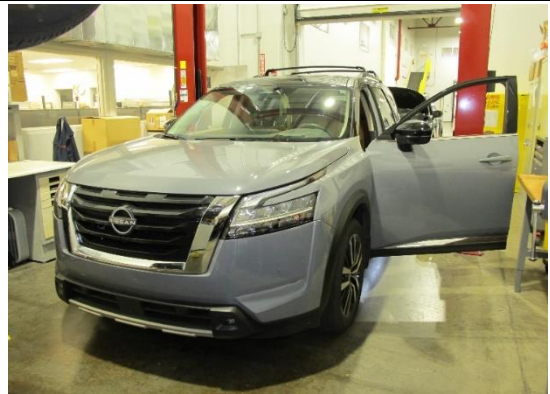
Figure 1

1. Open the driver's door (Figure 1).

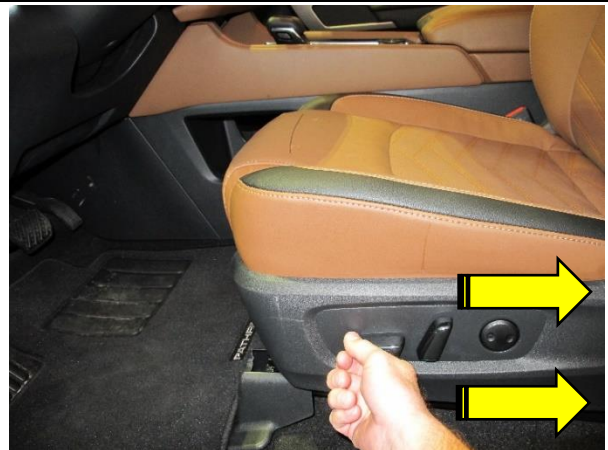
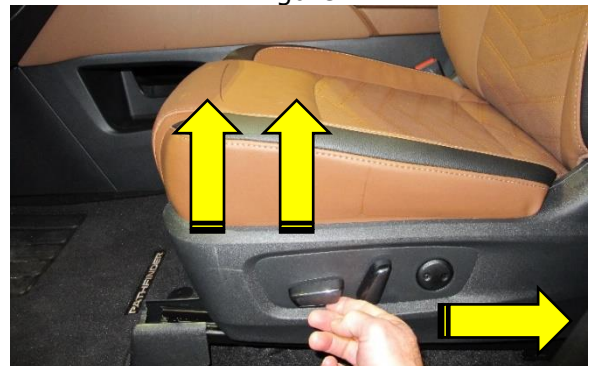
Figure 2

2. Move the driver's power seat to the full rearward and full up position (lift up & tilt up).

- Use the power seat switch to move the seat (Refer to Figures 2 and 3)

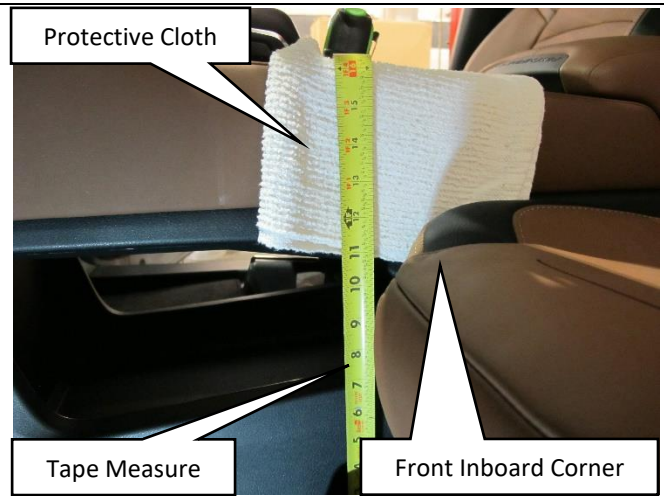
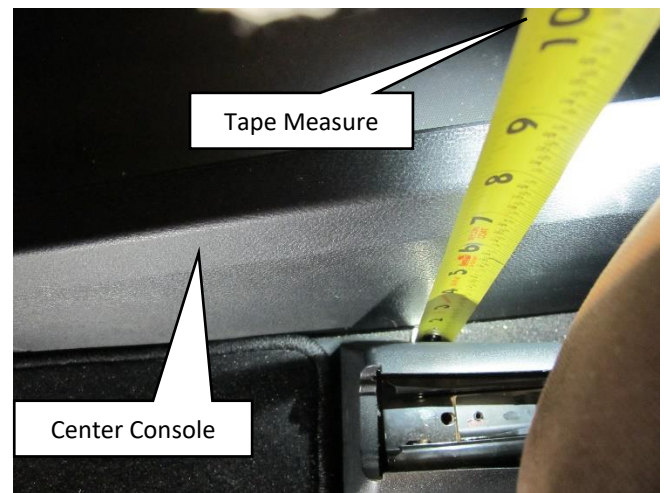
Figure 4

3. Place a tape measure between the center console and the front inboard corner of the driver seat (Figures 4 and 5).
- Make sure the end of the tape measure touches the floor of the vehicle

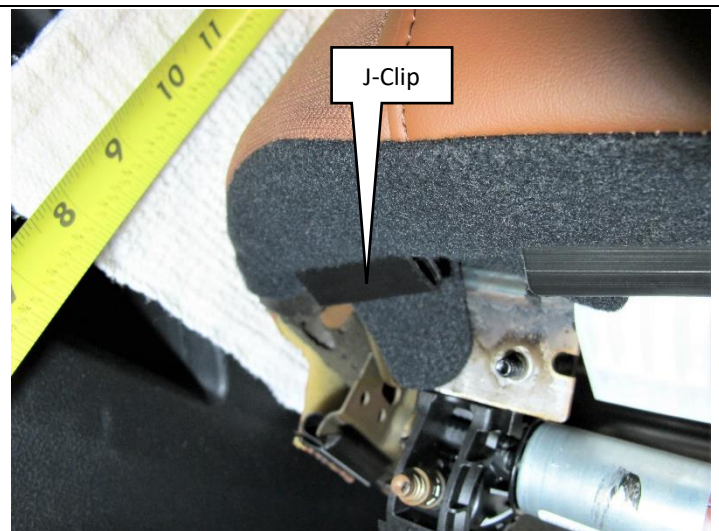
Figure 6

4. Locate the J-Clip under the front inboard corner of the seat (Figure 6).

7. Pull up at the J-clip location specified in Figures 6 and 7 (front inboard corner).

- If the front inboard corner of the seat **moves up**, use the tape measure as reference to measure the amount of **up** travel
- Document the amount of **up** travel in inches on the Repair Order for the driver's seat

- **YES** = Replace the affected front power seat cushion frame assembly per the Electronic Service Manual (ESM): **BODY INTERIOR-SEAT-UNIT DISASSEMBLY AND ASSEMBLY-FRONT SEAT-SEAT CUSHION-Seat Cushion.** Make sure to follow all ESM warnings and cautions.
- **NO** = No further action is required, refer to CLAIMS INFORMATION section submit a claim for the inspection.
