CAMPAIGN BULLETIN Seat Frame Weld

Reference: PC988

Date: September 15, 2023

PC988 – 2024 QX60 FRONT POWER SEAT FRAME WELD

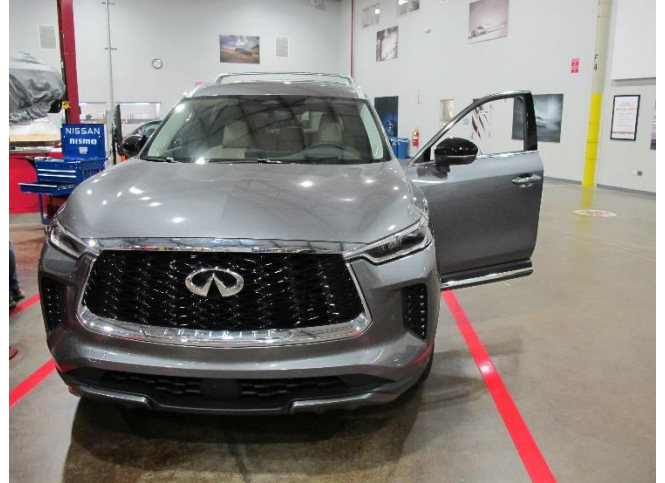
Figure 1

1. Open the driver's door (Figure 1).

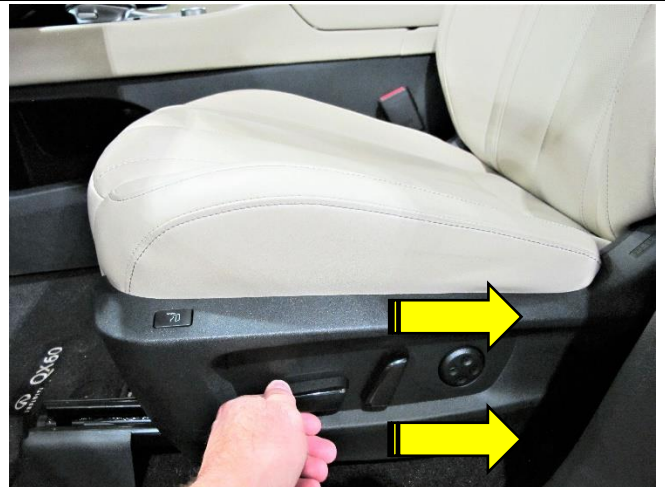
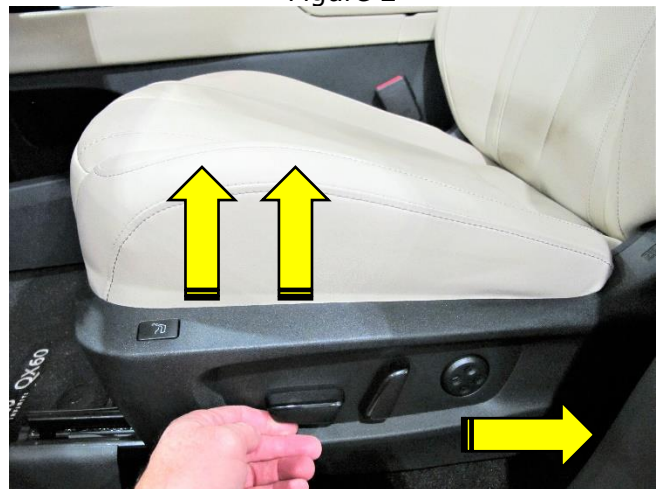
2. Move the driver's power seat to the full rearward and full up position (lift up & tilt up).

- Use the power seat switch to move the seat (Refer to Figures 2 and 3)

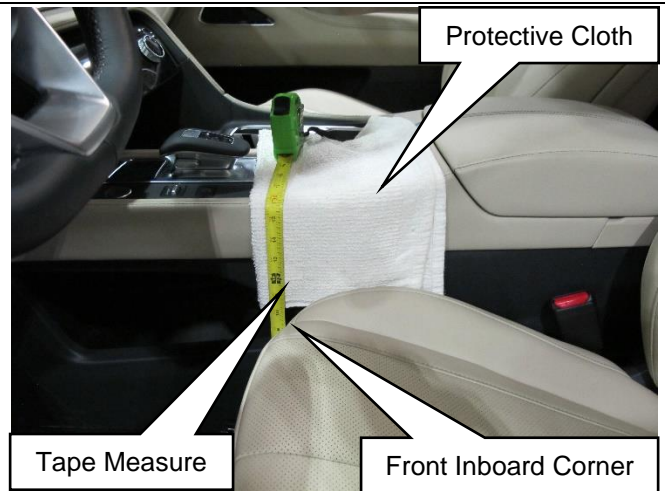
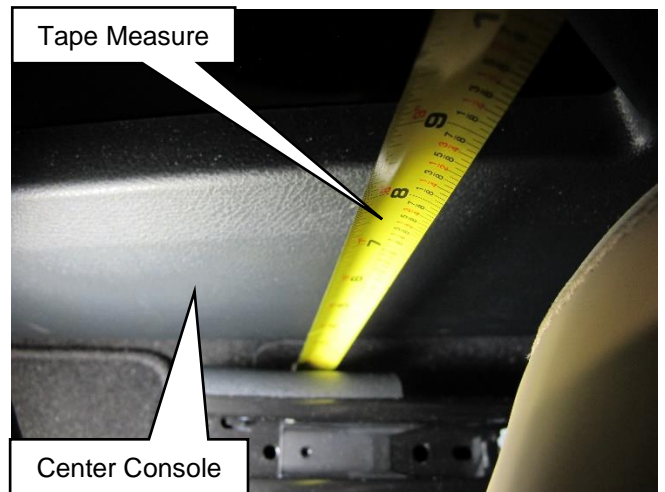
3. Place a tape measure between the center console and the front inboard corner of the driver seat (Figures 4 and 5).
- Make sure the end of the tape measure touches the floor of the vehicle

Note: It may be possible to hook the end of the tape measure under the center console.

- The other end of the tape measure can rest on top of the center console

Notice: To avoid damage to the center console, place a clean cloth between the tape measure and the center console.
