Service Bulletin

Bulletin No.: 23-NA-165

Subject: Vehicle Will Not Lock and Unlock (Loss of Active Functions) Crank or Start (Loss of Passive Functions) with DTC P0513 Set

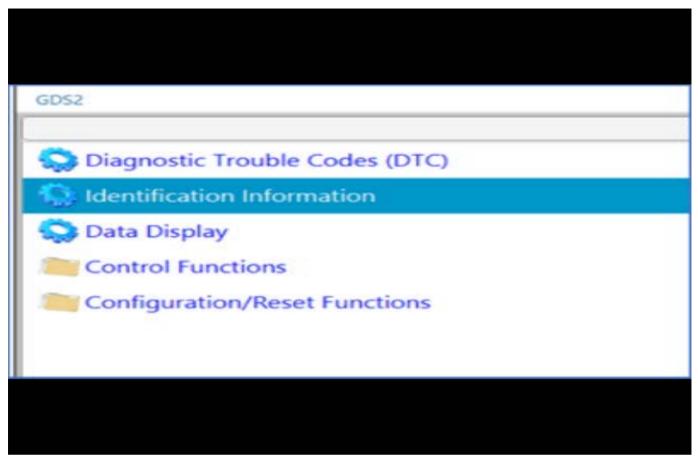
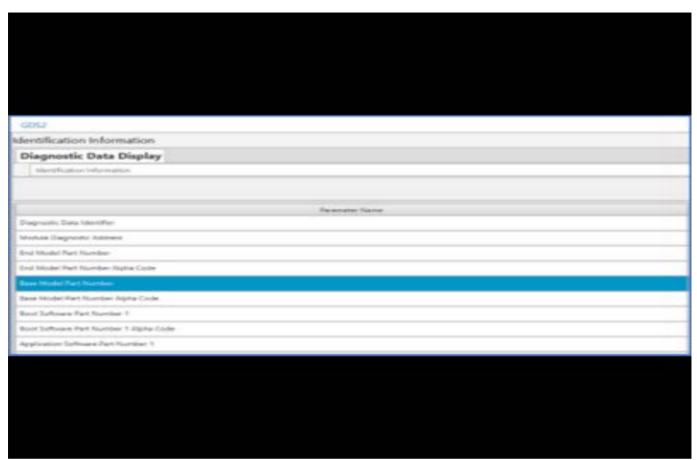
GDS2
Identification Information
Identification Information
Internal Control Module Performance Data

Verify you have a GEN3R BCM Base Model Part Number. Only GEN3R BCMS are eligible for this bulletin. Navigate to GDS2 > Module Diagnostics > [K9] Body Control Module > Identification Information > Identification Information.
