# Service Bulletin

Bulletin No.: 21-NA-228

Date: October, 2023

**Subject: Full Size Trucks Idle Time-out Disable**

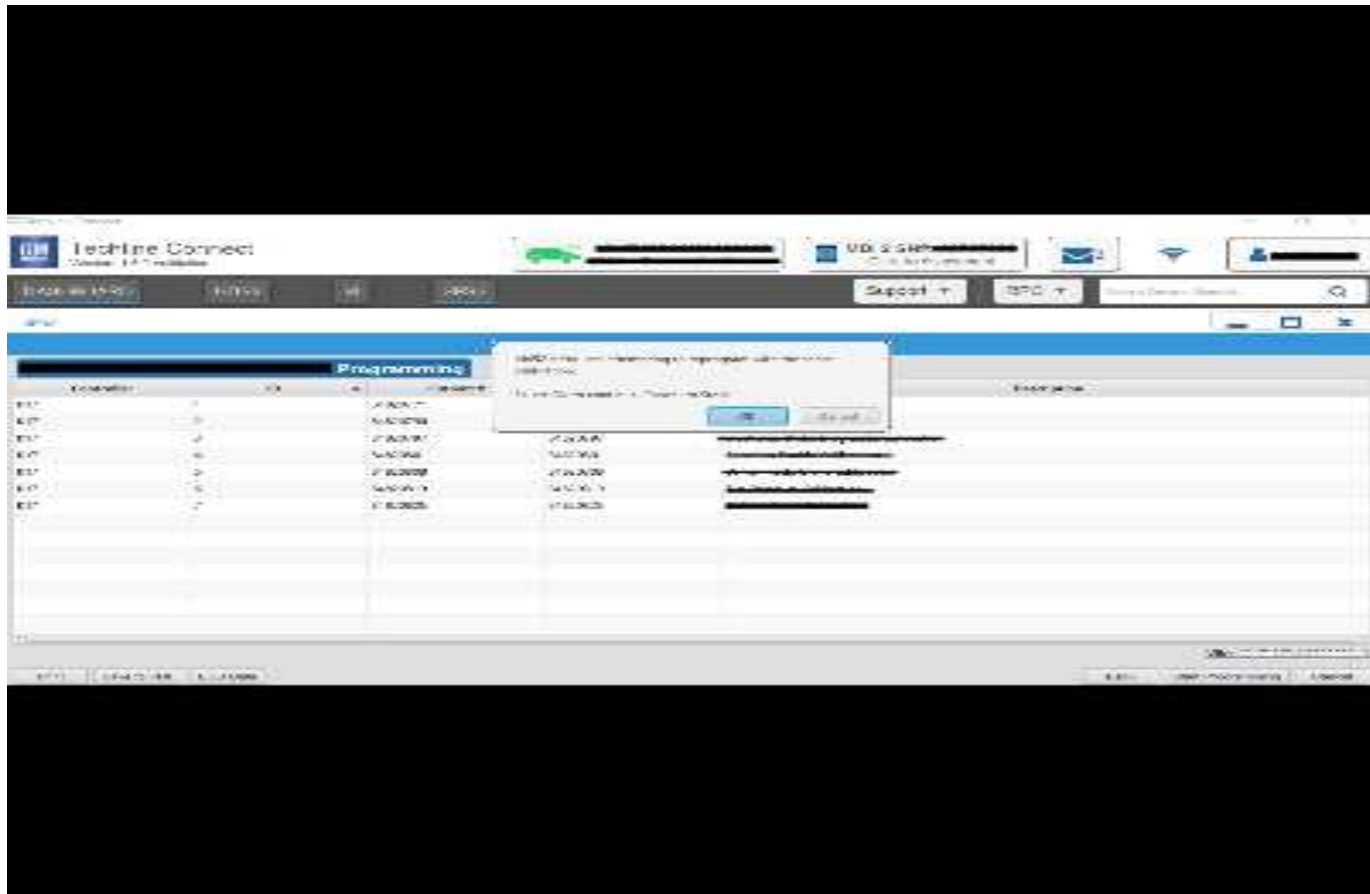
5644477

**Important:** Techline Connect screens shown above.

**Important:** If the same calibration/software warning is noted on the TLC Summary screen, select OK and follow screen instructions. After a successful programming event, the WCC is located in the Service Programming System dialogue box of the SPS Summary screen. No further action is required. Refer to the Warranty section of the bulletin.
