SIB 52 09 20

2023-10-20

**HEAD RESTRAINT AND/OR BACKREST OF 3RD ROW SEATS CANNOT BE FOLDED DOWN**This Service Information Bulletin (Revision 6) replaces SI B52 09 20 **dated August 2023**.**What's New:**

E-Series	Model Description
G07	X7 Sports Activity Vehicle

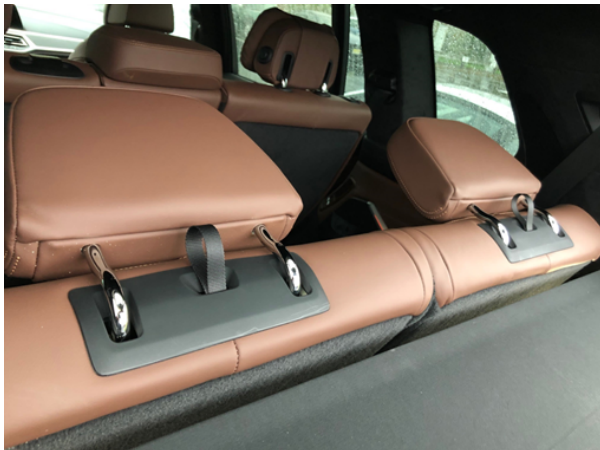
1. Head restraint cannot be folded down:

**YES** = Head restraint mechanism is faulty. Determine root cause of Bowden cable not moving (see steps below). If the cable is moving fully but the headrest is not folding, then replace the folding module of the head restraint (#2 in picture).

If the Bowden cable is mounted properly and cable correctly routed and the electric motor moving the common housing pulls all 3 Bowden cables equally but the headrest Bowden cable does not travel far enough, replace the Bowden cable for the headrest (shown in yellow in picture).

See REP 52 30 118 Remove and install/replace folding module of left or right head restraint

See REP 52 30 253 Replace Bowden cable for left or right head restraint (Bowden cable unlocking device for head restraint).

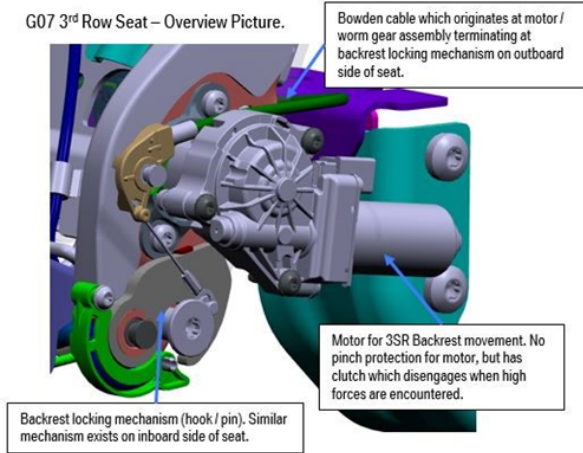
2. Third-row seating cannot be folded down:

Check if the latch (the fastener on the left or right side) of the third row of seats is open or closed? (this is the hook/pin shown in green in picture)
