GROUP	MODEL
ELE	2015-2017MY Soul EV (PS EV)
NUMBER	DATE
310	October 2023

TECHNICAL SERVICE BULLETIN

HIGH-VOLTAGE BATTERY PACK AND BATTERY MANAGEMENT SYSTEM

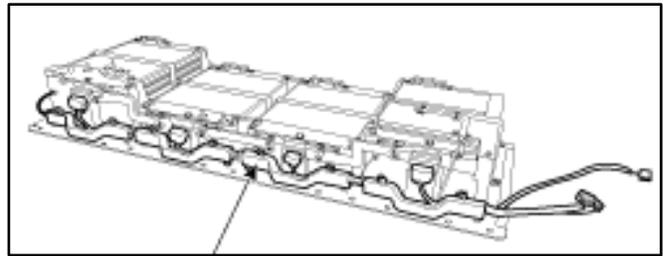
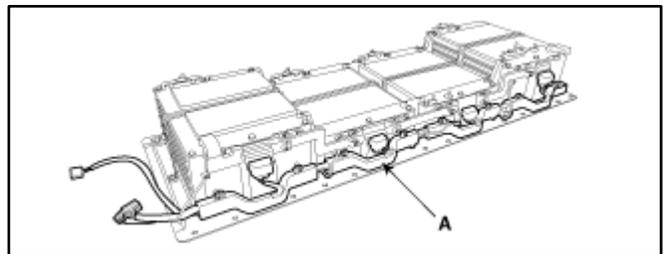
Note: The new harness is different for the removed harness when compared side by side.

- Replace the two voltage temperature sensor wire harnesses (VTSWH) with the 'new' parts.
