Subject: WATER LEAK AROUND THE OVERHEAD CONSOLE	Bulletin No.: 09-034/23
	Last Issued : 10/09/2023

2024 CX-90 (with panorama sunroof) with VINS lower than JM3KK*****121941 (produced before July 12, 2023)

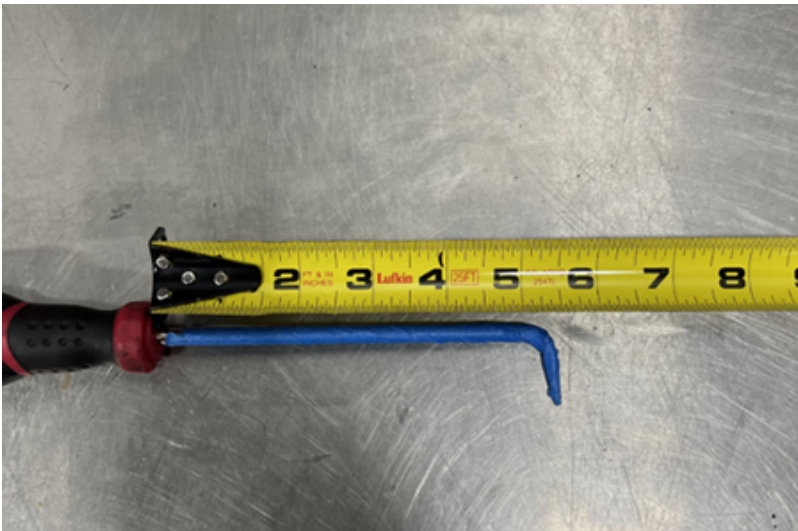
3. To aid in the repair procedure, a 90 degree pick tool may be used.

- The shank length should be at least 5.5" in length with a pick end about 1" long maximum.
- Wrap the metal shank and tip of the tool with tape to insulate the tool and conceal the pointed end of the pick and to prevent damage to the hose(s) from the sharp point of the tool.
