# Service Alert

<b>Subject:</b>  <b>WATER LEAK FROM ROOF CAUSING ELECTRICAL AND MECHANICAL CONCERNS</b>	<b>Service Alert No.: SA-074/23</b>
	<b>Last Issued : 10/31/2023</b>

2020-2024 CX-30

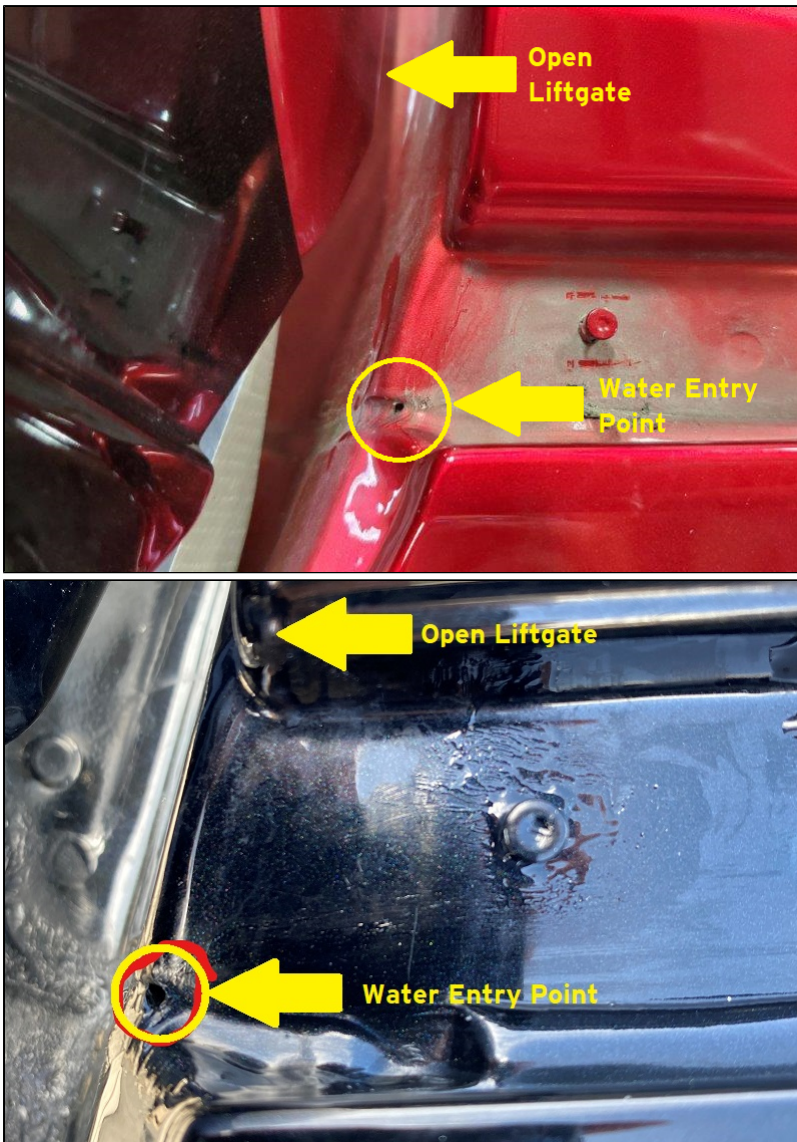
The source of the leak may be pinhole anywhere along the roof seams under the 2 trim strips (where the roof rails attach). Depending on the location of the leak, the headliner may or may not be visibly affected.

3. If no leak source was found in step 2, check the rest of the panel seams under the roof trim. If leaks are found there, sublet to a body shop for repairs.
4. If no leaks are found in steps 2 & 3, check the sunroof drains. If the hoses are detached, attach them to the correct locations. If they are damaged or kinked, replace them.
5. If no leaks were found in steps 4, 5, & 6, check for leaks from doors or glass. Recheck for leaks with the headliner lowered or removed. Repair as needed.
6. Repair or replace components that were damaged by the water leak. Take photos for warranty documentation.
