Release Date	10/24/2023	Technical Service Bulletin		
97HJ UPDATE

Audi
Retrofitting Cable Holder – (NVLW)

This Update has been proactively released to prevent the following condition(s) from occurring in the vehicle:	
Criteria	Technical Background
01	On Audi e-tron GT vehicles manufactured within a specific period, the movement of the wiring harness in the area of the rear lid hinge may be restricted.

Criteria	Remedy
01	The cable routing will be modified on the affected vehicles and an additional cable holder will be added.

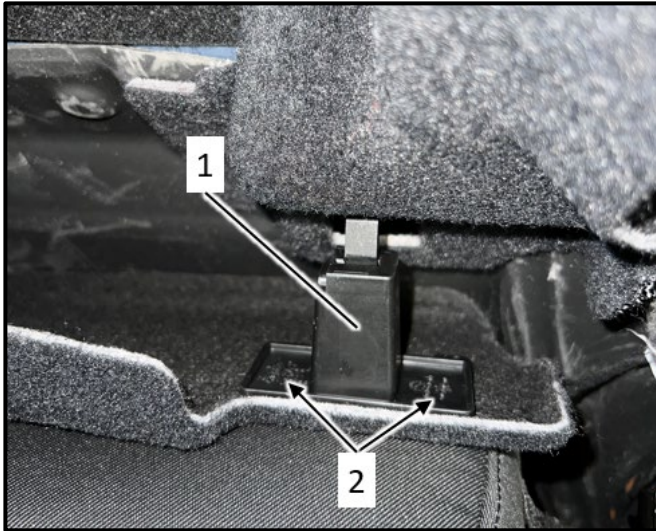
The front luggage compartment trim panel mounts <1> can detach from the trim panel if force is used when loosening the trim panel.

- When loosening the front luggage compartment trim panel, pry on the plastic mount in the areas indicated <2> using a suitable tool.
