**SERVICE BULLETIN**

**APPLICABILITY:** 2019-23MY Impreza  
 2019-23MY Crosstrek (Including Hybrid Model)  
 2019-23MY Forester  
 2019MY Legacy/ Outback  
 2019-21MY WRX  
 2019-21MY WRX STI  
 2019-21MY BRZ- Navigation -equipped ONLY  
 2019-22MY Ascent

**NUMBER:** 15-236-18R

**SUBJECT:** Reprogramming File Availability for Optimization of Harman Gen 3.1 and Gen 3.1α Audio and Navigation Head Units

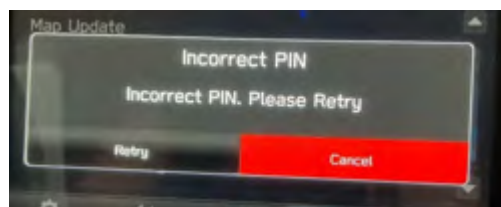
- 8) Repair Facility POI icons are now shown on the NAVI map display. See **NOTE 4** below.
- 9) Activation Code Not Accepted by Navigation System when updating Map Data

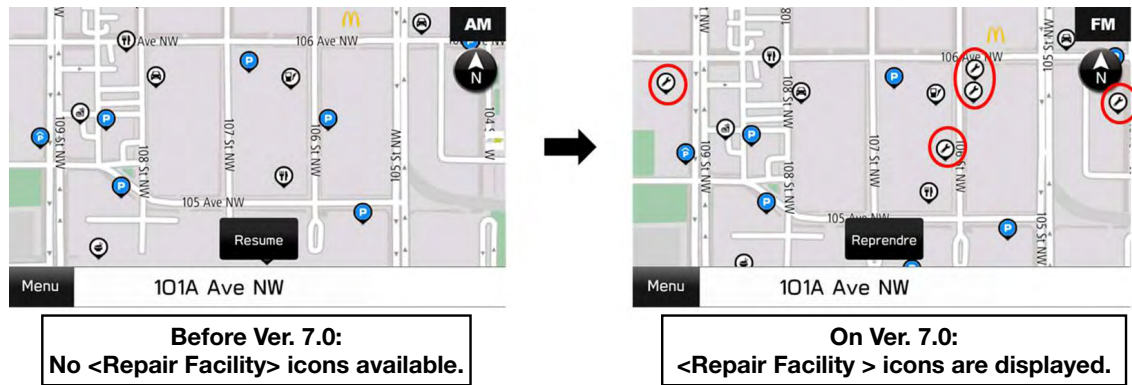
**NOTE 4:** Displaying Repair Facility POI icons:

<Repair Facility> Icons can be displayed in the NAVI Map.

<Repair Facility> Icons can be turned On or OFF by going to: Settings > Navigation > POI Icons.

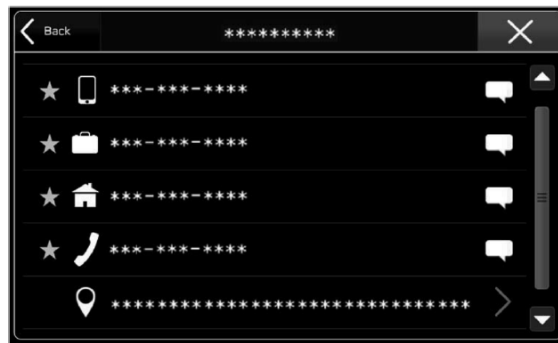
- 1) AM/FM radio station presets are lost.
- 2) Favorite Phone Contacts list is lost.

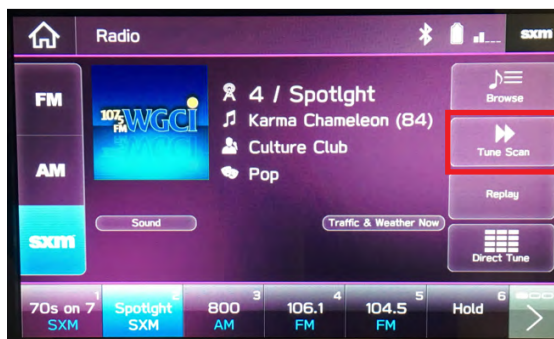
<Scan> previously displayed on SXM screen was changed to <Tune Scan> (a.k.a. SEEK).
