Technical product information

Topic	New Continental GT and GTC - Window drop glass operation
Market area	Australia E04 Bentley rest Asia and Australia (6E04),China 723 Volkswagen (Anhui) Automotive CO (6723),China 796 VW Import Comp. Ltd (Vico), Beijing (6796),Germany E02 Bentley rest Europe (6E02),Japan E03 Bentley Japan (6E03),Korea, (South) E08 Bentley South Korea (6E08),United Arab Emirates E06 Bentley Middle East and Africa (6E06),United Kingdom E01 Bentley UK (6E01),United States E05 Bentley USA and rest America (6E05)
Brand	Bentley
Transaction No.	2070497/5
Level	EH
Status	Approval
Release date

New Continental GT and GTC

Retailer glass reset procedure for GT/GTC

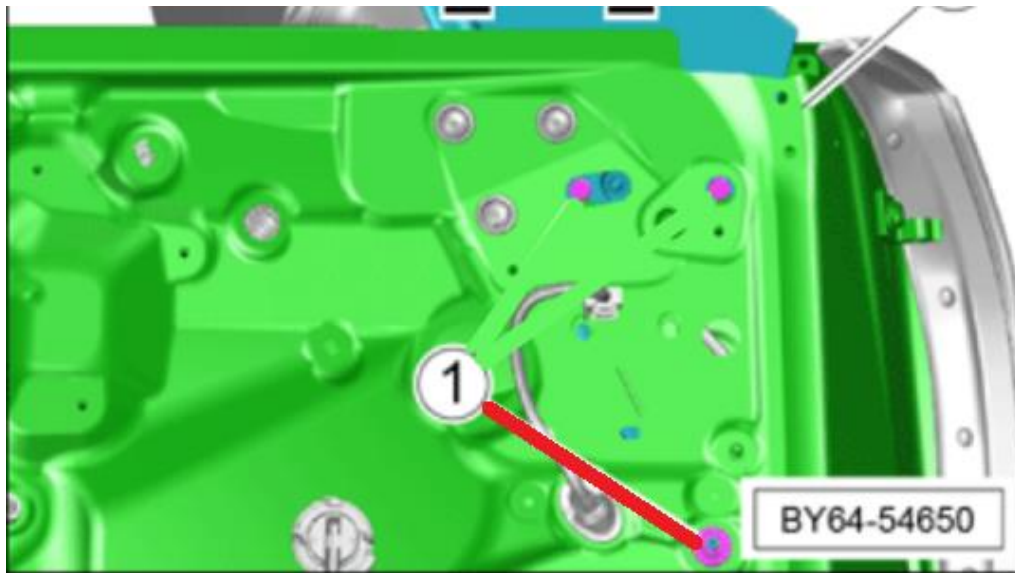
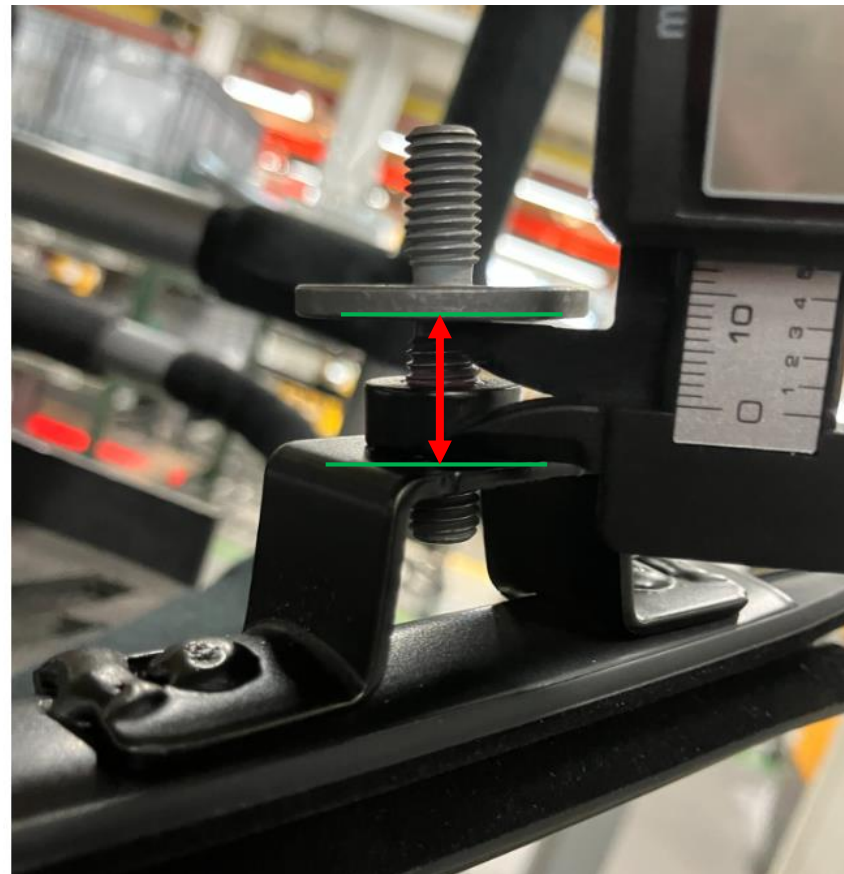
Image for reference, glass does not require removal from vehicle

To reset this adjuster without removing the quarter glass, loosen the lock nut, screw the adjuster all the way in clockwise until it bottoms out on the frame, then unscrew anti clockwise 4 complete turns then set height and profile to ELSA specification before moving on to the next step.
