GROUP	MODEL
TRA	2020-2022MY Multiple Models
NUMBER	DATE
105	November 2023

TECHNICAL SERVICE BULLETIN

4WD COUPLING NOISE INSPECTION AND SNAP RING REPLACEMENT

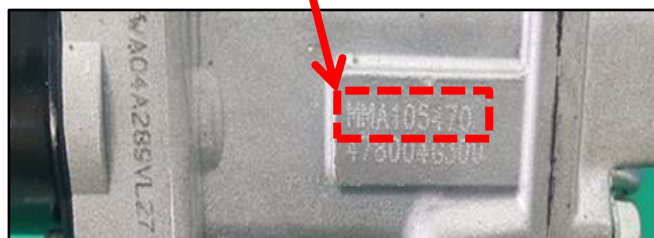
4. Notate the nine (9) digit serial number (A).

Note: If the serial number is illegible, replace the coupling assembly with DPSM approval. (DSA-A dealers do not require DPSM approval.)

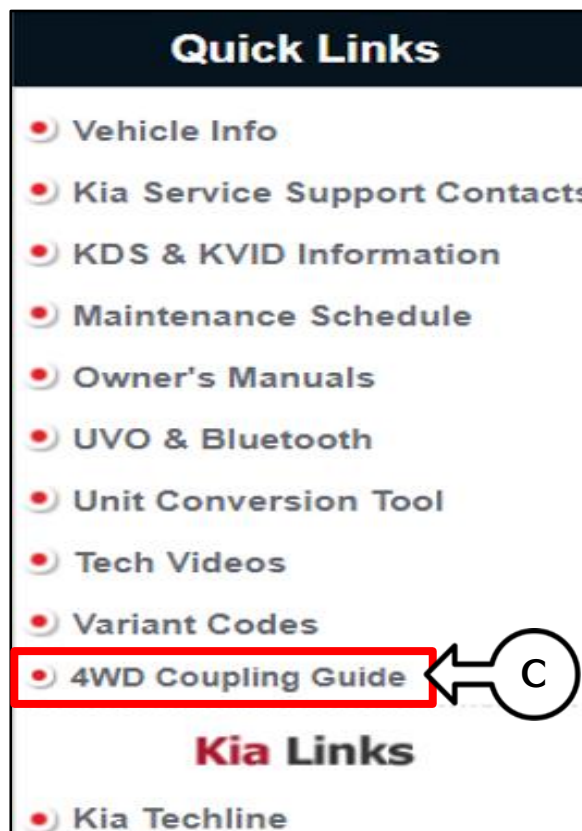
5. Select the '4WD Coupling Guide' (C) located in the 'Quick Links' section of KGIS.

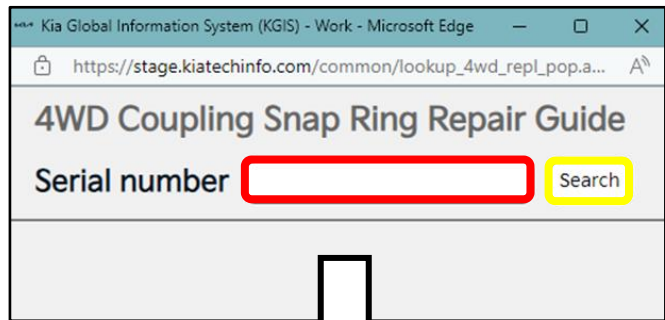
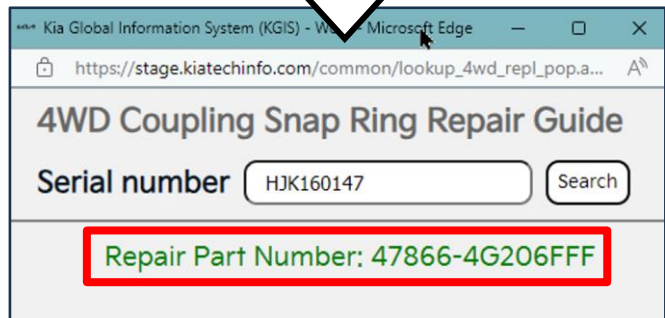
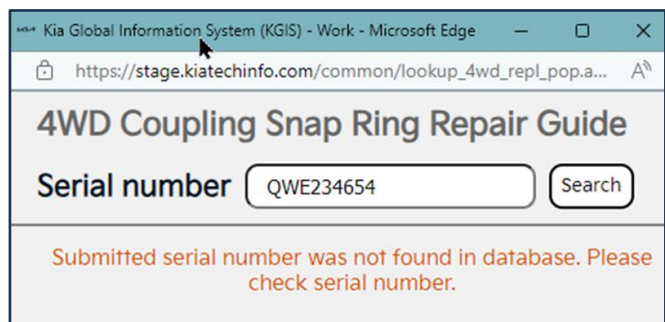
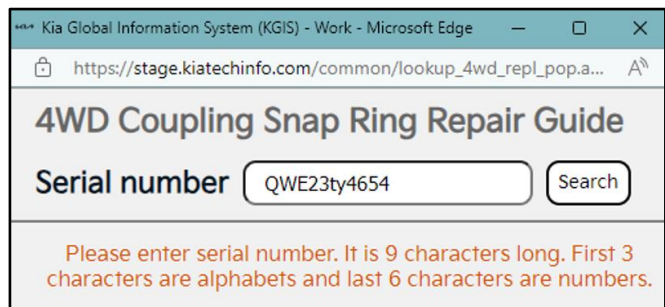
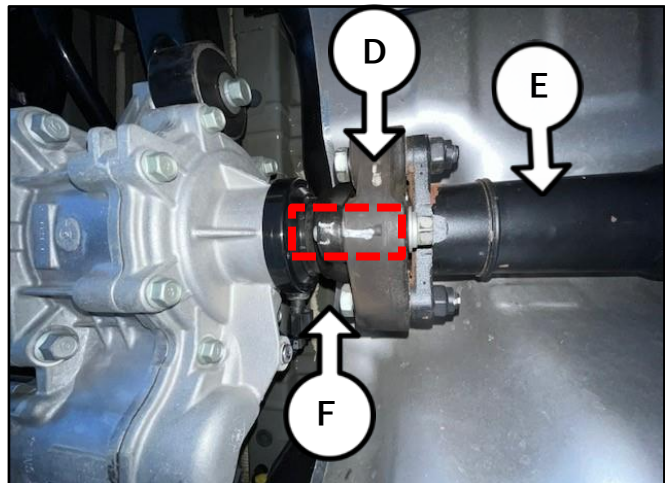
6. Enter the nine (9) digit serial number (A) into the '4WD Coupling Snap Ring Repair Guide' pop-up window, as shown.
7. Select 'Search'.

The corresponding snap ring part number will be displayed in **green**.

- If the incorrect serial number is input, the pop-up displays the message 'Submitted serial number was not found in database. Please check serial number.'. Clear and reenter the serial number.
- If too many numbers are input, the pop-up displays the message 'Please enter serial number. It is 9 characters long. First 3 characters are alphabets and last 6 characters are numbers.'. Clear and reenter the serial number.

8. Make an alignment mark on the rubber coupling (D) of the propeller shaft (E) and a corresponding mark on the 4WD Coupling (B) flange (F).
