Title: Baseline 1065/1066 Update**Applicability:** MY20 Revero GT and GTS,
and MY21-MY23 GS-6 vehicles**PRIORITY:** Vehicles on list (page 2)**PURPOSE:**

Type: Baseline Release

System: General Diagnosis

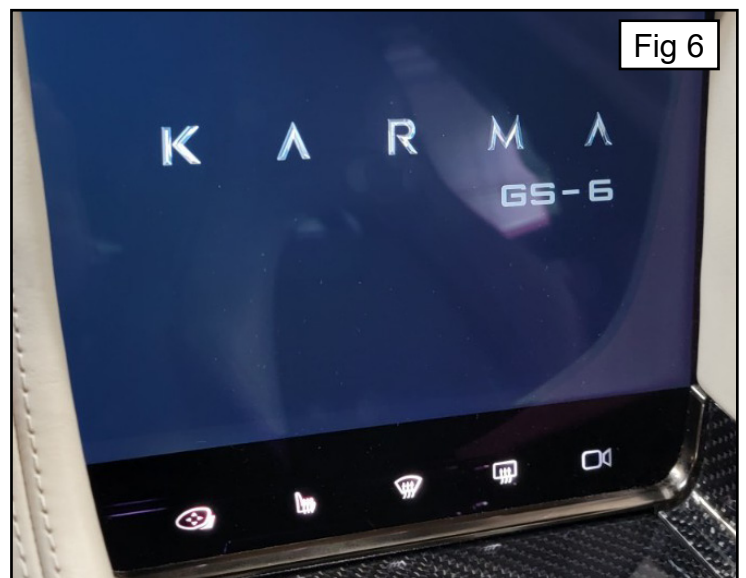
The reboot may take several minutes, even after placed in ready mode, wait until complete. if it does not reboot, turn off the vehicle and consult TSS and follow provided guidance.
