HYUNDAI Technical Service Bulletin	GROUP AUTOMATIC TRANSMISSION	NUMBER 23-AT-006H-2
	DATE NOVEMBER 2023	MODEL PALISADE (LX2) SANTA FE (TMA) SANTA FE HYBRID (TM/TMa HEV) SONATA (DN8A) SONATA HYBRID (DN8 HEV) TUCSON (NX4/NX4A) TUCSON HYBRID (NX4 HEV)
SUBJECT: AUTOMATIC TRANSAXLE PUSH-BUTTON SHIFTER DIAGNOSIS

This TSB supersedes TSB 23-AT-006H-1 to add additional information regarding harness damage repair for Tucson (NX4A), Step 6.

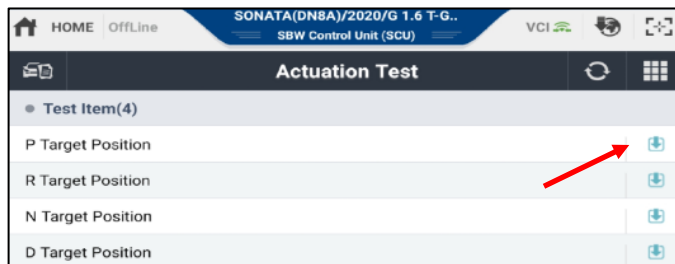
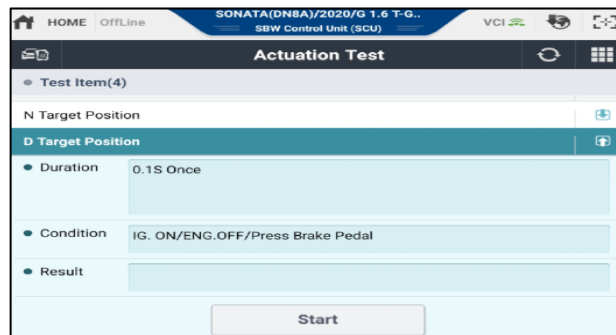
5. Turn the engine off and push the SSB 2 times to turn the ignition **ON**. Press the brake pedal. From the GDS home screen, select **Actuation Test** and **SCU** menu. Test the Target position for P, R, N and D. Press the arrow to change the selection. If the GDS and cluster show:
- Correct **Target Position** for P, R, N and D: The SCU sent electrical current to the SBW actuator, the SCU and SBW actuator are currently operating correctly and the related harness currently does not have an open/short circuit. Go to Step 6.
 - Does not show the correct **Target Position** for P, R, N and D: The SCU, SBW actuator or related harness may have a fault.
