**HYUNDAI**
Technical Service Bulletin

GROUP CAMPAIGN	NUMBER 23-01-085H-1
DATE NOVEMBER 2023	MODEL(S) TUCSON (NX4A) SANTA CRUZ (NXT)

SUBJECT: WINDSHIELD WATER LEAK REPAIR (SERVICE CAMPAIGN 9A6)

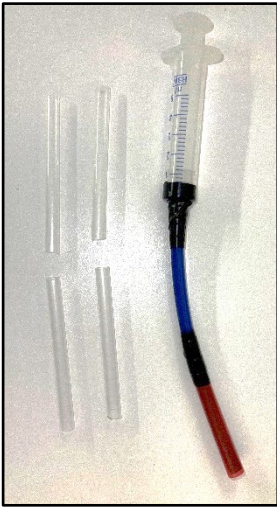
Part Name	Part Number	Figure	Remarks
Syringe Kit	SVC9A-6SYRINQQH

<p><u>Contents:</u> 1 syringe and 4 barrier tubes</p> <p>For dealer stock units, perform this repair on all affected vehicles at the same time.</p> <p>Use a new syringe if the sealant has solidified inside the syringe.</p>
Permatex Windshield and Glass Sealant	N/A
