**RAPID UPDATE**

# Rapid Update 667 Grecale – Gearbox Wiring Check

DATE: OCTOBER 18 2023

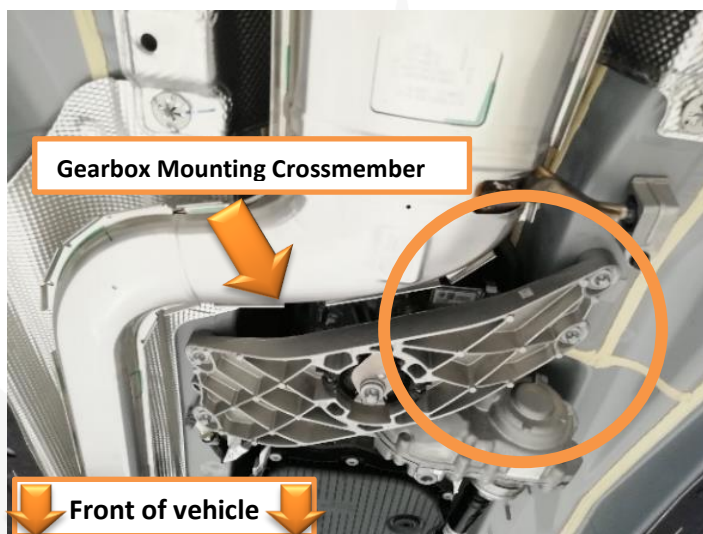
1. Always check ModisCS+ to see if the vehicle is involved in this action and if it has not been previously performed.
2. Safely lift the vehicle on a lift and inspect the area around the gearbox mounting cross member.
