Subarunet Announcement

From: Subaru of America, Inc.

Date: November 10, 2023

New Safety Recall/STOP SALE: WRP-23 Driveshaft Failure

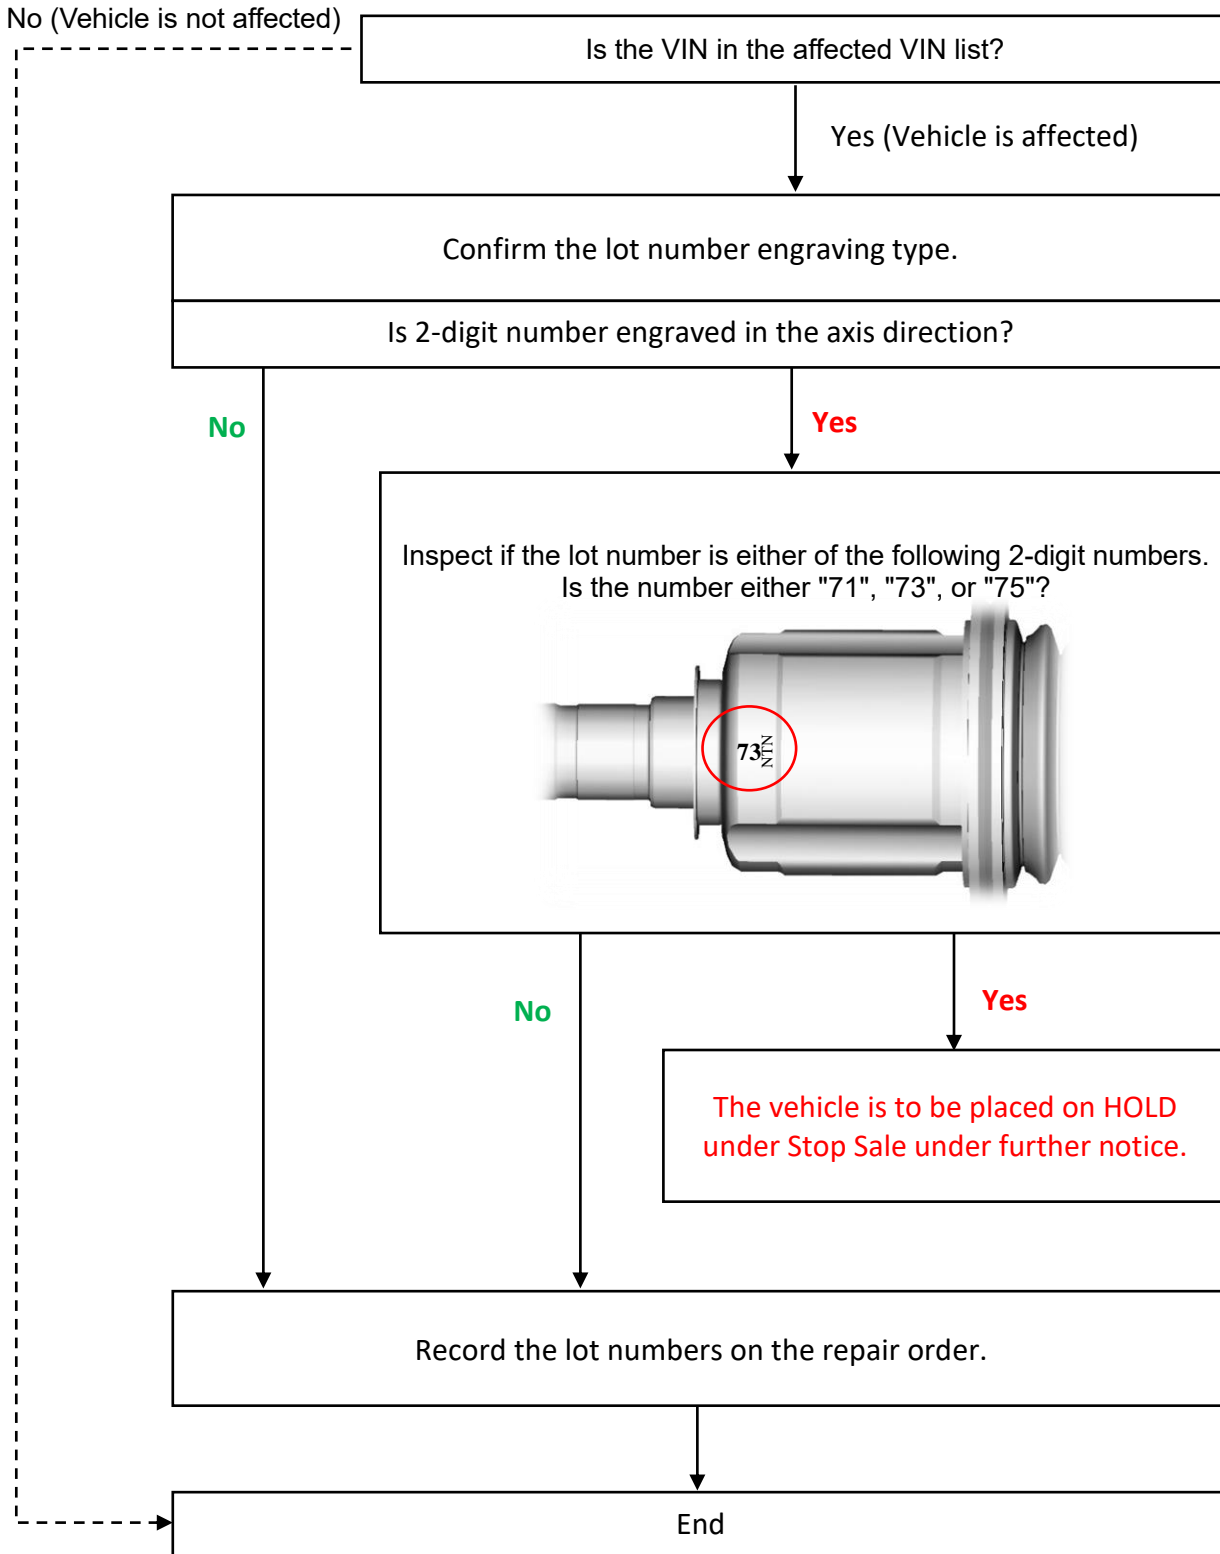
SERVICE PROCEDURE FLOWCHART:

For stop sale vehicles only, Subaru retailers should inspect the front drive shaft lot numbers. If the affected lot number is found, the vehicle is to remain on HOLD under this stop sale until recall remedy parts are available. A future announcement will be made when parts are available.

STEP 4: Do any of the drive shafts require replacement?

YES: The vehicle should remain on HOLD under Stop Sale until remedy parts are available. No claim should be submitted until the affected driveshaft(s) are replaced.
