## SERVICE BULLETIN

**APPLICABILITY:** 2020-22MY Legacy and Outback Models

**NUMBER:** 15-261-20R

**SUBJECT:** Reprogramming File Availability for Optimization  
 of Gen 4 Denso CP1 Infotainment Systems

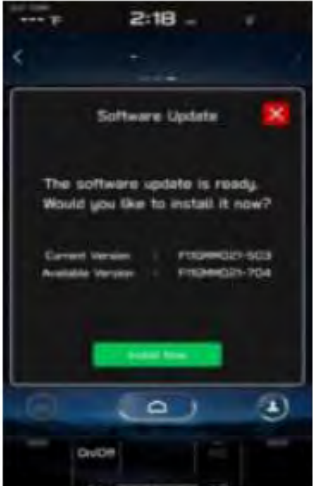
| Number | Symptoms to be Improved: |
|---|---|
| 1 | <p>System restarts itself during FOTA (Firmware Over The Air) update. FOTA operation is conducted in two processes: downloading (from the server to the Cockpit Control Unit via Wi-Fi) and installation (inside the Cockpit Control Unit). During the FOTA operation, after the new software has been downloaded to the Cockpit Control Unit (CCU) customer is to push “Install Now” on the Center Information Display (CID) to start installation of the software.</p> <p><b>FOTA Normal process</b></p> <p><b>However, in rare case, the CCU restarts itself* during installation.</b></p> <p><b>Linux reset occurs</b></p> <p><b>Note*</b> Even if this symptom occurs, after approximately 2 minutes, the system resumes, and the CID comes back to the below screen. Customer can then push the “Install Now” to proceed with the installation.</p> |

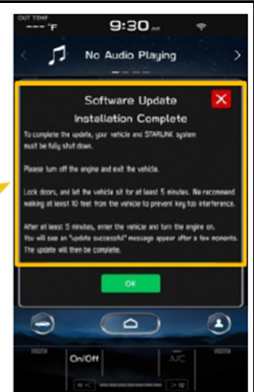
| Number | Symptoms to be Improved: |
|---|---|
| 2 | <div style="display: flex; align-items: center;"> <div style="flex: 1;"> <p>Clarification of the post-FOTA procedure instructions required to complete the update. The screenshot below will appear and explain what must be done to complete the update installation.</p> <div style="border: 1px solid black; padding: 5px; margin-top: 10px;"> <p><b>Software Update Installation Complete</b><br/>To complete the update, your vehicle and STARLINK system must be fully shut down. Please turn off the engine and exit the vehicle. Lock doors, and let the vehicle sit for at least 5 minutes. It is recommended to walk at least 10 feet from the vehicle to prevent key fob interference. After waiting at least 5 minutes, enter the vehicle and turn the engine on. An “Update Successful” message will appear after a few moments. The update will then be complete.</p> </div> </div> <div style="flex: 1; text-align: center;"> </div> </div> |
