SERVICE PROGRAM BULLETIN

APPLICABILITY: 2020-2021MY Legacy and Outback **NUMBER:** WRI-20R
SUBJECT: Reprogramming of Denso CP1 Infotainment Units to Optimize System Performance **DATE:** 12/11/20
REVISED: 11/13/23

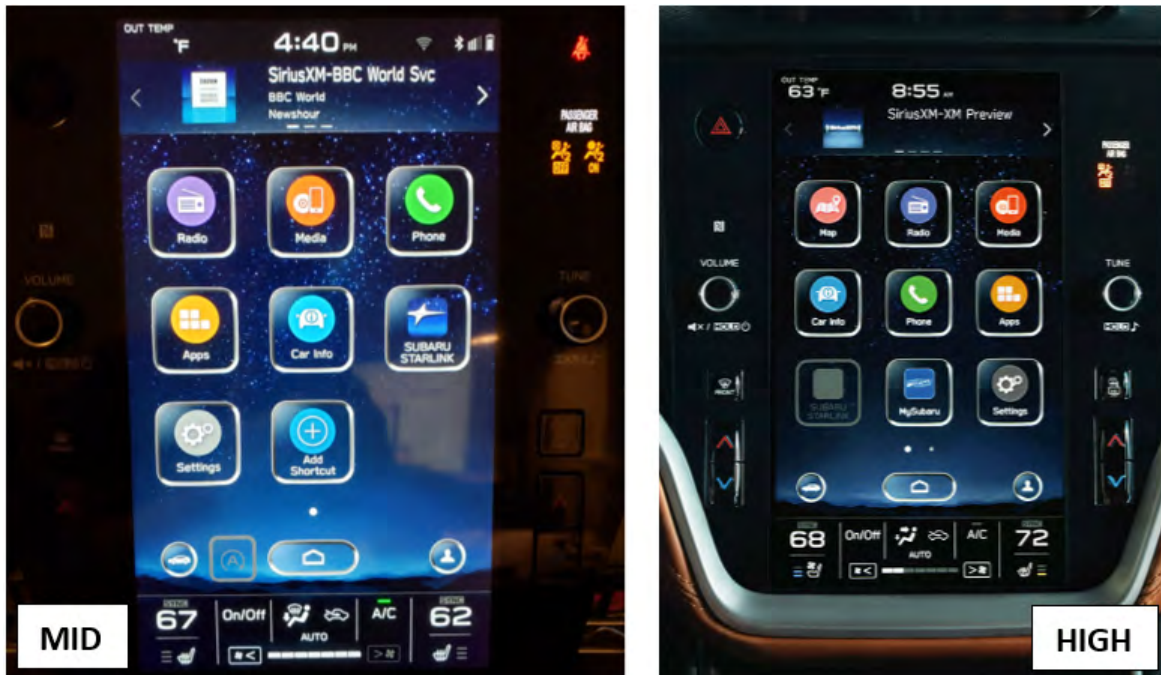
This Campaign affects certain “Mid” and “High” (w/ Navigation) -level CP1 Head Units with 11.6-inch display ONLY as pictured below. The “Base” model (2- 7.0-inch display screen unit) is NOT affected.
