**SERVICE BULLETIN**

**APPLICABILITY:** 2017-18MY Impreza  
 2018MY Crosstrek  
 2018MY Legacy and Outback  
 2018MY BRZ\*

**NUMBER:** 15-211-17R  
**DATE:** 06/13/17  
**REVISED:** 11/13/23

**SUBJECT:** Reprogramming File Availability for Additional Optimization of Harman Gen 3 Audio and Navigation Head Units

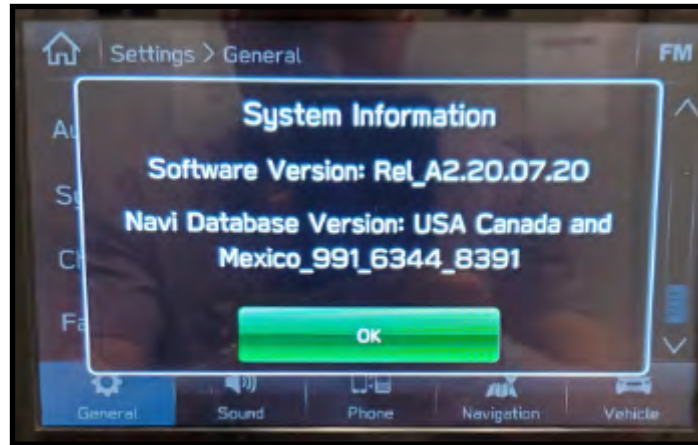
- Confirm the current Software Version ID. If the Current Version is **Rel\_A2.22.10.20, Rel\_A2.22.39.20, or Rel\_A2.23.10.20** STOP as this latest update has already been installed.

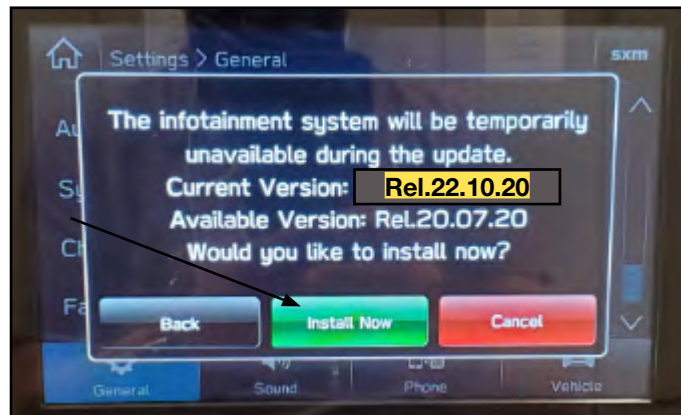
- The current and available software version information will be displayed. The Available Version I.D should be **Rel\_A2.22.10.20**.

**NOTE:** The displayed Available Version as shown below does not show the \_U0 after the Rel. This is normal.

- After confirming the Available Version, press “Install Now” to start the reprogramming process. The screen will go blank (black) for a brief period after installation begins.
- Each of the updates (Base, Mid and High) should take less than 10 minutes to install.

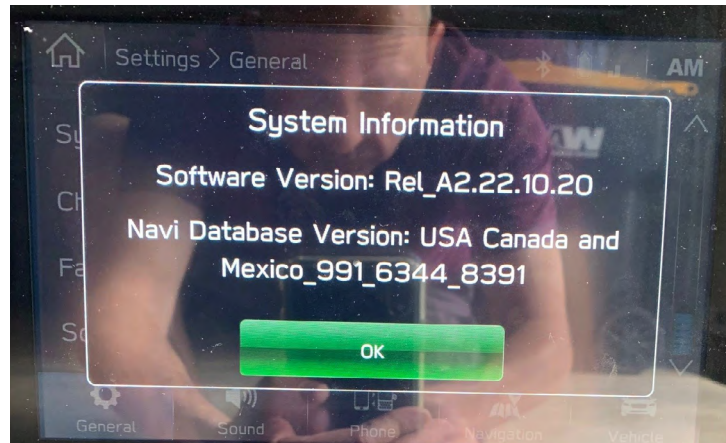
- Confirm Software Version is now “**Rel\_A2.22.10.20**”.

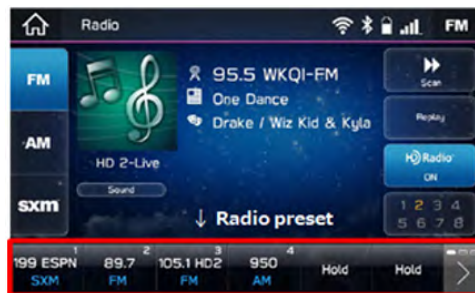
- Update to address some or all AM/FM station presets becoming lost and replaced by “Hold”

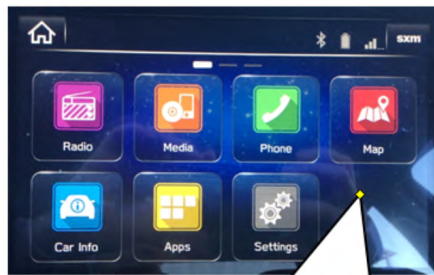
**Normal HOME screen with icons**

- On 2018MY Legacy / Outback models with Navigation (High) head units, the update corrects a condition where the head unit remains powered even after the ignition is OFF and the driver door is opened.
- Update for a condition where the SXM presets become lost and only “Initializing” appears as shown below.
- Update for condition where only the star field background is displayed (without icons) after the HOME button is pressed.

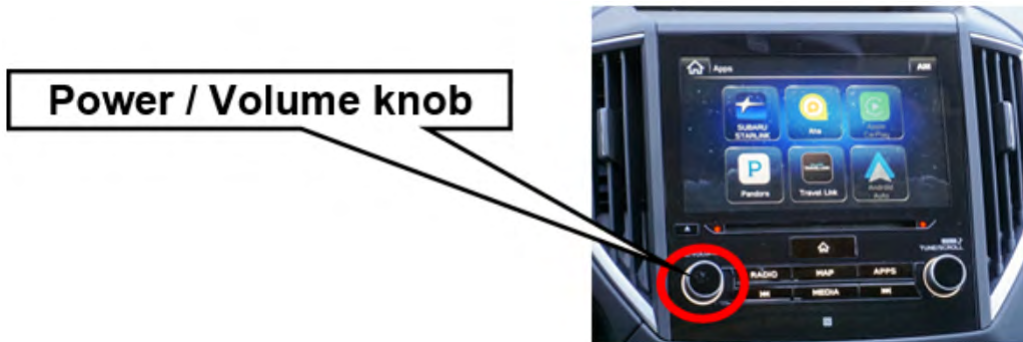
- The Mute function of the Power / Volume knob (a brief press and release of the Power / Volume knob to mute audio output) is unchanged.
- A “system reboot” function is initiated by pressing and holding the Power / Volume button for 10 seconds. This feature was included as part of the previous (11/2017) software update.
