SERVICE BULLETIN

APPLICABILITY: 2023MY Ascent
 2024MY Crosstrek
 2023-24MY Legacy/Outback

NUMBER: 15-315-23
DATE: 11/17/23

SUBJECT: Telematics Data Communications Module (DCM) Product Improvement Reprogramming

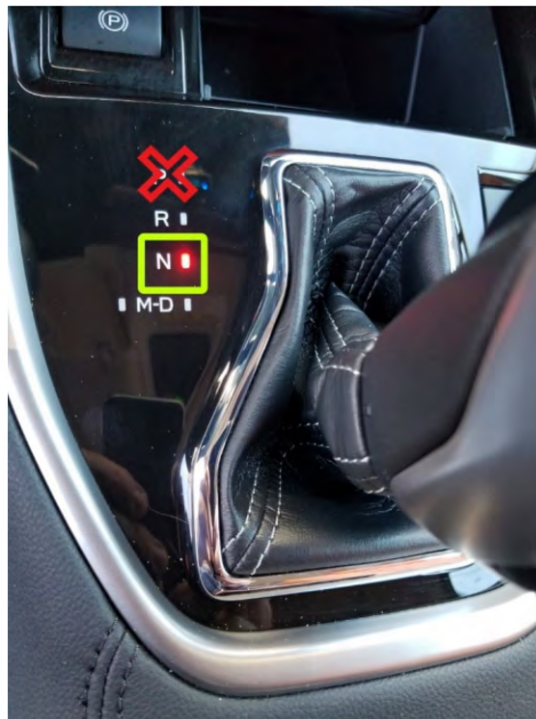
CRITICAL: This reprogramming procedure takes approximately 2 hours. Maintaining the battery during the software reprogramming is mandatory. Ensure the Midtronics GR8 / Midtronics DCA-8000 set to Power Supply Mode is connected to the vehicle, the parking brake is engaged, ignition is in the “ON” position, the engine is OFF, the shift selector is in NEUTRAL and the wheels are blocked. Having the vehicle in Neutral must be done to ensure the power supplied to the DCM is not turned off. If this step is not performed, the CAN will power down the DCM during the reprogramming, and the procedure will fail, resulting in irreparable DCM damage.

- For instructions on using the Power Supply Mode, reference the applicable User Manual for the Midtronics DCA-8000 Dynamic Diagnostic Charging System and the Midtronics GR8-1100 Diagnostic Battery Charger on STIS.
- Confirm all electrical loads such as lights, audio, HVAC, seat heaters, and rear defroster are all switched OFF before setting up the charger for Power Supply Mode.
- Select the correct battery type (Enhanced Flooded, Flooded, Gel, AGM, or AGM Spiral).
- Input the CCA, which matches the vehicle’s battery.
