SIB 52 09 20

HEAD RESTRAINT AND/OR BACKREST OF 3RD ROW SEATS CANNOT BE FOLDED DOWN

E-Series	Model Description
G07	X7 Sports Activity Vehicle

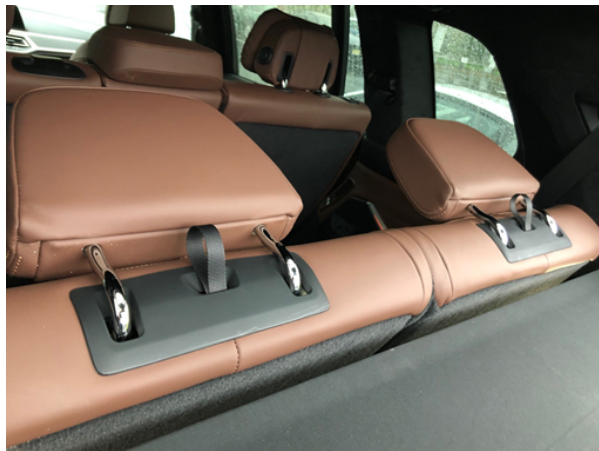
1. Head restraint cannot be folded down:

YES = Head restraint mechanism is faulty. Determine root cause of Bowden cable not moving (see steps below). If the cable is moving fully but the headrest is not folding, then replace the folding module of the head restraint (#2 in picture).

See REP 52 30 118 Remove and install/replace folding module of left or right head restraint

NOTE: The head restraint cannot be removed without destroying the covering material. **A new cover (leather) will be required to perform this repair.**

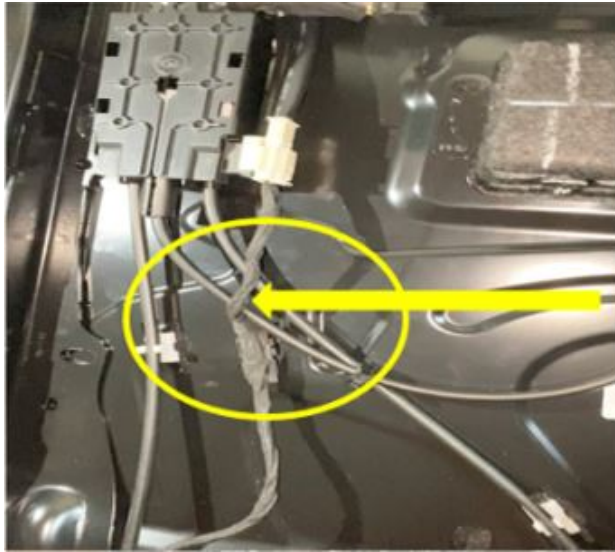
3. Noise from third-row seat backrest when vehicle goes over bumps:

The wire harness going to the electric motor for the Bowden cables is supposed to be routed underneath the Bowden cables to keep the cables from vibrating against the back metal panel.

Replace seat frame assembly if necessary.
