Technical product information

Topic	New Continental GT and GTC - Window drop glass operation
Market area	Australia E04 Bentley rest Asia and Australia (6E04),China 723 Volkswagen (Anhui) Automotive CO (6723),China 796 VW Import Comp. Ltd (Vico), Beijing (6796),Germany E02 Bentley rest Europe (6E02),Japan E03 Bentley Japan (6E03),Korea, (South) E08 Bentley South Korea (6E08),United Arab Emirates E06 Bentley Middle East and Africa (6E06),United Kingdom E01 Bentley UK (6E01),United States E05 Bentley USA and rest America (6E05)
Brand	Bentley
Transaction No.	2070497/6
Level	EH
Status	Approval
Release date

Retailer glass reset procedure for GT/GTC

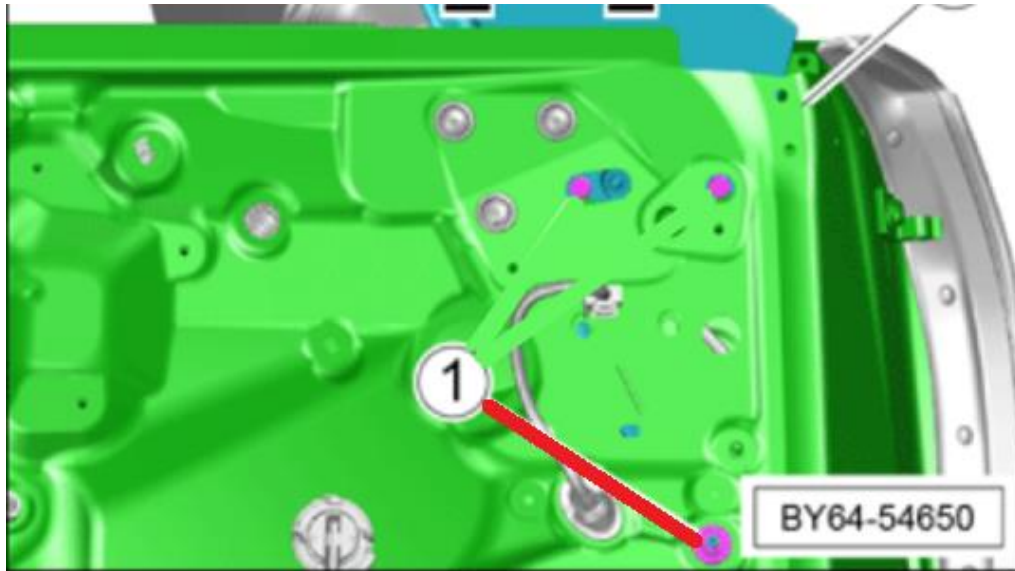
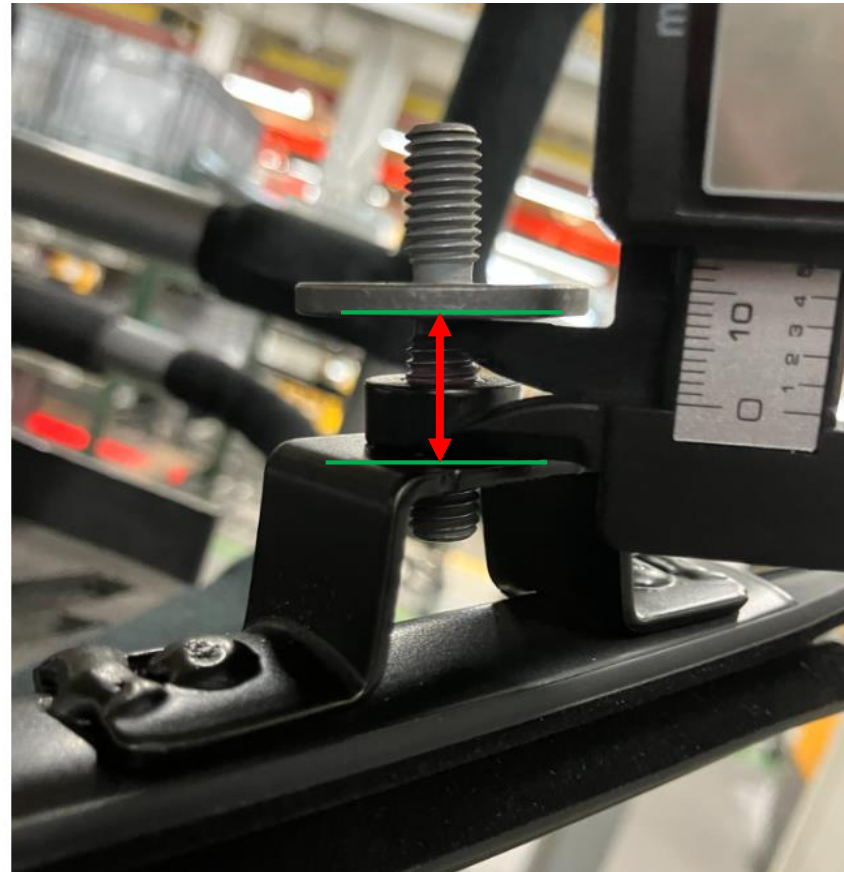
To reset this adjuster without removing the quarter glass, loosen the lock nut, screw the adjuster all the way in clockwise until it bottoms out on the frame, then unscrew anti clockwise 4 complete turns then set height and profile to ELSA specification before moving on to the next step.

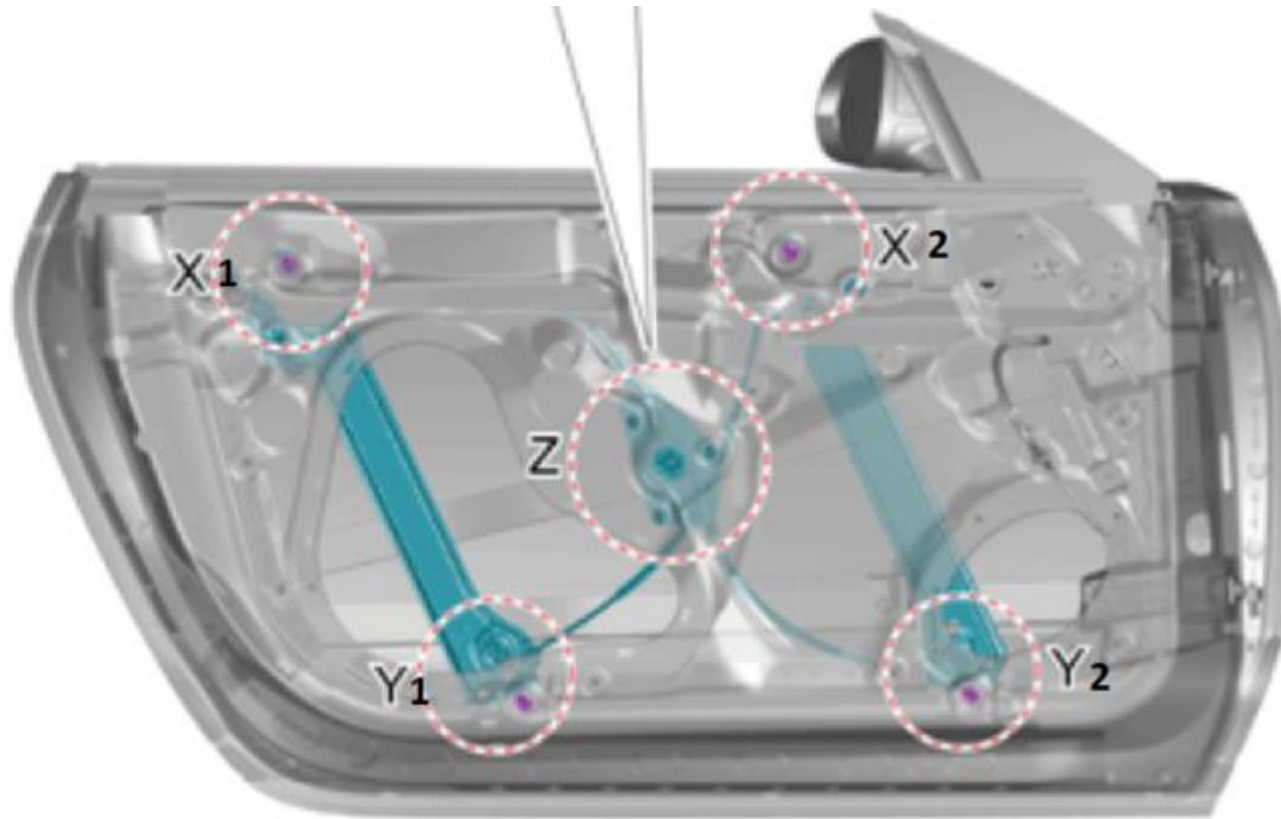
- Front door regulator adjuster reset

Regulator adjusters X1 X2

Measure from top of mounting washer to frame

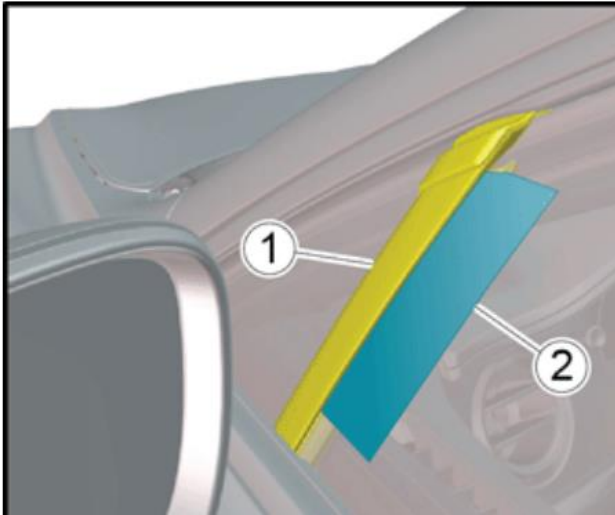
- **Measuring front glass intrusion into front division bar**

Example of incorrect fitment:
10mm intrusion into division bar seal not achieved. Only 6mm seen, front and rear side glasses will be too far rearwards, potentially clash condition between rear of rear glass and cant rail/roof seals

When reinstalling front drop glass ensure tape is applied at 10mm from front edge and align this with the previously set quarter glass division bar.

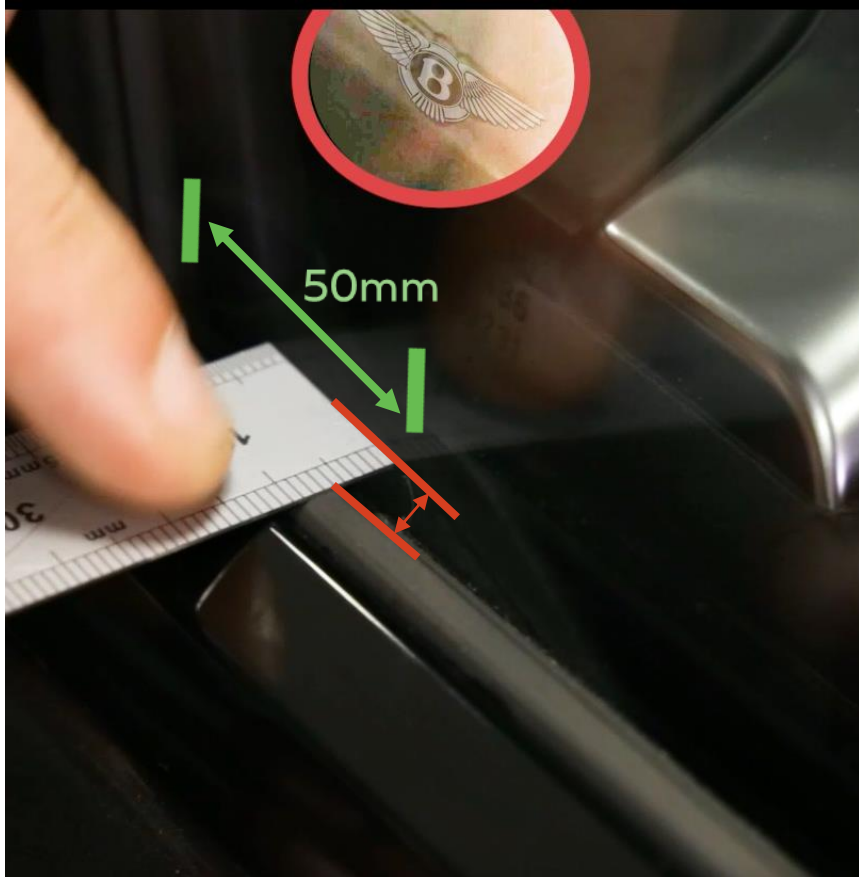
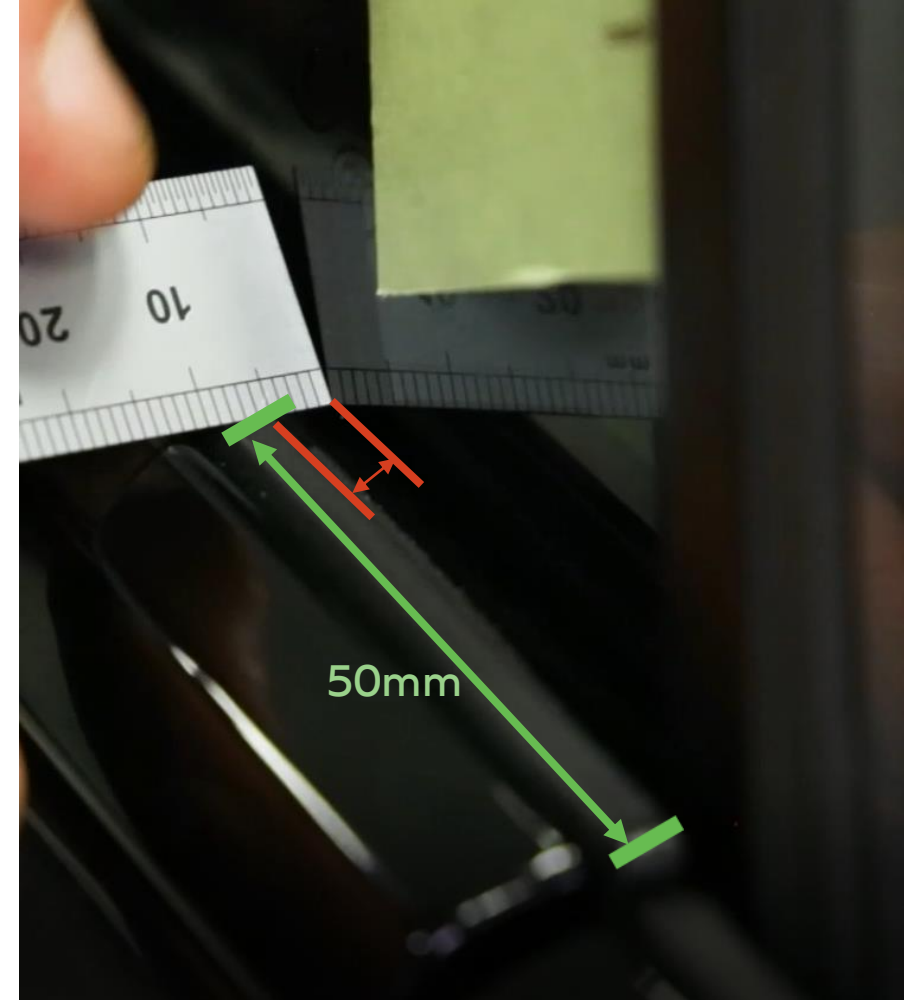
- **Waistrail measurement checking/resetting**

2mm at rear edge would have been set to achieve specified flush/2mm underflush profile condition between front and rear glasses, the rear quarter glass mirrors this taper condition. This potentially increases the risk of false anti trap as rear window/seal does not engage with front window at the correct angle. Suggested to set to specification on problem vehicles as per next slide. If both windows are set between 4-6mm then the flush/2mm underflush profile can be easily achieved.

Set waist rail gapping to between 4-6mm as mentioned in Glass setting guide videos on E-Academy and also check for parallelism along front and rear windows to door/quarter. 50mm from edge of Waistrail seal, roughly underneath the Bentley wings.
