TECHNICAL SERVICE BULLETIN

TSB #:	TSB55102302	Release Date:	10/26/2023
Main Group:	55 - Body Closures		
Subject:	Hood Bolt Rivet Nut Attachment		
Vehicle: 32	FM29 OCEAN	Production Range:	ALL
Model Year(s):	2023	Region(s):	Global
Mobile Service:	NO

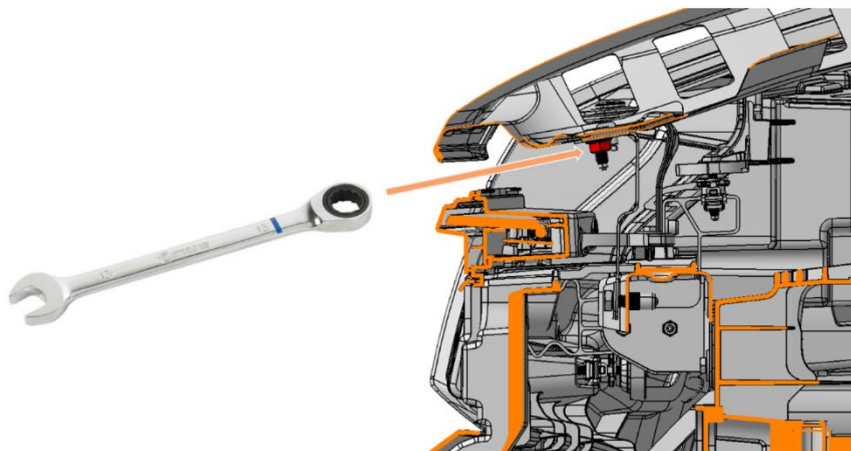
3. For the spinning bolt(s), attempt to lose as much as you can the hood. The hood needs to be able to move enough to create a gap.
4. Hold the hood as open as possible, use a 13mm wrench to remove the nut of the hood latch bracket.

Fisker recommends that a second person help hold the hood up while doing this step.
