## Rangeline TSB

Airstream has identified a few service opportunities on Rangeline models built before 5/22/2023. The following service bulletin will help identify the issues and the solutions. Please complete each procedure in the order provided. Not all Rangeline's will require every update. All Rangeline's, even those built between 5/22/2023 and 10/10/2023, will require the Firefly firmware to be updated to 1.28.

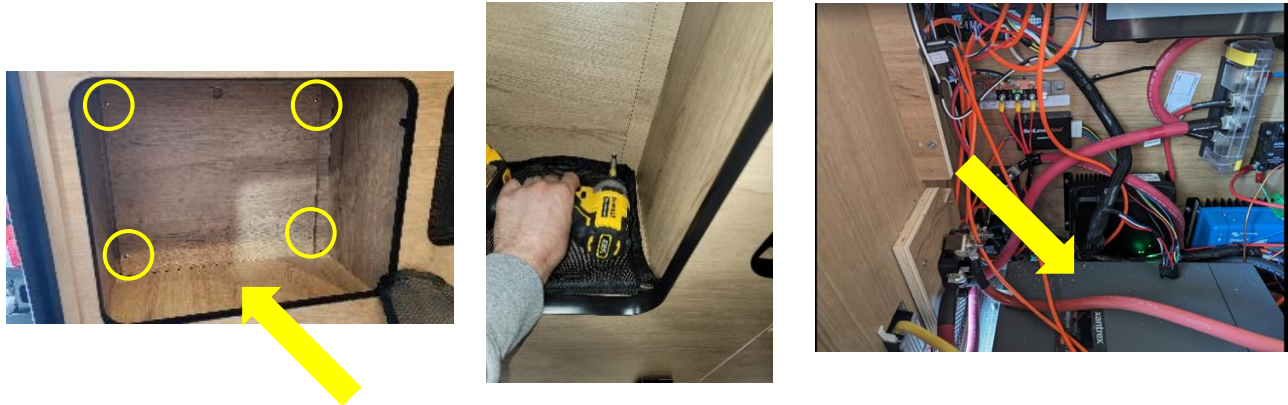
Airstream has found that the Xantrex inverter/charging system sometimes loses its settings, has incorrect settings, or shuts off automatically. It has been determined that a communication error exists between the Firefly and Xantrex systems. To correct the issue, the Xantrex inverter/charger firmware needs to be updated to version 02.11.

1. To gain access to the electrical cabinet, located below the driver's side bed base, remove the 4 screws from the back panel and the screws from the bottom panel. The Xantrex inverter/charger will be on the floor in the lower left side of the cabinet.

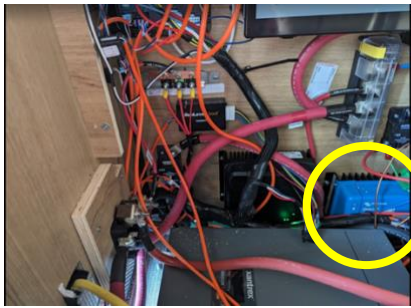
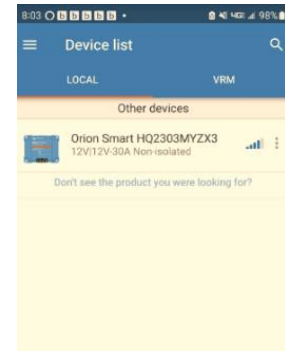
Airstream has determined that the Victron Orion-Tr Smart DC-DC Converter's programming is defaulting to an incorrect setting of "Power Supply" instead of the correct setting of "Charger." It was also found that the connector on the DC-DC harness may have a socket-to-socket connection, instead of the correct pin-to-socket connection.

1. Download the VictronConnect app from the App store.
2. Once downloaded, start the program and search for the local Orion device. When prompted, enter the passcode. The default passcode could be 000000 or 111111. If neither of those work, the passcode can be found on the Orion DC/DC charger, located in the electrical cabinet. The passcode will be a 6-digit number identified on the label as "Pin."

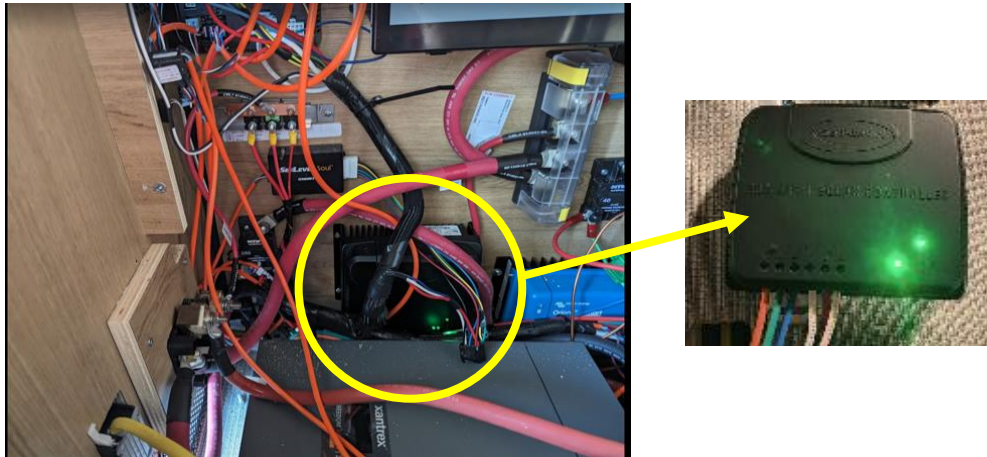
Airstream has determined that the roof mounted solar panels were wired to the chassis battery as primary and the house battery as secondary. This wiring provides solar charging to the chassis battery before charging the house battery. The GoPower box will need to be rewired to allow the solar panels to charge the house battery, providing better utilization of the solar panels.

1. Locate the GoPower box. It will be a black box towards the bottom of the electrical cabinet, beside the Orion DC/DC charger.

2. Verify that the wiring on the solar controller is wired to make the house battery the primary solar function with the chassis battery being secondary.

- a. SC1e (Blue wire - house battery) wired to Battery #1 +terminal
  - b. SC1c (Red wire - chassis battery) wired to Battery #2 +terminal
3. If the controller is wired with SC1c (chassis) into Battery #1, it will need to be relocated to the Battery #2 +terminal. The SC1e (house) wire will be relocated into the Battery #1+terminal. See wiring schematic below.
