Service Action

Code: 34L4

Subject	Transmission Control Module (TCM) Software				
Document History	Date		Summary		
	12/14/2023		Updated parts and claiming information		
	11/03/2023		Updated repair steps after software update is completed. Added example photos of transmission damage.		
	08/03/2023		Original publication		
Affected Vehicles	Country	Beginning Model Year	Ending Model Year	Vehicle	Vehicle Count
	USA	2017	2018	A3 CABRIOLET	713
	USA	2017	2018	A3 SEDAN	7,898
	USA	2018	2018	S3 SEDAN	589
	CAN	2017	2018	A3 SEDAN	515
	CAN	2018	2018	S3 SEDAN	115
	<p><i>Check Campaigns/Actions screen in Elsa on the day of repair to verify that a VIN qualifies for repair under this action. Elsa is the <u>only</u> valid campaign inquiry & verification source.</i></p> <ul style="list-style-type: none"> ✓ Campaign status must show "open." ✓ If Elsa shows other open action(s), inform your customer so that the work can also be completed at the same time the vehicle is in the workshop for this campaign.

About this Service Action	Audi is providing updated transmission control module (TCM) software to enhance an in-vehicle alert should a problem arise within the auxiliary hydraulic pump. Additionally, i

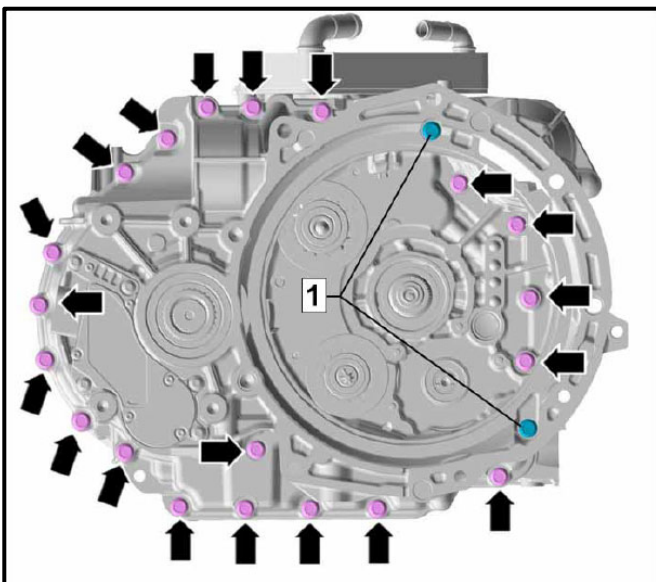
Remove housing bolts on clutch side:

- **DO NOT REMOVE BOLTS <1>.**
- Remove bolts <arrows>.
- Note the lengths of the removed bolts. There are two different length bolts.

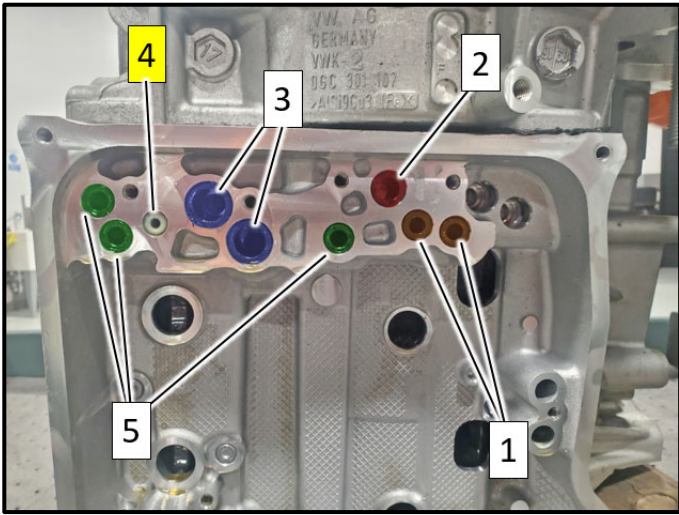
Remove oil guide tubes:

- Loosen each oil tube by turning slightly using suitable circlip pliers.
- Then pull each oil tube out.
- Screw a suitable self-tapping screw or wood screw into the oil tube <4>, loosen the tube and then pull it out.

When removing the oil tubes, parts of the seals can become cut off. Make sure there no seal pieces left in the gearbox.

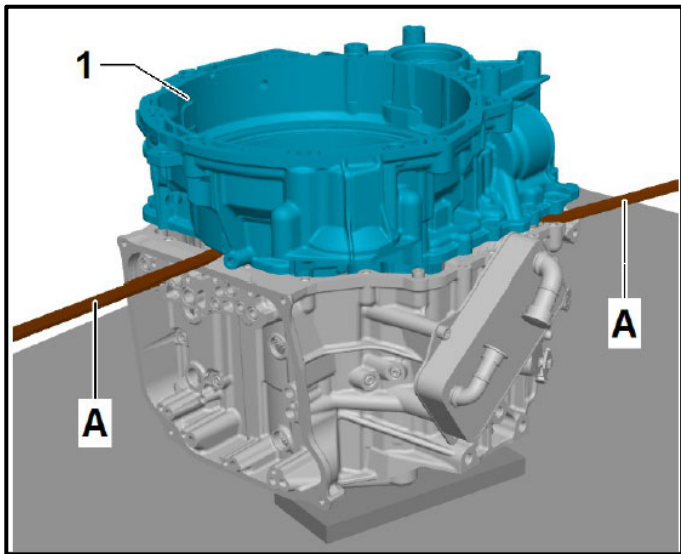
Release sealant bead:

- Carefully release sealant bead between housing sections by applying minimal force using pry bars <A>.

If the housings are not separating, make sure all of the oil guide tubes are removed.

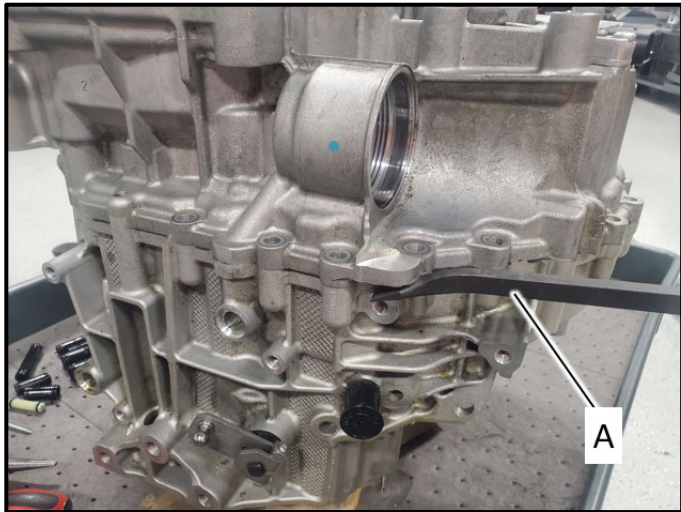
Proper positioning of pry bar <A> shown.

Risk of irreparable damage to gearbox housing.

Use extreme care when releasing the sealant bead and do not use excessive force.

Pay close attention to surfaces being pried against so that damage does not occur.

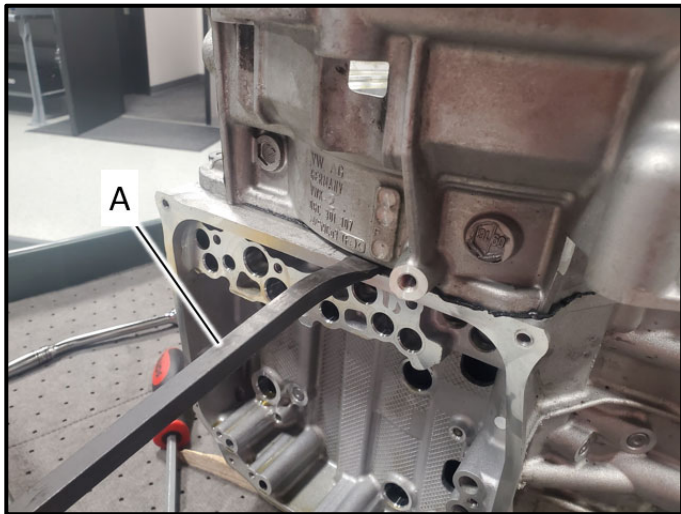
Proper positioning of pry bar <A> shown.

Risk of irreparable damage to gearbox housing.

Pay close attention to surfaces being pried against so that damage does not occur.

Pay particular attention to the transmission oil pan sealing surface. The surface must not be damaged.

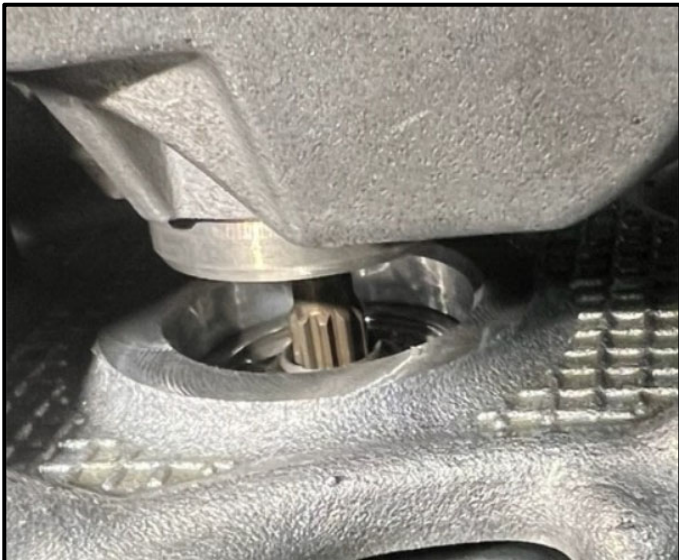
Detail of auxiliary hydraulic pump shaft splines shown.

- Install new auxiliary hydraulic pump with oil pipe from the repair kit in the reverse order of removal.
- When installing, ensure that the shaft matches up with the splines in the housing <arrow 1> and the oil pipe guide is fitted on the rib <arrow 2> on the housing.

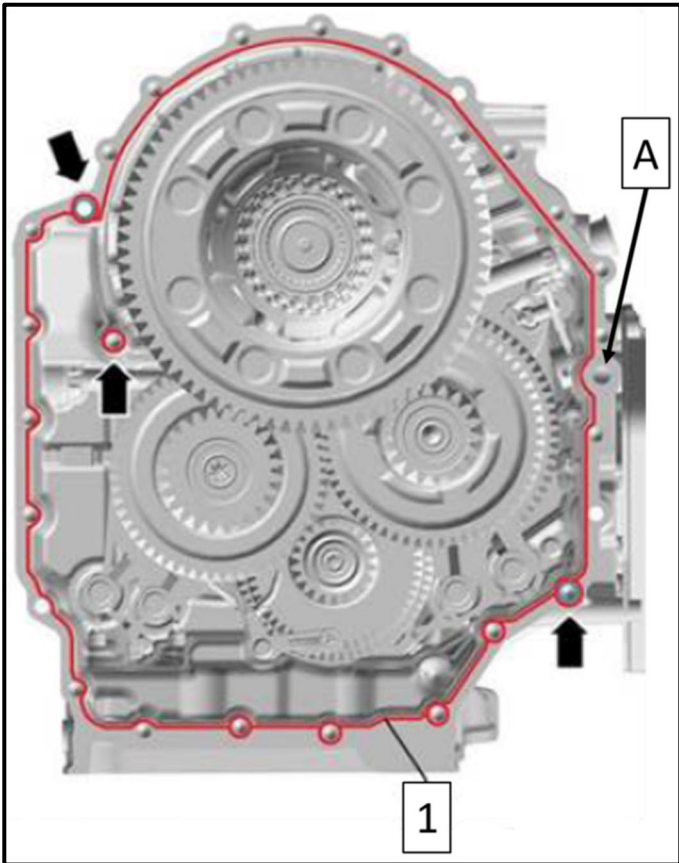
Apply sealant:

- Apply a bead of sealant <1> to the gearbox housing as shown.
- Ensure sealant is applied completely around any openings as shown in the illustration.
- Pay close attention to the dowel sleeves and “turret” <arrows>. Ensure sealant is applied completely around those openings.
