## PRODUCT CAMPAIGN BULLETIN

**APPLICABILITY:** 2003-2004 Baja  
 2003-2008 Legacy and Outback  
 2004-2005 Impreza, WRX, STI

**SUBJECT:** Takata Front Passenger Air Bag  
 Inflator Replacement

**NUMBER:** WQR-53R

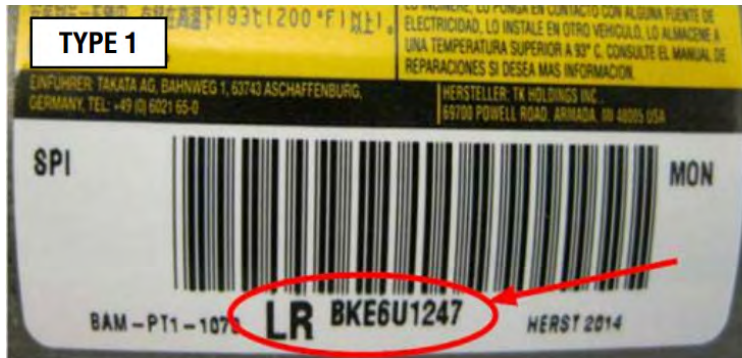
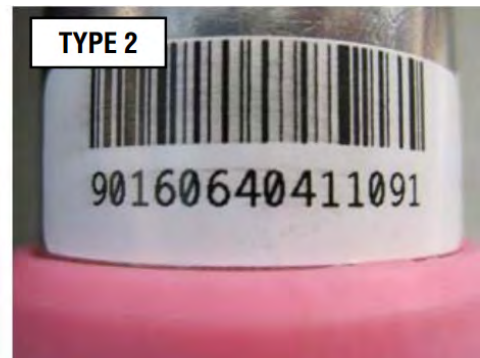
**STEP 9 - VERY IMPORTANT:** Record the **11-digit alpha-numeric serial number** for both the **new Type 2** and the **original Type 1 inflators** on the hard copy of the Repair Order. **For SOA and SDC Retailers ONLY**, this information will be required for claim approval. **For SNE retailers**, this information will be required for completion of the Part Return Notice which will be forwarded by the retailer to the PCC.

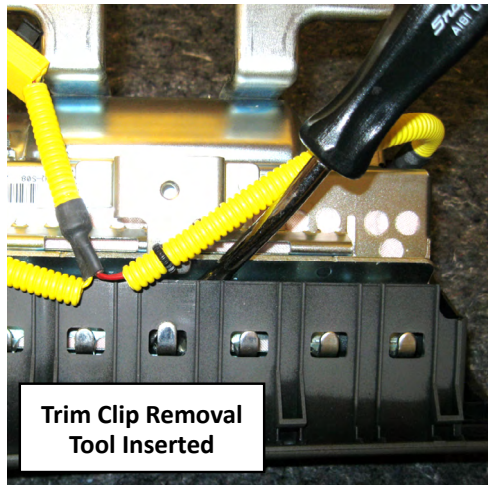
Trim Clip Removal  
Tool Inserted

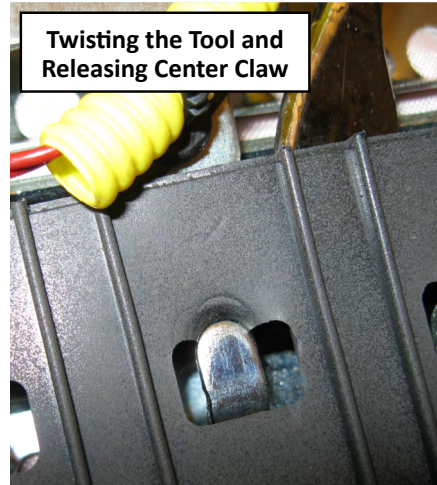
Twisting the Tool and  
Releasing Center Claw

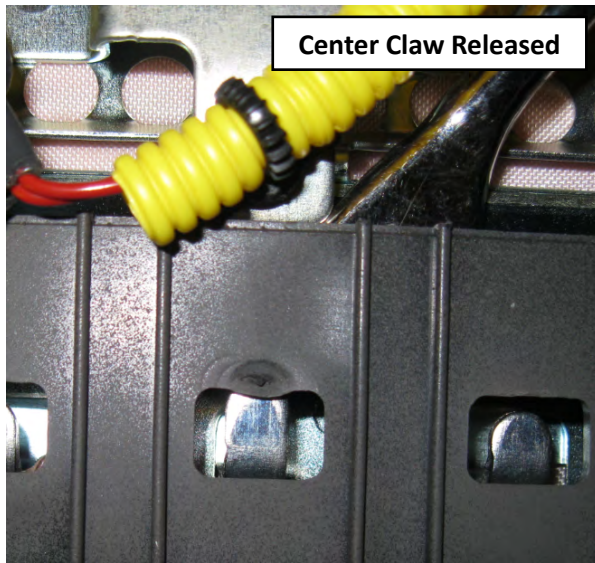
Center Claw Released

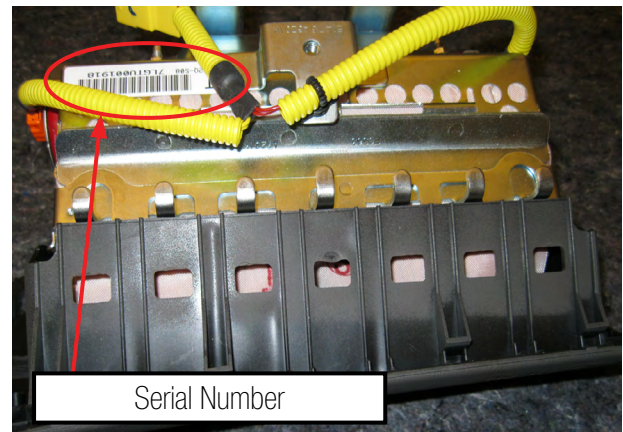
All Harness-Side Claws Released

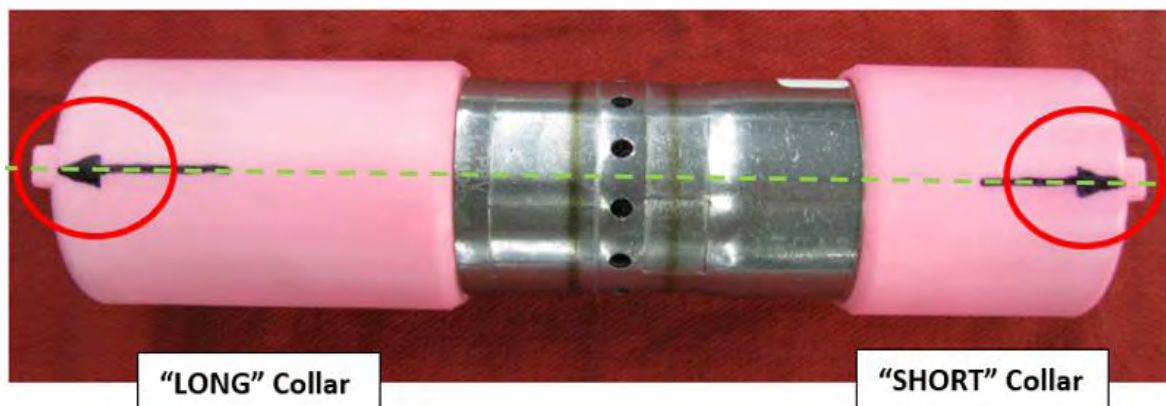
**STEP 9-** Inspect the new **Type 2** inflator to confirm the locating protrusions on each of the pink collar portions are aligned as shown below. The “short” collar can be rotated as needed to align it with the protrusion on the “long” collar if necessary.

**NOTE:** The **Type 2** inflator is installed in the opposite direction of the original. This change puts the connector on the other end. The new harness has been extended approximately 2” to compensate.
