**PRODUCT CAMPAIGN BULLETIN**

<p><b>APPLICABILITY:</b> 2003-14 MY Legacy          2003-14 MY Outback          2003-06 MY Baja          2009-13 MY Forester          2004-11 MY Impreza          2004-14 MY WRX and STI</p> <p><b>SUBJECT:</b> Takata Front Passenger Airbag Module /          Inflator “Like for Like” Recall</p>	<p><b>NUMBERS:</b> TKA-20R          TKB-20R          TKC-20R</p> <p><b>DATE:</b> 01/06/20</p> <p><b>REVISED:</b> 12/28/23</p> <p><b>NHTSA ID:</b> 20V001          20V002          20V003</p>
---	--

**DESCRIPTION OF THE SAFETY DEFECT AND SAFETY HAZARD**

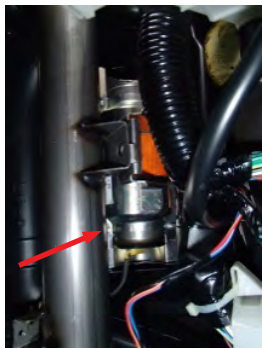
Model Years	Carline	Part Number	Type	Procedure / How to Identify	ZF TRW End Collar Color	ZF TRW: OK - Do NOT replace the Inflator or Module Assembly. Process Claim for INSPECTION ONLY.	TAKATA: NG - Replace the Inflator or Module Assembly per the table.
2004-05MY	IMPREGZA WRX	98279FE070 98279FE07A	Inflator	<ol style="list-style-type: none"> <li>For these models, there is no need to remove any parts.</li> <li>Check the inflator collar from the bottom backside of the instrument panel (IP) on the passenger side.                             <ul style="list-style-type: none"> <li>If the color of the collar is <b>Pink</b>, it is a ZF TRW inflator.</li> <li>If <b>no</b> collar is found, it is a Takata inflator.</li> </ul> </li> </ol>	Pink

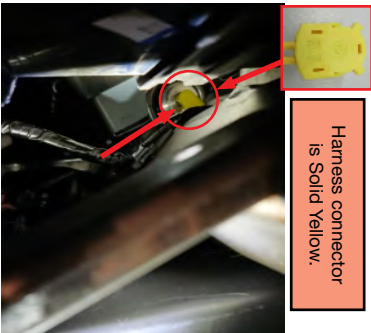
<p>Harness connector is a combination of Black and Yellow.</p>

<p>Harness connector is Solid Yellow.</p>
