Mazda North American Operations Irvine, CA 92618-2922

WATER PUMP COOLANT LEAK

Service Alert No.: SA-081/23

Last Issued : 12/05/2023

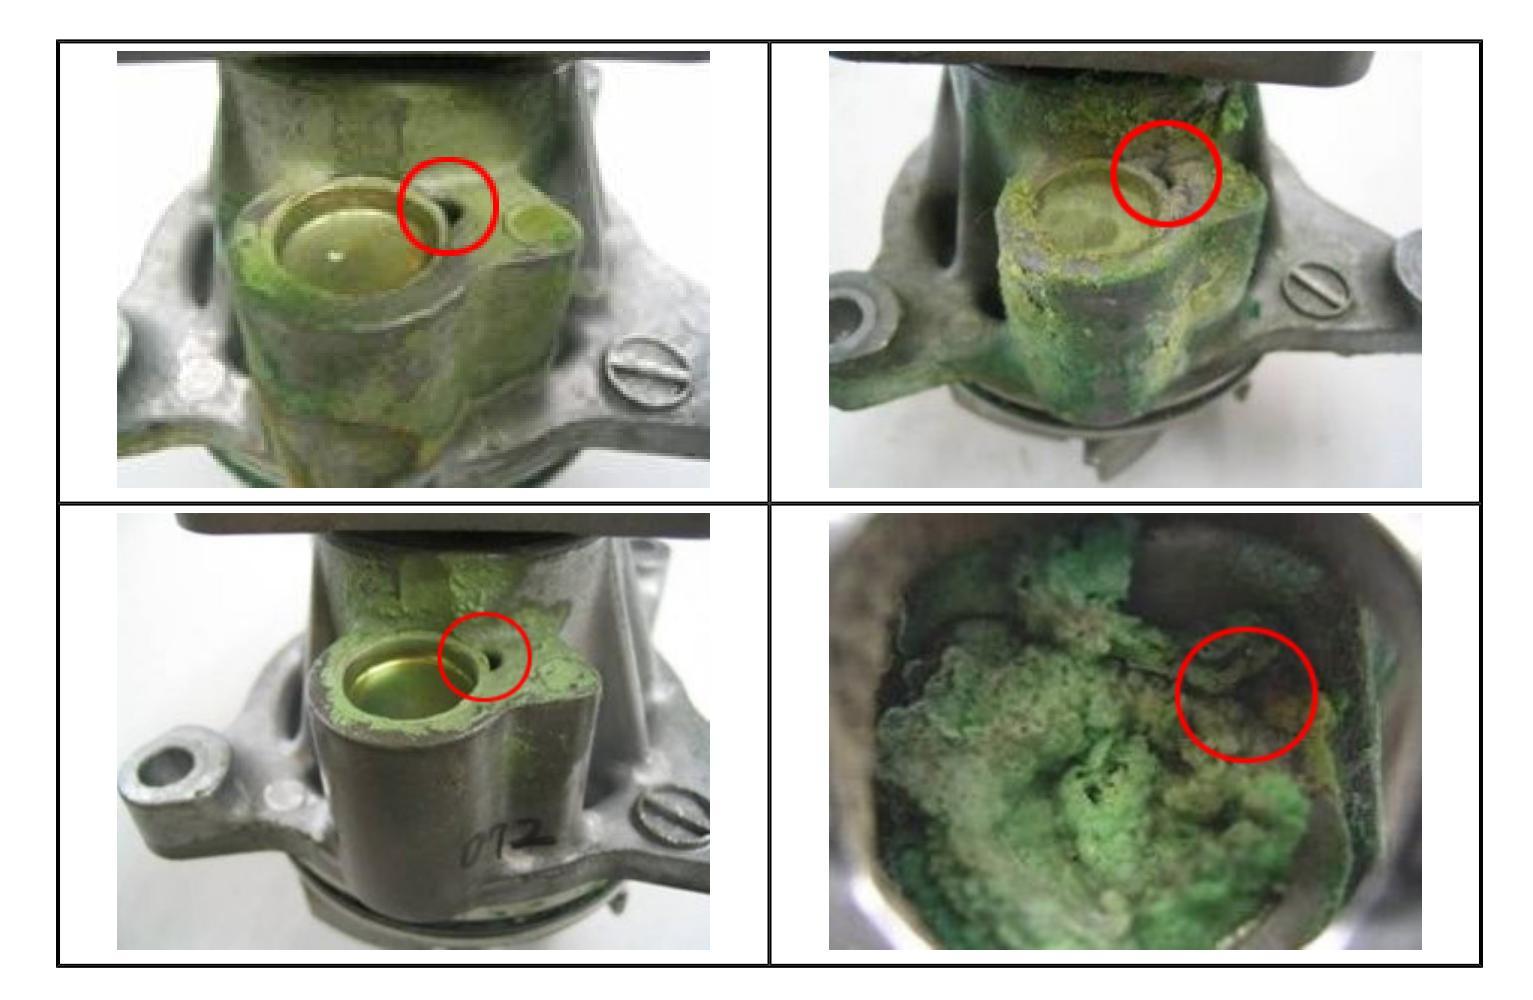
NOTE:

- Regarding the following engines, diagnose whether the water pump requires replacement as with the other engines in this service information.
- Refer to the following images regarding the location of the bleeding hole (white dotted circle).
