# Rapid Update 678

## Grecale – Intercooler pipe replacement

DATE: DECEMBER 5 2023

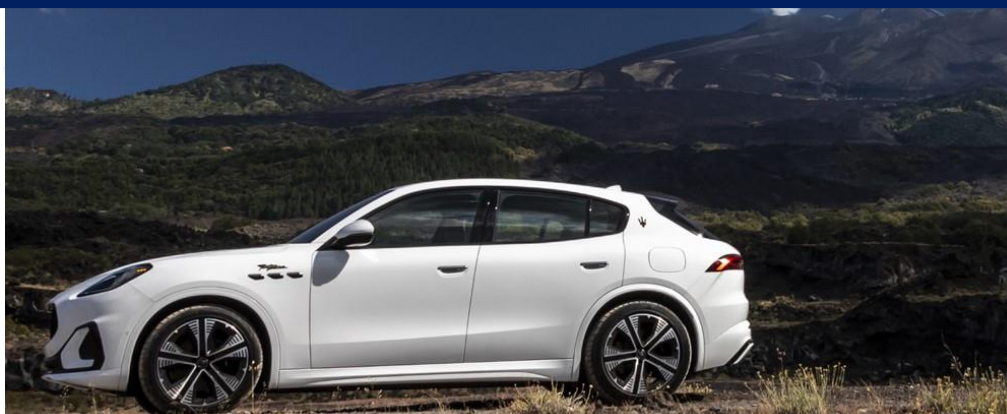
A limited batch of vehicles may potentially have been fitted with piping that has a plastic burr in the connection area. Over time, it can detach and cause noise and disruptions in the component's operation. The expectation of this anomaly occurring is very low and is usually detected early by triggering a MIL and setting a P2261 DTC. The procedure consists of replacing the non-compliant component.
