MAS003863 RU 23-69

# Rapid Update 681

## Granturismo – Front Wiring Repositioning

DATE: DECEMBER 5 2023

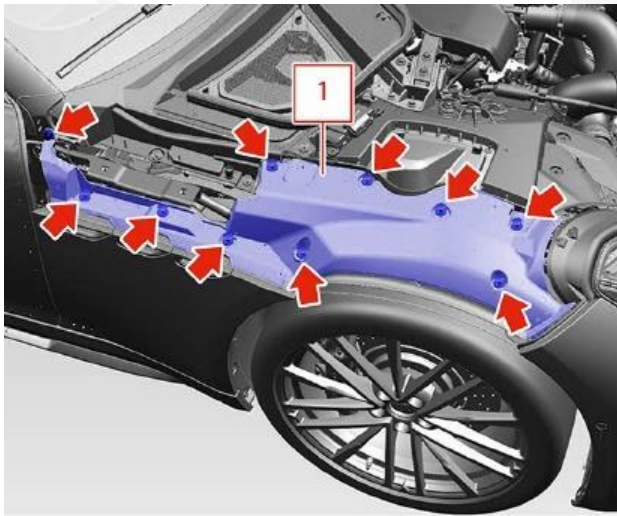
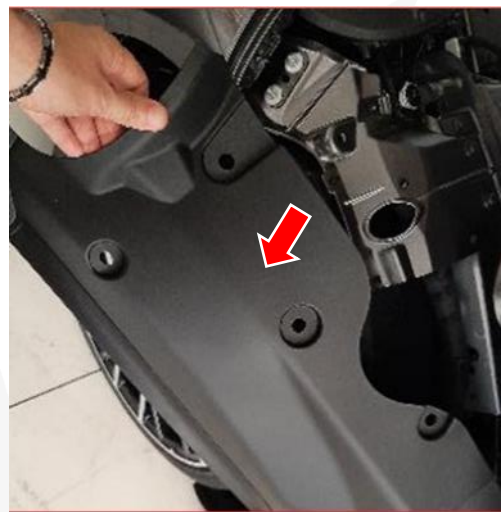
4. Locate the wiring harness underneath the front fender cover and inspect the entire circumference of the wiring harness for damage or abrasions, especially the area where the harness is routed between two screw fasteners.

- **OK** ▶ No damage or abrasions to the harness is found. Continue with the cable tie install **Step 7**.
- **NOT OK** ▶ Wire wrap shows signs of damage, unwrap the electrical tape of the suspected area and inspect for signs of damage to the individual wires.

6. If no damage to the individual wires is found, re-wrap the harness using electrical tape similar to factory (e.g., Tesa 51036) and proceed to **Step 7 (Cable tie installation)**.
