Service Bulletin

Bulletin No.: 02-08-42-001J

Subject: Headlamp, Tail Lamp, License Lamp, or Fog/Driving Lamp Damage

Models: 2024 and Prior GM Passenger Cars and Trucks

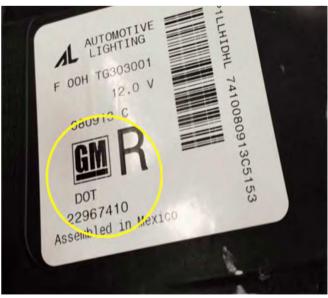
2014 Cadillac XTS

Note: The graphics below are examples of GM Trademarks that may appear on lamp assemblies. Not all lamp assemblies currently have the trademark, however future assemblies will contain the trademark on a label affixed to the assembly.
