2024-01-08

This Service Information Bulletin (Revision 6) replaces SI B54 11 19 **dated March 2023**.

F95 (X5 M Sports Activity Vehicle)	F96 (X6 M Sports Activity Coupe)	F97 (X3 M Sports Activity Vehicle)	F98 (X4 M Sports Activity Coupe)
G01 (X3 Sports Activity Vehicle)	G02 (X4 Sports Activity Coupe)	X5 (Sports Activity Vehicle)	X6 (Sports Activity Coupe)
X7 (Sports Activity Vehicle)

SUNROOF DIAGNOSIS

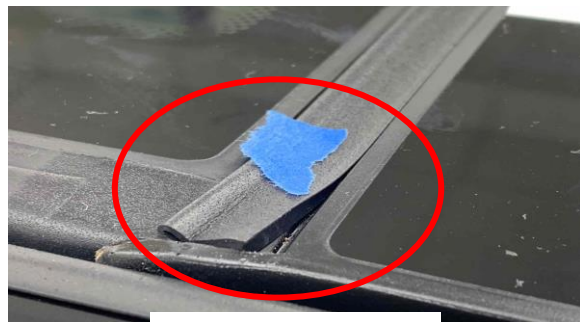
Defect: separated

Situation: Excessive water enters through the sunroof seals.

Repair: Look for gap near end of the seal on front glass. If found, replace seal according to ISTA/AIR instructions REP 54 13 052. Also refer to B54 04 21.

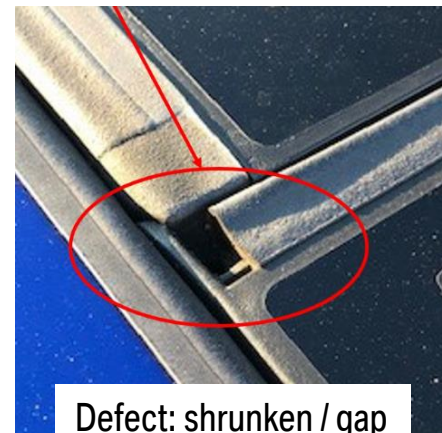
Defect: shrunken / gap

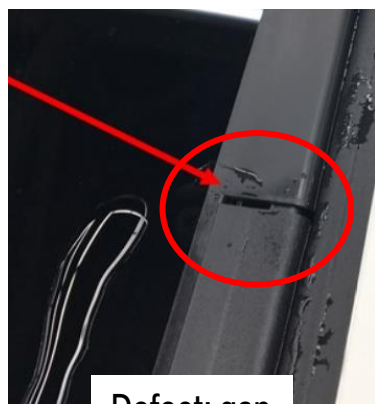
Situation : Excessive water enters through the sunroof seals. (see pictures)

Defect: gap

Repair: Look for gap near ends or twist in seal. If found, replace seal according to ISTA/AIR instructions.
REP 54 13 050

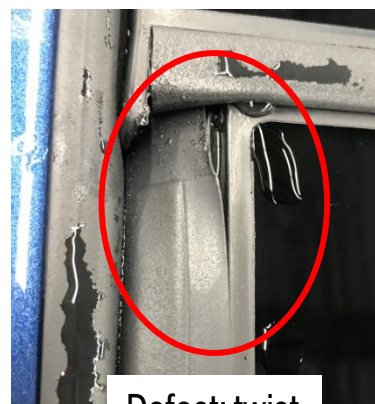
Defect: twist

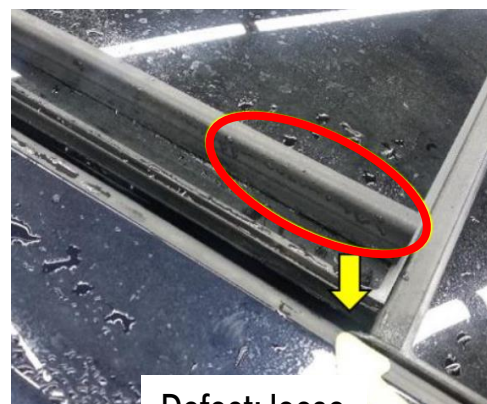
Defect: loose

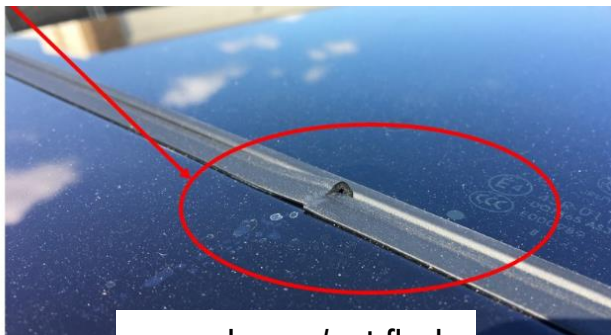
example: gap/not flush

Situation : Excessive water enters through the sunroof seals.

Repair: Inspect the sunroof perimeter seal for defects. Replace body seal according to ISTA/AIR instructions REP 54 13 055.

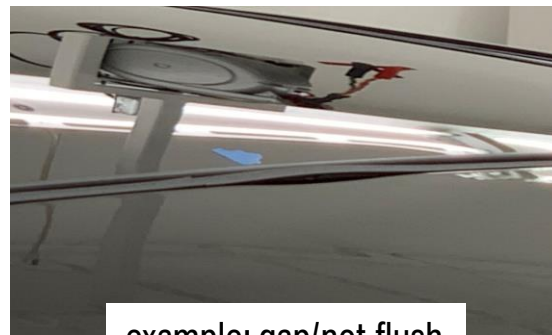
example: gap/not flush

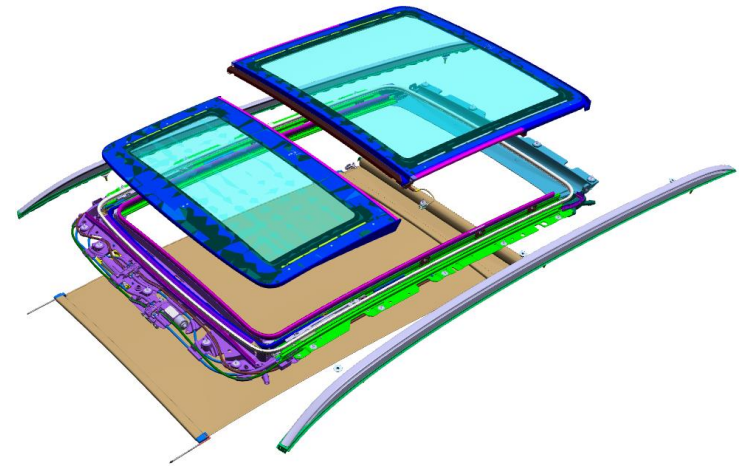
FRONT/REAR GLASS NOT ALIGNED IN X

Situation: Excess water enters the perimeter of the glass. Front and/or rear glass panels misadjusted front to rear.

Repair: Adjust both sunroof glass panels according to ISTA/AIR instructions REP 54 13 002.

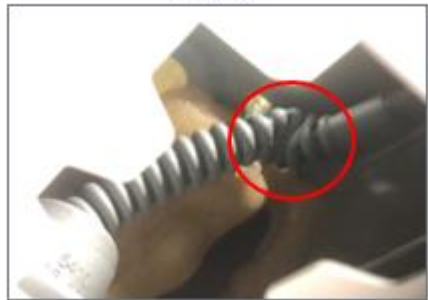
twisted

Situation: There is a water leak near the front or rear carpets. The drain tubes may be twisted. Remove A-pillar kick panels to check if front drain tube is twisted/kinked. Use borescope if needed.

Repair: Reposition hose to remove kink. If kink can't be removed, refer to B54 11 19 Attachment 1 for repair instructions.

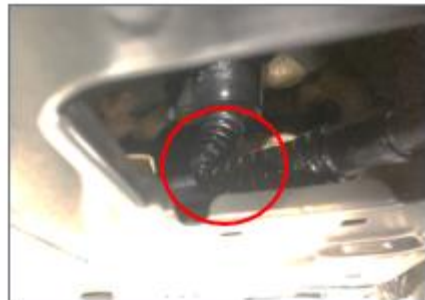
kinked

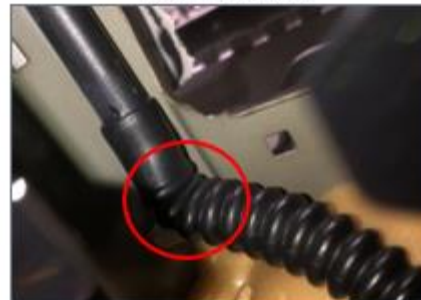
Slightly kinked

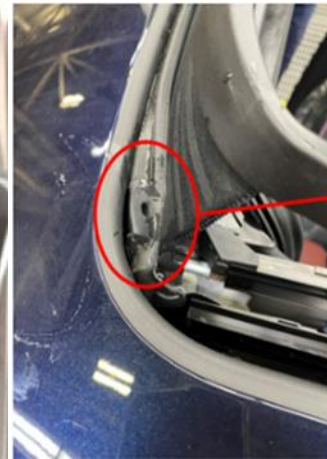
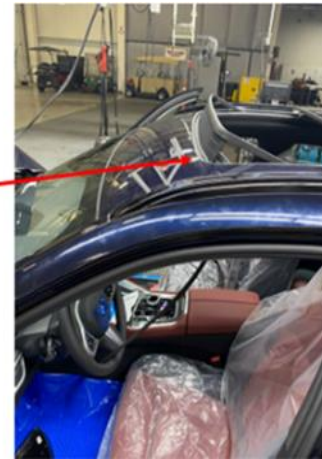
AERO ACOUSTIC SEAL NOT INSTALLED / STUCK

Situation: There is a water leak in the front. The aero-acoustic seal may be incorrectly installed or deformed.

Repair: Check if seal is properly seated and in good condition. If not, then reseal or replace the aero-acoustic seal and replace the body seal according to ISTA/AIR instructions REP 54 13 055.

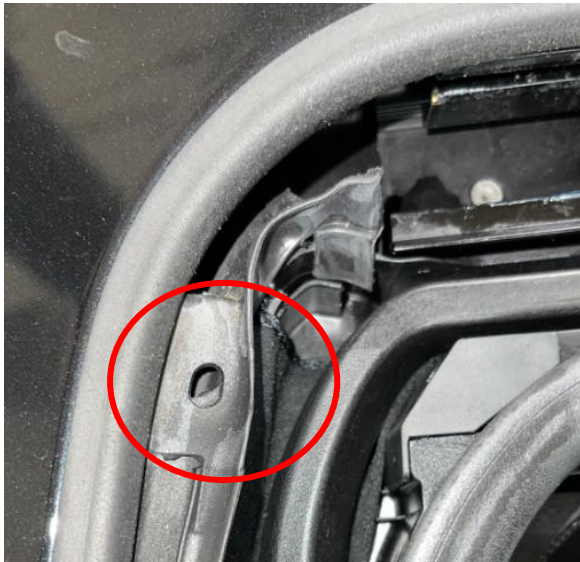
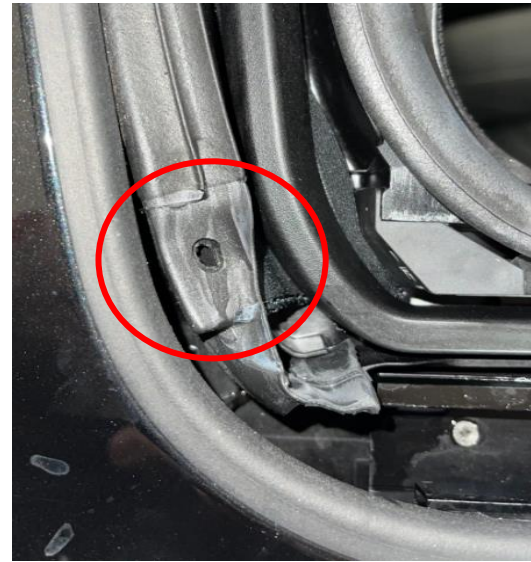
AERO ACOUSTIC SEAL VENT/ DRAIN HOLES BLOCKED/ FLASH

Solution: There is a water leak in the front. The aero-acoustic seal may have flash or blockage at the front vent/ drain holes.

Repair: Check if the seal is blocked at the front corners. If the holes are block by flash then replace the aero-acoustic seal.

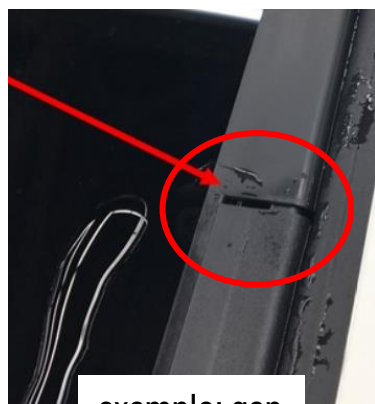
example: gap

Situation: Wind noise heard at speeds of 30mph.

Repair: Look for gap near ends or twist in seal. If found, replace seal according to ISTA/AIR instructions. REP 54 13 050. If the knob or locking feature is missing on the rear glass panel replace the rear glass panel.

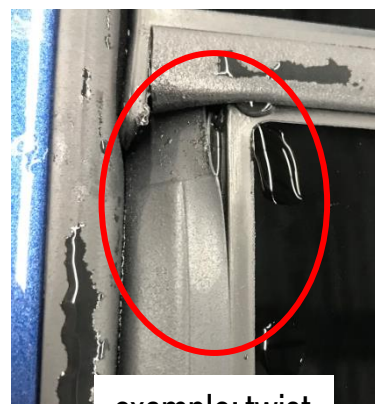
example: twist

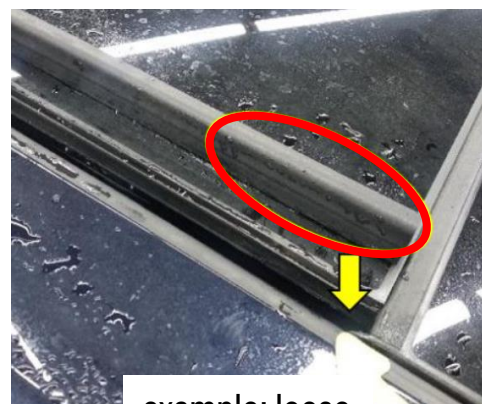
example: loose

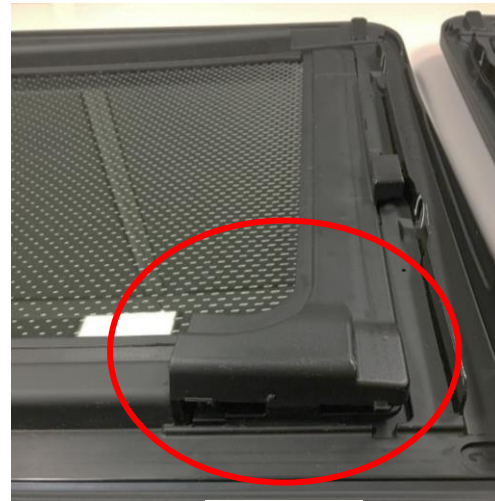
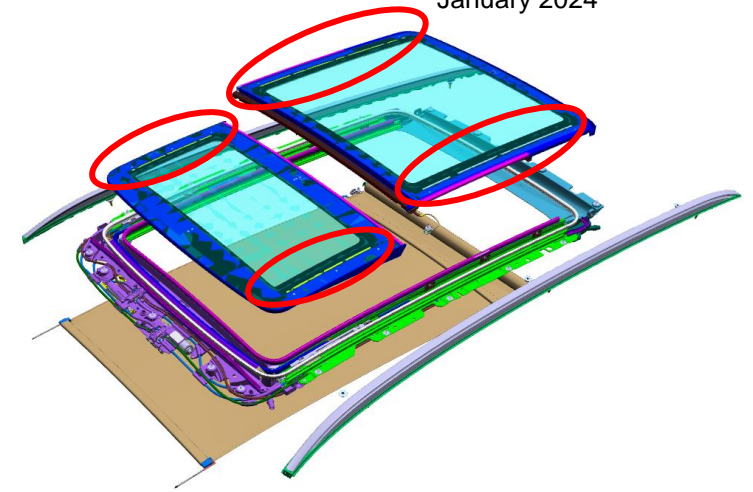
AMBIENT LIGHT COVERS LOOSE

example

Situation: Rattle is heard from plastic cover tapping on glass panel (front or rear glass) when driving on rough road surfaces.

This situation only affects vehicles with SA407 (Panoramic Sky Lounge LED Roof)

Repair: Attempt to insulate with felt tape is visually appropriate. Replace glass panel according to ISTA/AIR instructions REP 54 13 250 if insulation is not possible.

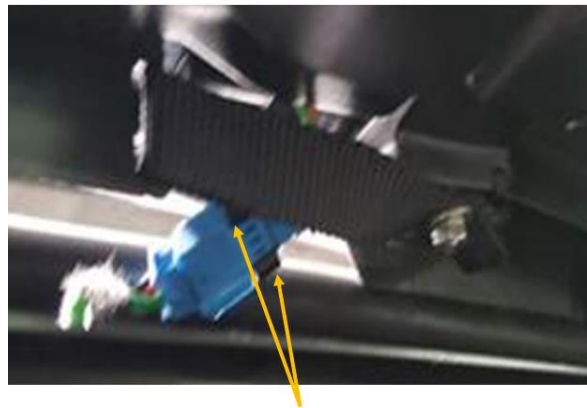
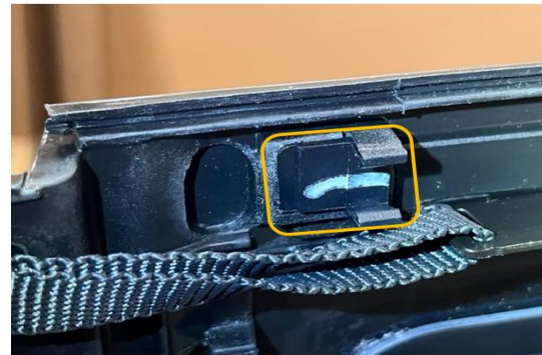
AMBIENT LIGHT CLIP LOOSE/NOT INSTALLED

Clip loose with prongs attached to connector

Clip attached to panel with a press fit rib on the back into a slot on the panel. Glass supplier glues the rib with cyanoacrylate glue.

Situation: A loose clip for the ambient light harness is tapping on the glass or contacting the sunroof mechanism. Only affects vehicle with SA407 (Panoramic Sky Lounge LED Roof).

Repair: Correctly install the harness clip.

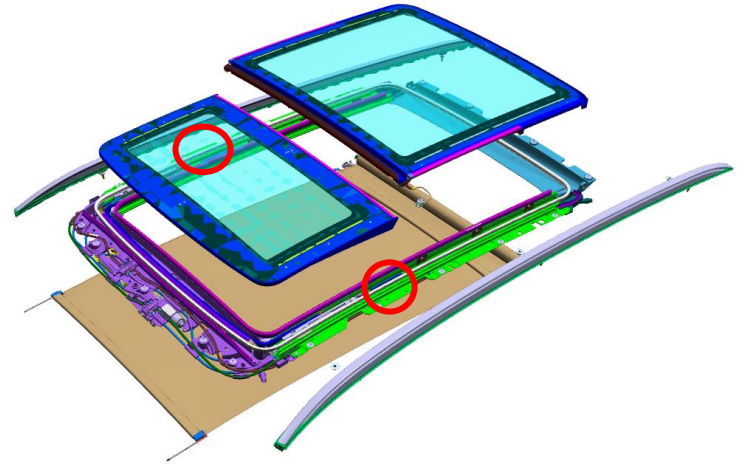
CABLE TUBE CLIP NOT INSTALLED

Situation: There is humming / crackling sound when opening the sunshade or plastic rattling while driving on rough roads.

Repair: Engage/set clip correctly. If tube is damaged and noise persists then replace cassette according to repair instructions.

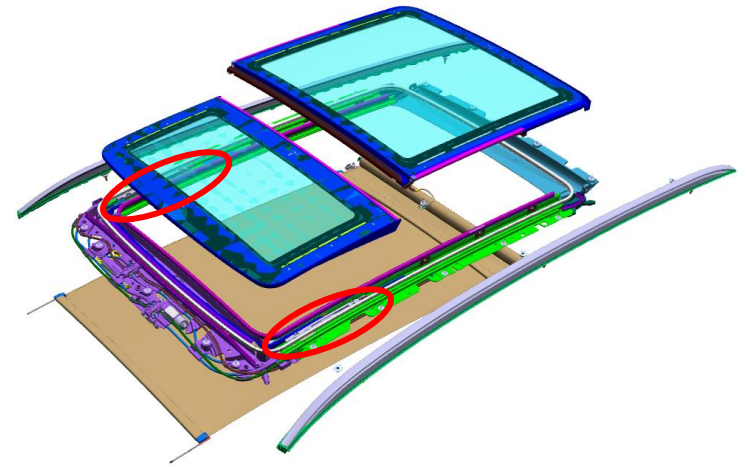
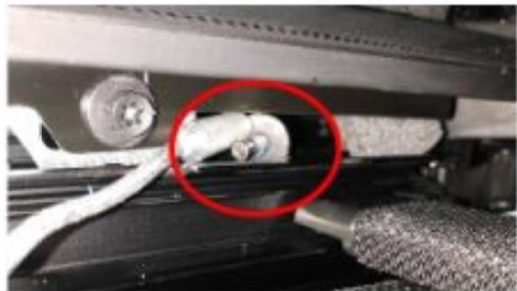
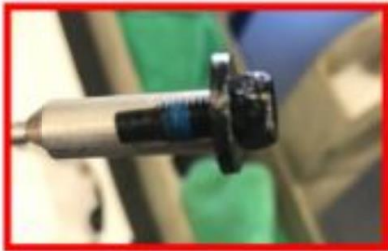
EXTRA SCREW

Situation: A metallic “rolling” noise is heard during acceleration/deceleration. An extra screw may have fallen into the track during production. The screw is not missing from any location.

Repair: Remove the extra screw. Additional repairs are not necessary, all other screws are correctly installed.

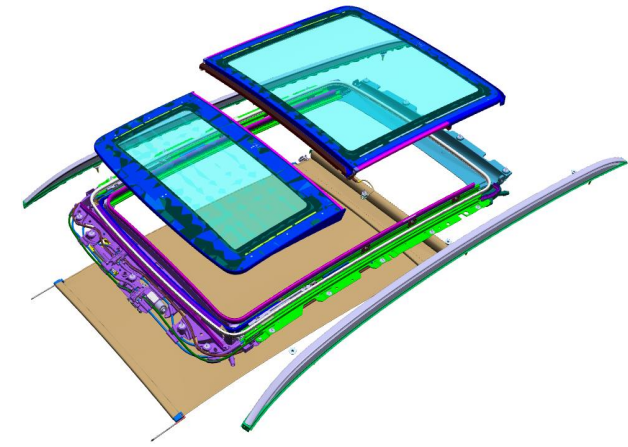
LOOSE FRAME TO BODY SCREW/ FRAME TO GLASS SCREW

Situation: Rattling noise is heard from the roof area. One or more sunroof frame screws may be loose.

Repair: Inspect screws for signs of cross-threading. Replace screws if damaged. Retorque frame screws correctly according to ISTA/AIR repair instructions to 5.4nm. Retorque glass panel screws to 4.5nm. Note: Ensure headliner clips are engaged and not broken.

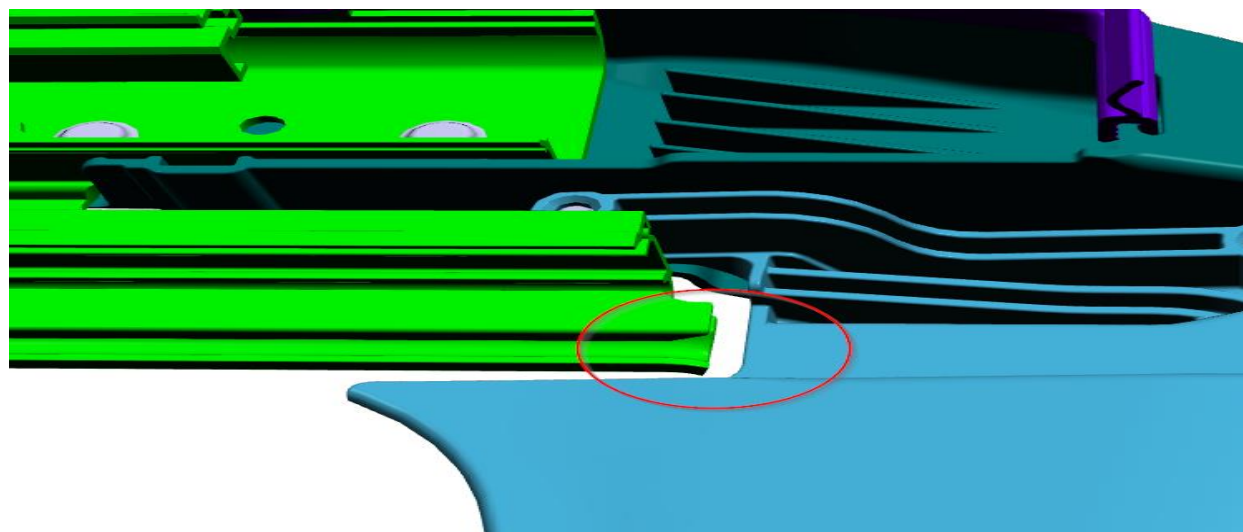
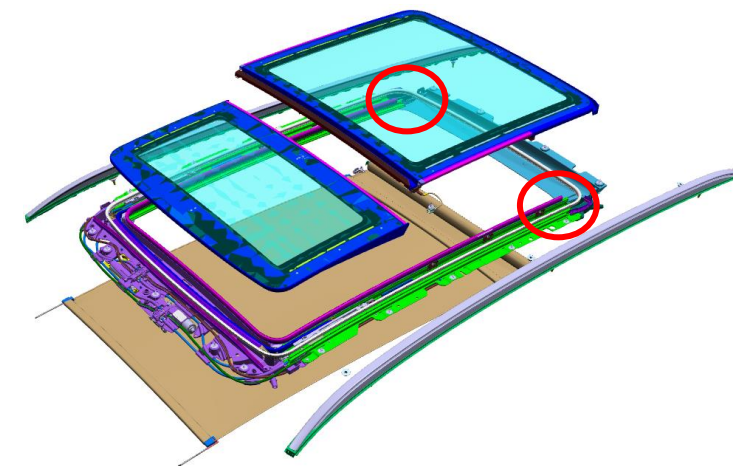
PDF RAIL BURR

Sharp/Burr on Rollo entry at rear of guide

Burr on PDF lip on guide

Situation: A scratching/catching noise is heard while shade is moving.

Repair: Remove the burr on the edge of the PDF rail to break the edges. If the noise is still present then replace cassette frame according to ISTA/AIR instructions REP 54 13 261.

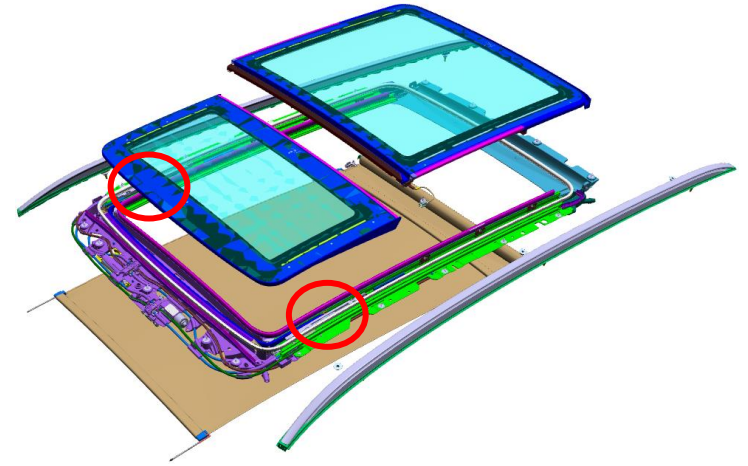
GUIDE SHOE NOT INSTALLED CORRECTLY

Situation: A rubbing/tapping noise heard when glass is moved.

Repair: Replace mechanism according to ISTA/AIR instructions REP 54 13 515.

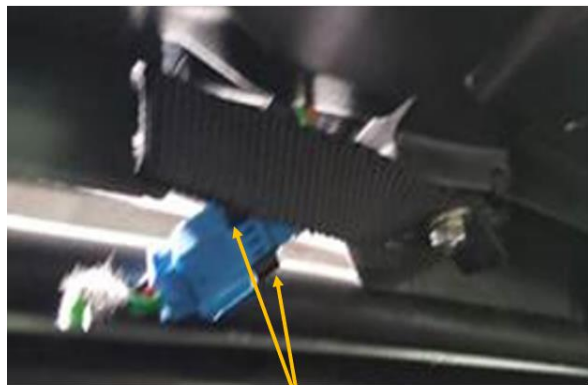
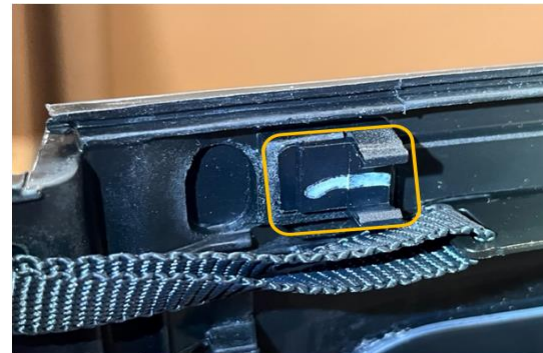
AMBIENT LIGHT CLIP LOOSE/NOT INSTALLED

Situation: A loose clip for the ambient light harness is tapping on the glass or contacting the sunroof mechanism. Only affects vehicle with SA407 (Panoramic Sky Lounge LED Roof).

Clip loose with prongs attached to connector

Clip attached to panel with a press fit rib on the back into a slot on the panel. Glass supplier glues the rib with cyanoacrylate glue.

Repair: Correctly install the harness clip.

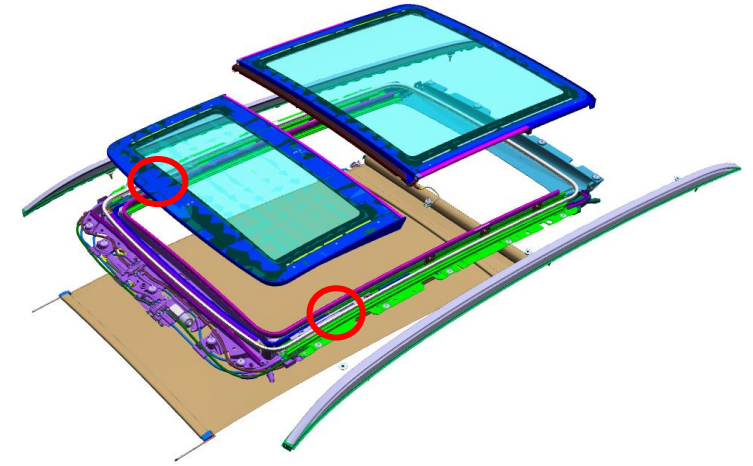
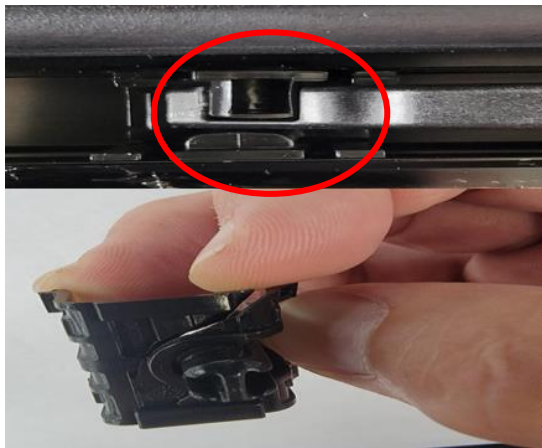
WIND DEFLECTOR PIVOT POINT LOOSE/BROKEN

Situation: A creaking noise is present while the wind deflector raises/lowers. Sunroof may reverse due to anti-trap when closing.

Repair: Replace pivot point and wind deflector according to ISTA/AIR instructions REP 54 13 090

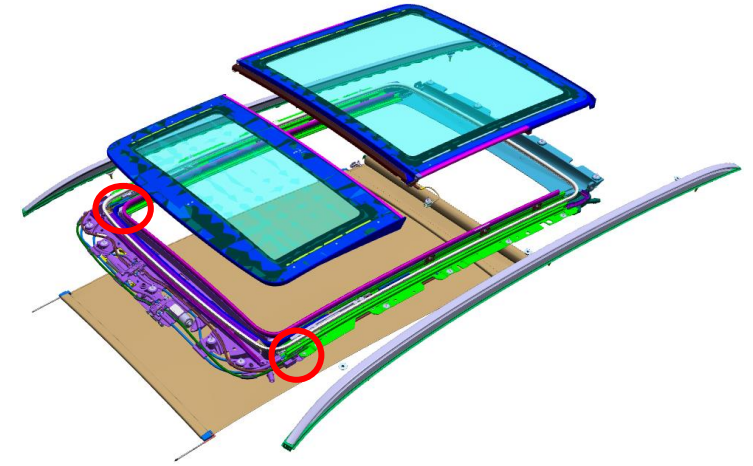
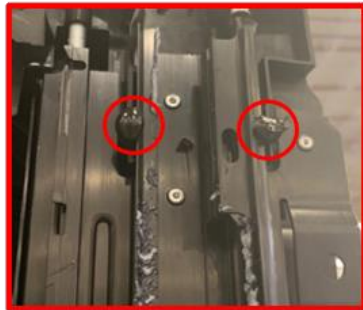
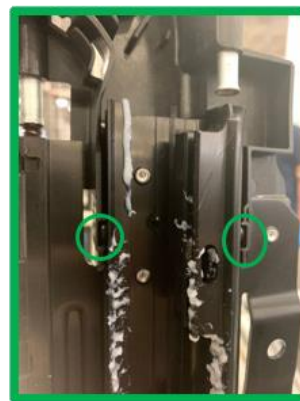
WIND DEFLECTOR EXCESS BUTYL

Picture of NOK (Before adjustment)

Picture of OK (After adjustment)

Situation: A popping noise is heard when the wind deflector raises/lowers.

Repair: Remove excess butyl to allow the wind deflector to move freely.

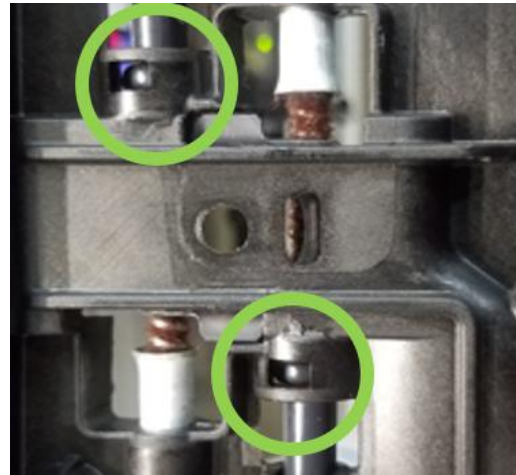
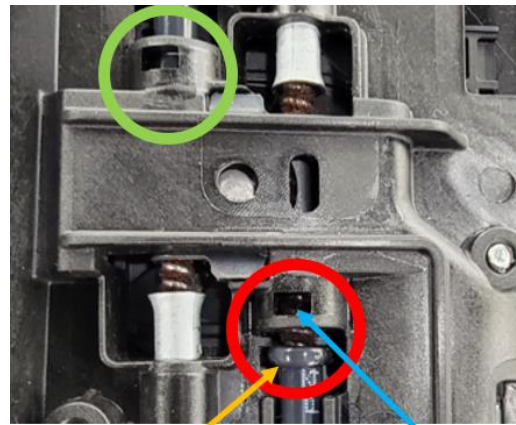
RELIEF CABLE TUBE NOT INSTALLED

Bead not visible in window

Situation: A humming / crackling noise is present when opening the glass or sunshade.

Repair: Replace frame according to ISTA/AIR instructions REP 54 13 261.

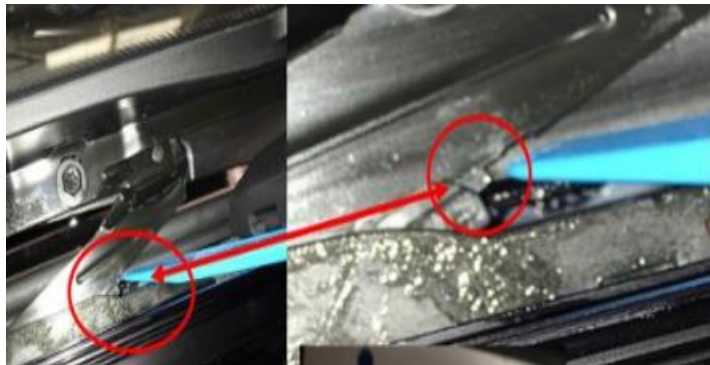
MECHANIC ARM BURR

Situation: A clicking sound is present when the glass is opened to vent.

Repair: Inspect the pivot area for a burr and remove it if found. If the burr can't be found or it can't be repaired, replace the sunroof mechanisms according to ISTA/AIR instructions REP 54 13 515.
