# Service Bulletin

Bulletin No.: 23-NA-004  
Date: January, 2024

Subject: Front Door Panel Separating

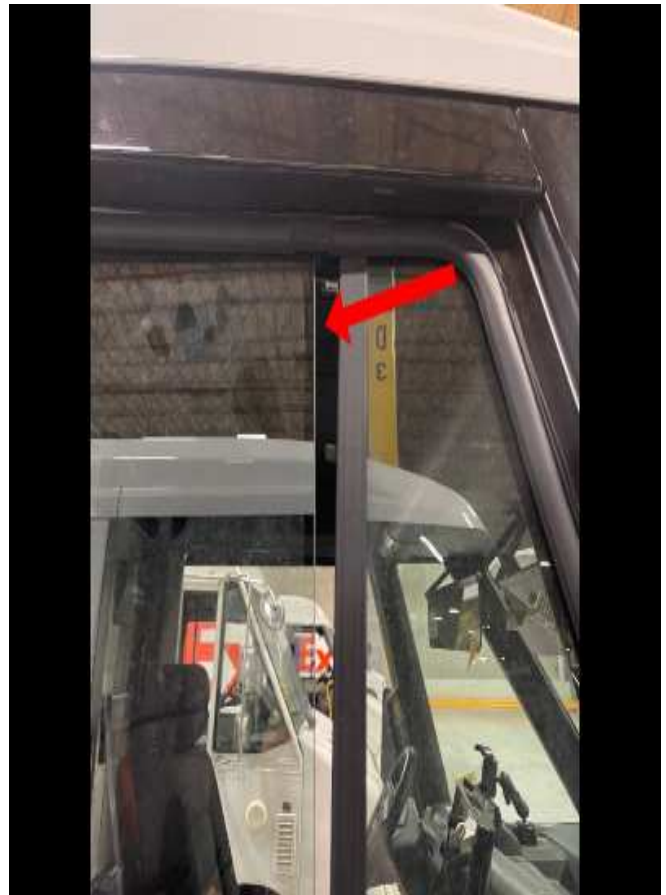
6252120

1. Disengage the inner and outer upper weatherstrips at the front side door stationary window and inspect the upper bracket for signs of breakage or damage.

- If the bracket shows any signs of breakage or damage, replace the front side door stationary window. Refer to *Front Side Door Stationary Window Replacement in the Service Manual*.
