SIB 41 05 23

2024-01-22

SERVICE ACTION: CHECKING THE GAPS ON THE TAILLAMPS

E-Series	Model Description	Production Date
U11	X1 Sports Activity Vehicle	August 2, 2022 – August 31, 2023

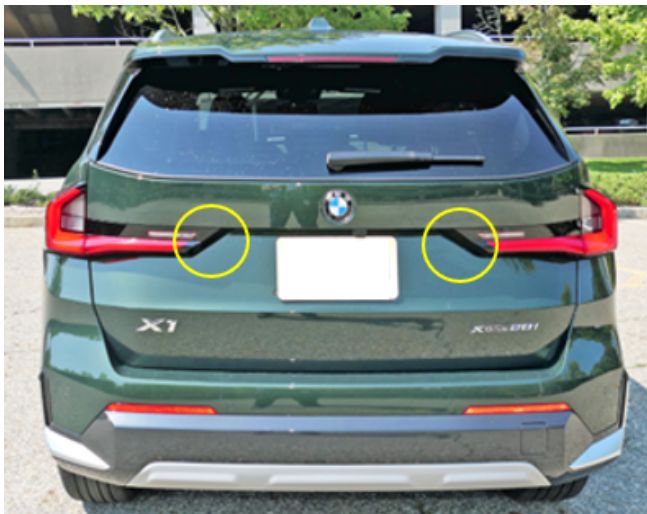
A. Measure the gap between the inner taillamps and the tailgate.

1. Inspect the inner taillamp(s) housing on the tailgate for correct gap.

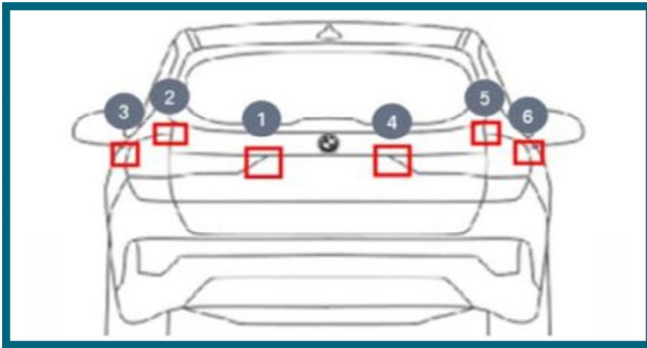
When it is necessary to perform a consequential paint finish repair (Paint pen or CCRC/Auto Body Shop), it is mandatory to identify and record the area that required attention due to the issue described in the Service Information Bulletin.

- Chafe mark 1, or
- Chafe marks 2, 3, or
- Chafe marks 4, 5, 6

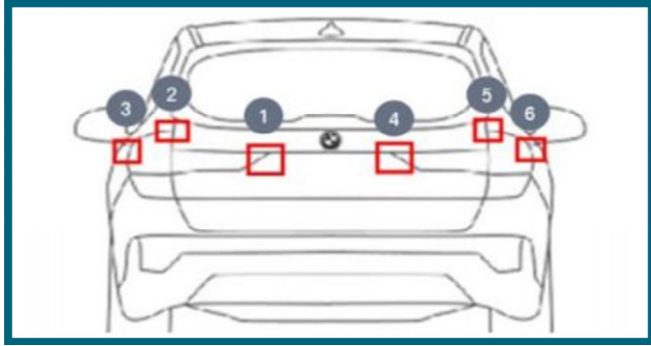
When it is necessary to perform a consequential paint finish repair (Paint pen or CCRC/Auto Body Shop), it is mandatory to identify and record the area that required attention due to the issue described in the Service Information Bulletin.

- Chafe mark 1, or
- Chafe marks 2, 3, or
- Chafe marks 4, 5, 6
