LVO LR Power Steering Assist Cylinder Castle Nut Torque

Section Function Group 642

Model Years	Models
2024	LR

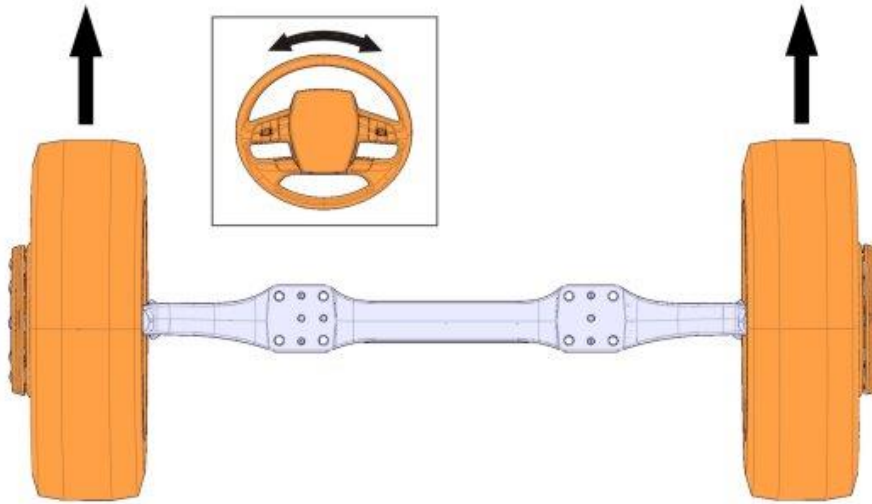
- Locate the castle nut on the power steering assist cylinder connected to the steering arm on the right side of the vehicle.
