SERVICE BULLETIN

APPLICABILITY: 2017-22MY Forester

NUMBER: 09-113-23

SUBJECT: DTC P2404 / Reprogramming Files

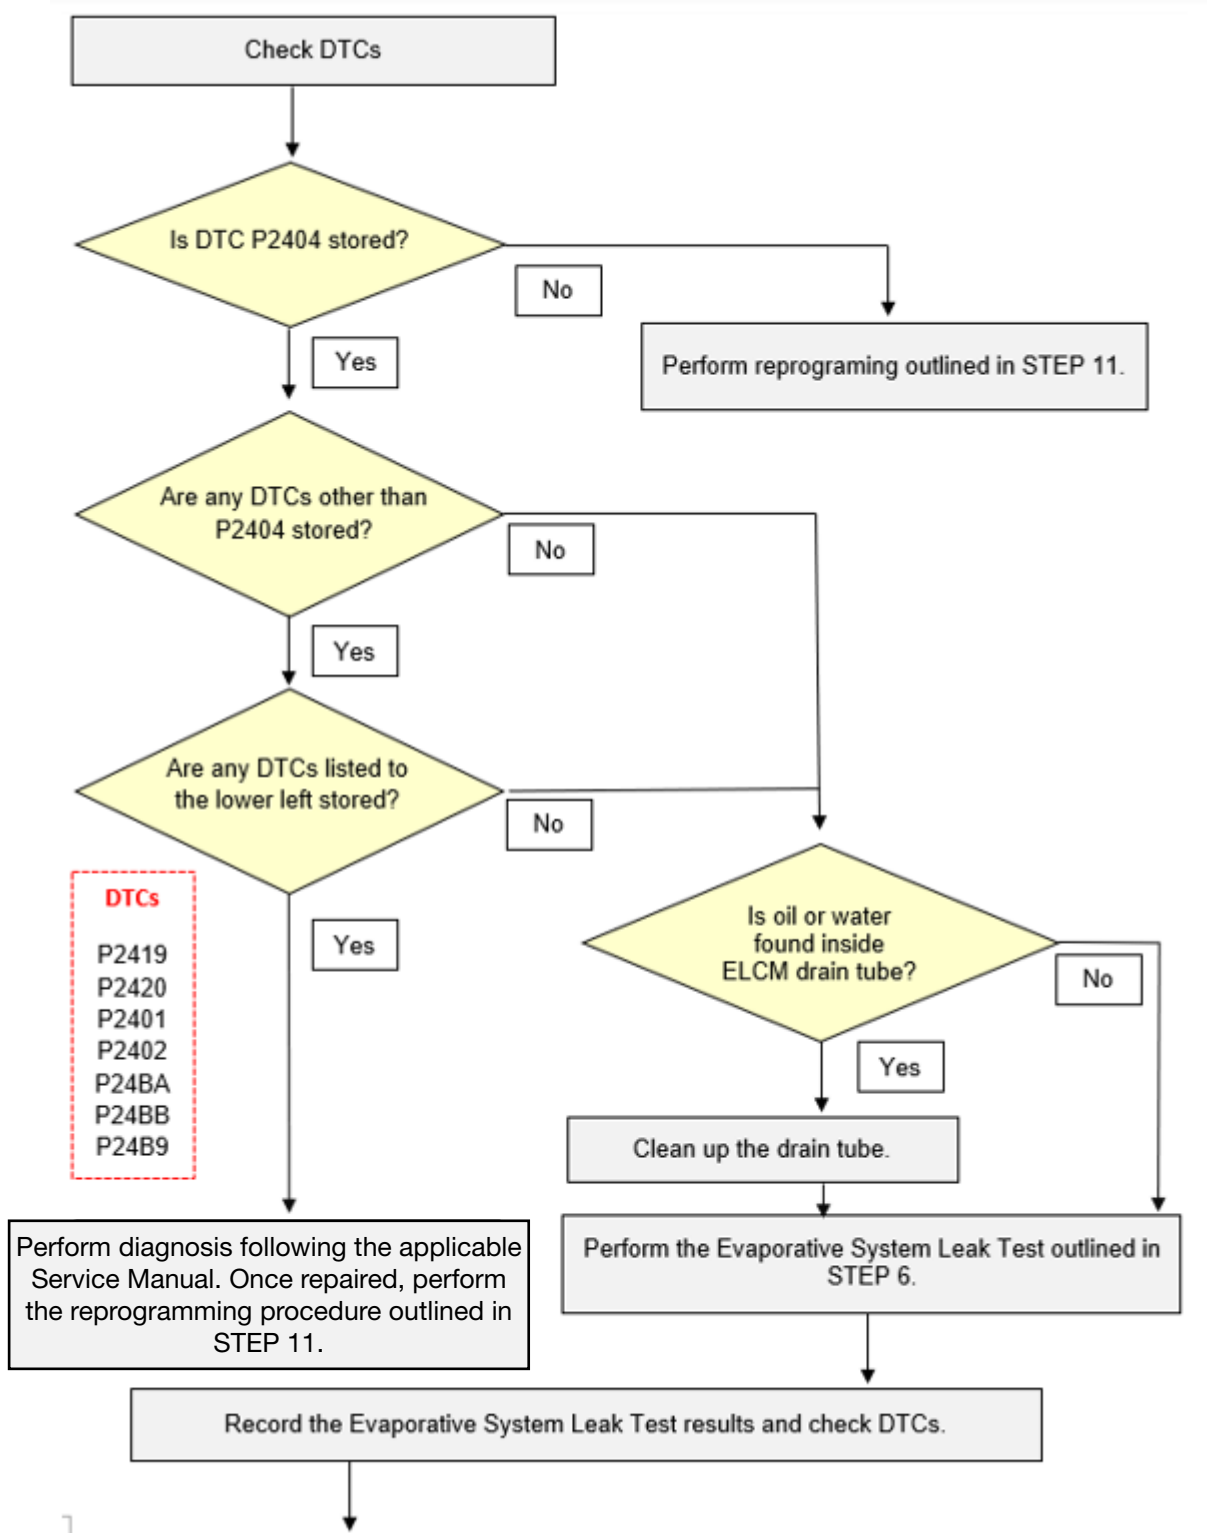
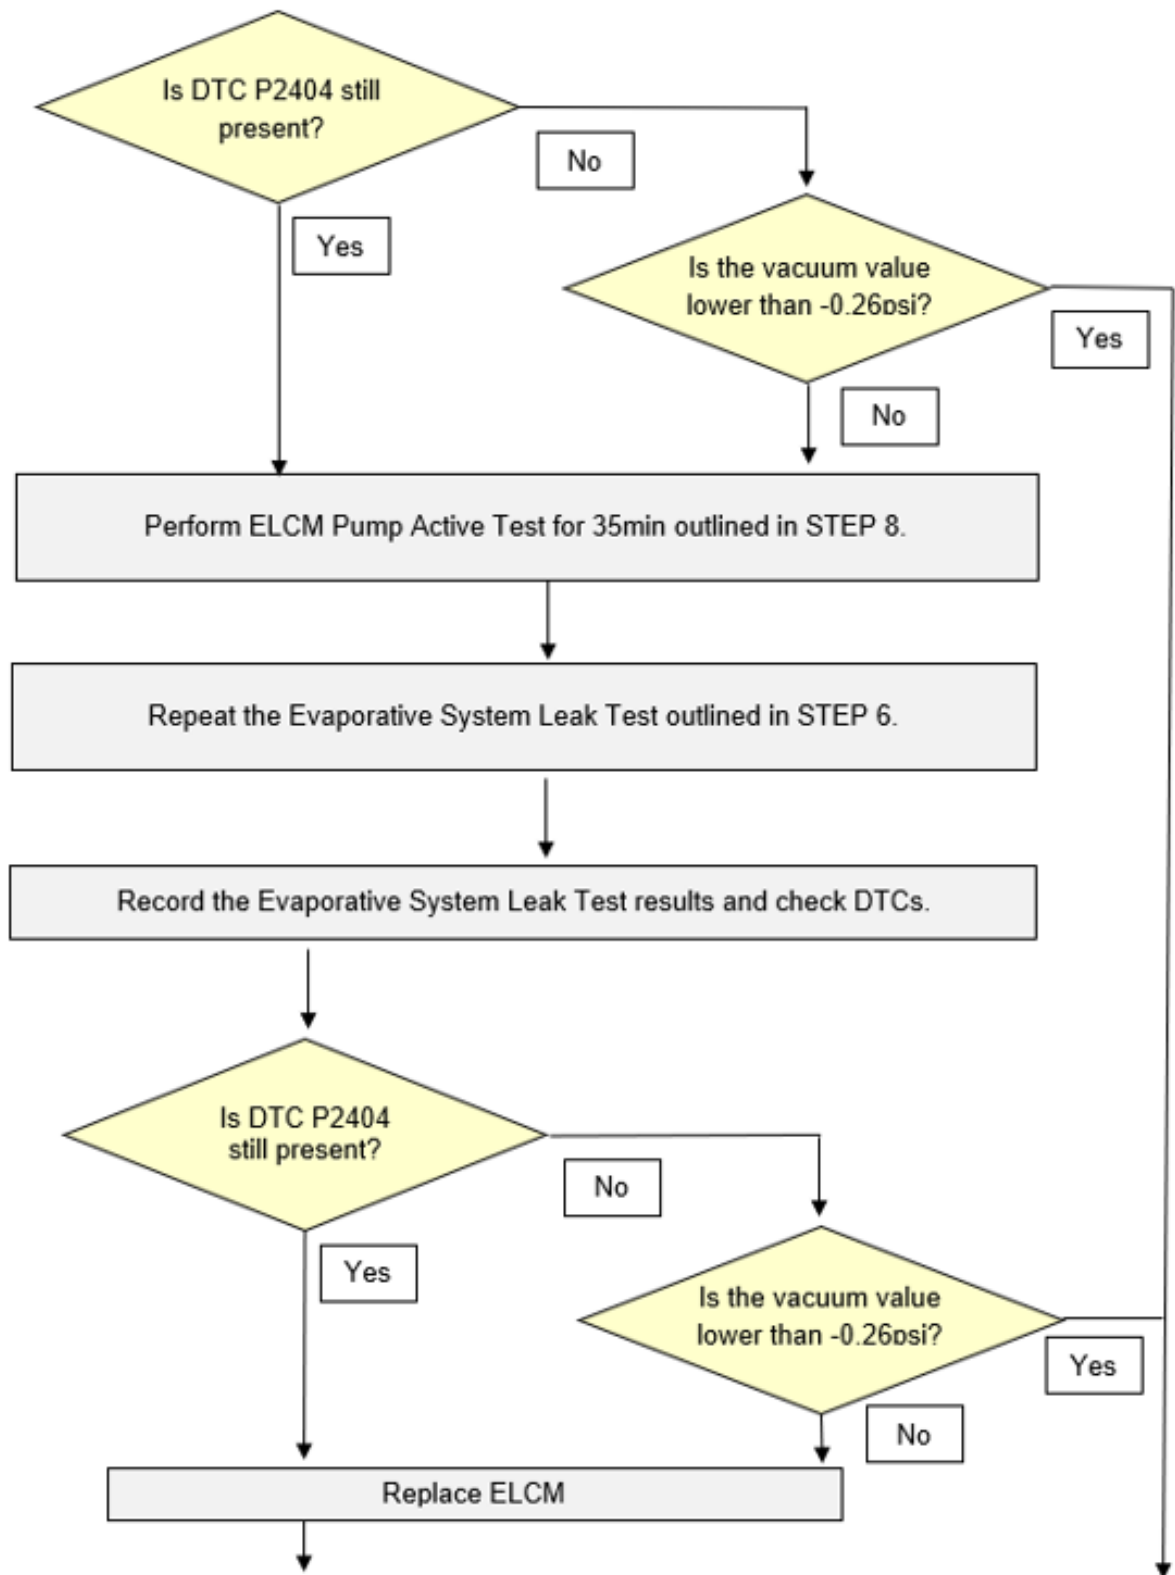
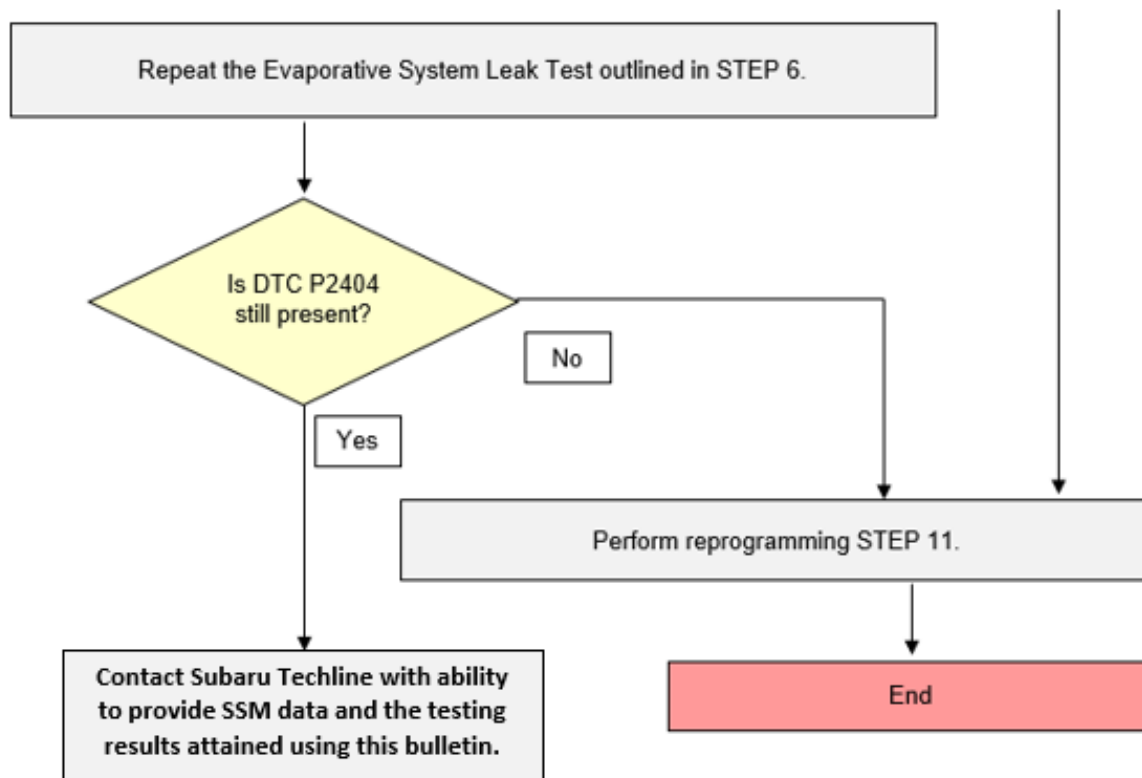
SERVICE PROCEDURE FLOWCHART:

This bulletin announces diagnostic procedures and availability of new Engine Control Module (ECM) reprogramming files to address DTC P2404 (Evap System Leak Detection Pump Sense Circuit Range/Performance) detection. In rare cases, the internal pump for the Evaporative Leak Check Module (ELCM) system can seize temporarily. The new files contain enhanced logic to prevent the ELCM pump from seizing. If P2404 is found in the fault memory, follow the procedures outlined below.

STEP 1: Using the Subaru Select Monitor (SSM), check for diagnostic trouble codes. Confirm DTC P2404 is stored and proceed to the next step.

STEP 6: Connect the vehicle to a recommended power supply. See **APPENDIX A** for additional information regarding the power supply. Using SSM, perform the Evaporative System Leak Test. Collect and save all data.

Once the evaporative system leak test is complete, check the DTCs and examine the vacuum value results. Record the value shown in the row labeled MID: \$3C, TID: \$C4, and Scaling ID: \$FE. This value should be lower than -0.26 PSI.

STEP 10: Replace the Evaporate Leak Check Module and repeat the Evaporative System Leak Test outlined in STEP 6. Check the DTCs and the vacuum value results.
