GROUP	MODEL
BOD	2023-2024MY K5 (DL3a)
NUMBER	DATE
322 (Rev 1, 02/02/2024)	November 2023

## TECHNICAL SERVICE BULLETIN

### SERVICE ACTION: TRUNK LID AND C-PILLAR GARNISH INSPECTION & REPLACEMENT (SA552)

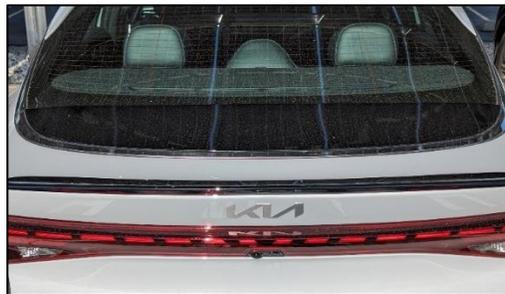
This bulletin provides information to inspect the rear trunk lid chrome garnish trim and the C-Pillar(s) chrome garnish trim on certain 2023-2024MY K5 (DL3a) vehicles produced from May 1, 2023 through September 29, 2023, which may be loose due to an insufficient lamination layer. Follow the procedure outlined in this publication to inspect the rear trunk lid chrome trim, and both left and right side C-pillar chrome trims, and replace the affected rear trunk lid chrome trim and/or the (left and/or right side) C-Pillar(s) chrome trim on the applicable vehicle. Before conducting the procedure, verify that the vehicle is included in the list of affected VINs.
