Service Bulletin

PRELIMINARY INFORMATION

Subject: Information on Vibration Analysis and Diagnostic

Models: 2014 Chevrolet Silverado 1500
 2015-2018 Chevrolet Silverado 1500
 2019 Chevrolet Silverado LD *
 2014 GMC Sierra 1500
 2015-2018 GMC Sierra 1500
 2019 GMC Sierra Limited *
 EXCLUDES HD Trucks

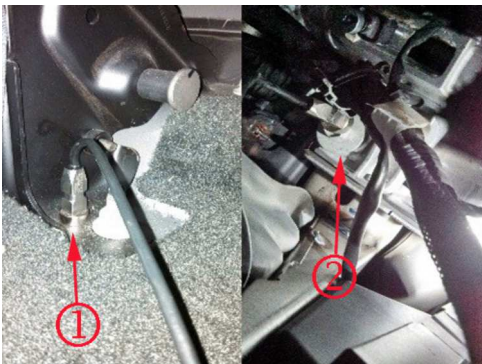
3. Using a Pico Oscilloscope Diagnostic Kit, mount the PicoScope vibration sensor on one of the two locations shown above.

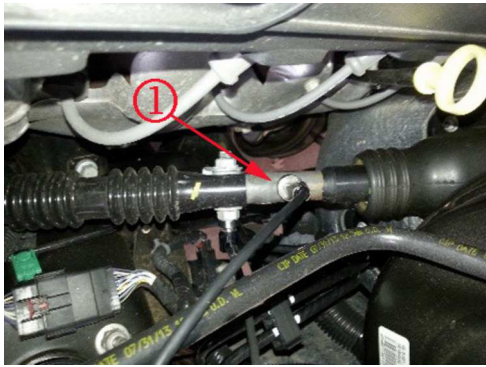
4. This step should be only be used if the vibration can be felt while running the vehicle on the rack. Mount the sensor on the steering shaft (1), under the hood as illustrated above.
5. Measure the vibration. Typically trucks should be driven in M5 for 6 speed applications and M7 for 8 speed applications to keep the engine from switching in and out of active fuel management (AFM).

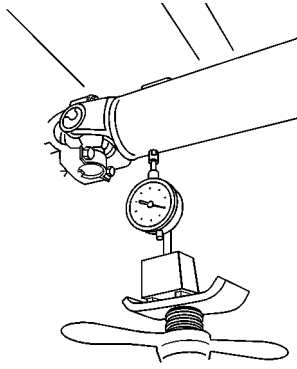
5. Mount the GE-7872 Magnetic Base Dial Indicator Set, or equivalent, or the GE-8001 Dial Indicator Set, or equivalent, to the vehicle underbody or to a service stand positioned just clear of the U-joint yoke weld on the prop shaft.

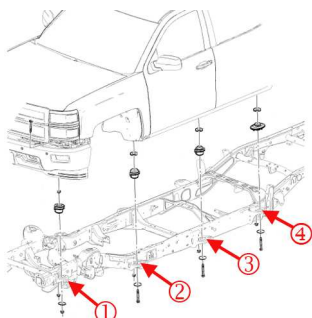
The numbers in the picture below indicate the specific mount position. The mounts on the passenger side of the vehicle are identified the same way. This will assist the technician to identify the correct location of each mount so they can be torque to the proper specification.

1 = body mount cushion front

- 2 = body mount cushion position number 1
- 3 = body mount cushion position number 2
- 4 = body mount cushion position number 3

Visually verify that the cab to box alignment is correct before re-torquing all mounts to specification found in Service Information, body repair, frame and under body section.

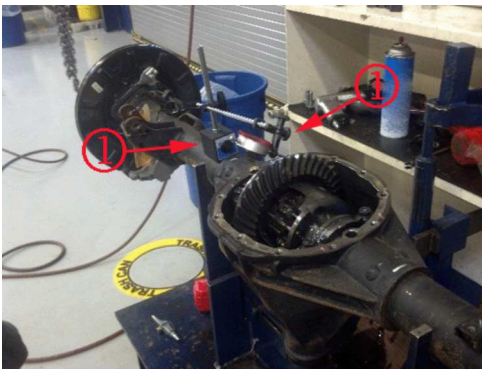
Note: The illustration above is for reference only. The differential does NOT need to be removed from the vehicle.

3. Set the J-8001-3 indicator (1) so that the stem is aligned with the gear rotation (1) and square to the tooth angle.
4. Hold the drive pinion stationary and move the ring gear back and forth.
5. Repeat the measuring procedure at **each tooth** around the ring gear.
6. The difference between the backlash at all of the measuring points should not vary by more than 0.05 mm (0.002 in).
7. If the difference between the backlash at all of the measuring points varies by more than 0.05 mm (0.002 in), inspect for burrs, a distorted case flange or uneven bolting.
8. If the difference between all the measuring points is within specifications, the backlash at the minimum lash point measured should be 0.08-0.25 mm (0.003-0.010 in) with a preferred backlash of 0.13-0.18 mm (0.005-0.007 in).

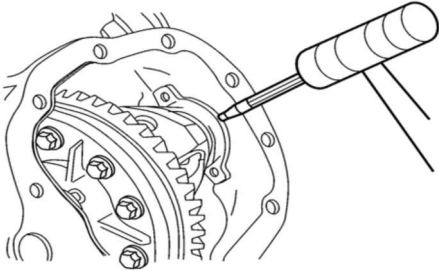
Note: The service spacers must be installed between the service shim(s) and the axle housing.

15. Using the brass drift for 9.5/9.76 axle, install the left side service spacer.
16. Recheck the backlash and adjust, if necessary.
17. Install the bearing caps and bolts and tighten to 85 Y (63 lb ft).
18. Recheck the backlash and adjust, if necessary.
19. Once backlash is correct, perform a gear tooth contact pattern check in order to ensure proper alignment between the ring and pinion gears. Refer to the Gear Tooth Contact Pattern Inspection in SI.
