Service Bulletin

Bulletin No.: 23-NA-072

Subject: Shudders or Shakes at Low Speeds

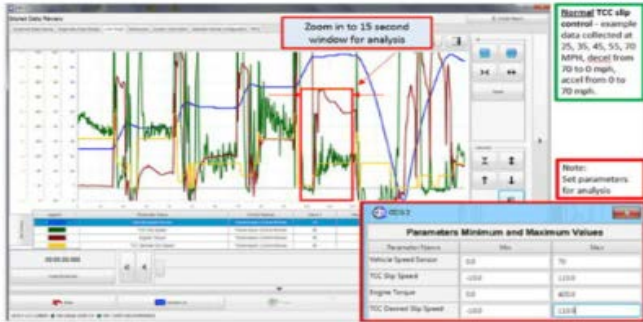
Figure 1 Parameter Minimum and Maximum Values

1. Utilize TIS2Web / GDS2 / MDI service tool
2. Select module diagnostics – TCM
3. Select TCC data for session log / data collection
4. Collect data between 89 and 113 km/h (30 and 50 mph) steady state / steady throttle with minimum 15 seconds.
5. For line graph evaluation, set parameter minimum and maximum to values stated for comparison: See Figure 1
6. Evaluate collected data with line graphs and compare data to each figure below:
 - Normal State: See Figure 2
 - Degraded State: See Figure 3
 - Damaged State: See Figure 4
