Service Action

Code: 87H9

Subject	Pressure & Temperature Sensors				
Document History	Date		Summary		
	02/13/2024		Original publication		
Affected Vehicles	Country	Beginning Model Year	Ending Model Year	Vehicle	Vehicle Count
	USA	2021	2022	E-TRON QUATTRO	7,387
	USA	2020	2022	E-TRON SPORTBACK QUATTRO	3,307
	CAN	2021	2022	E-TRON QUATTRO	391
	CAN	2020	2022	E-TRON SPORTBACK QUATTRO	423
Problem Description	<p>On vehicles manufactured within a specific period, the pressure and temperature sensors in the air conditioning system may fail. If this happens, the air conditioning system will no longer function.</p>				
Corrective Action	Inspect and, if necessary, replace the affected pressure & temperature sensors.				
Code Visibility	On or about February 13, 2024, the campaign code will be applied to affected vehicles.				
Owner Notification	Owner notification will take place in February 2024. Owner letter examples are included in this bulletin for your reference.

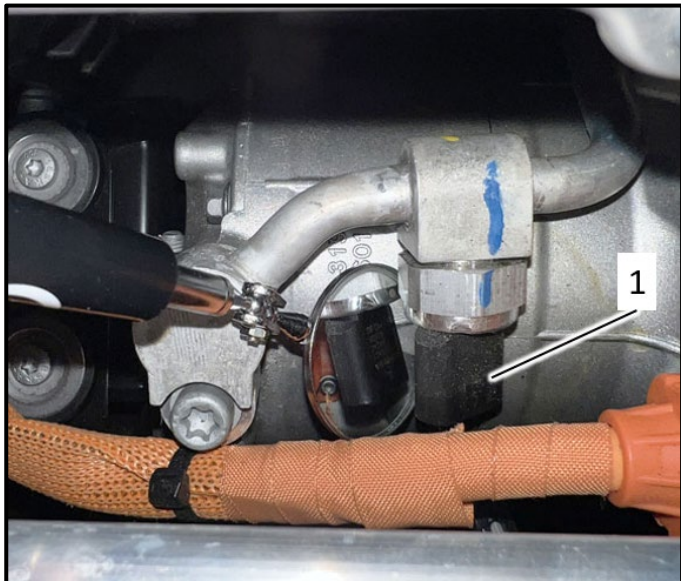
The production date <1> of the sensor pictured is calendar week 31 of 2022. This sensor does not require replacement. The date format is week/year.

If either sensor is positioned in a way that the production information is not visible on the connector <1>, a mirror can aid in inspecting the sensor.
