MAS003953 RU 24-03

Rapid Update 698

Ghibli - Trunk lid Bump Stop Check

DATE: JANUARY 30, 2024

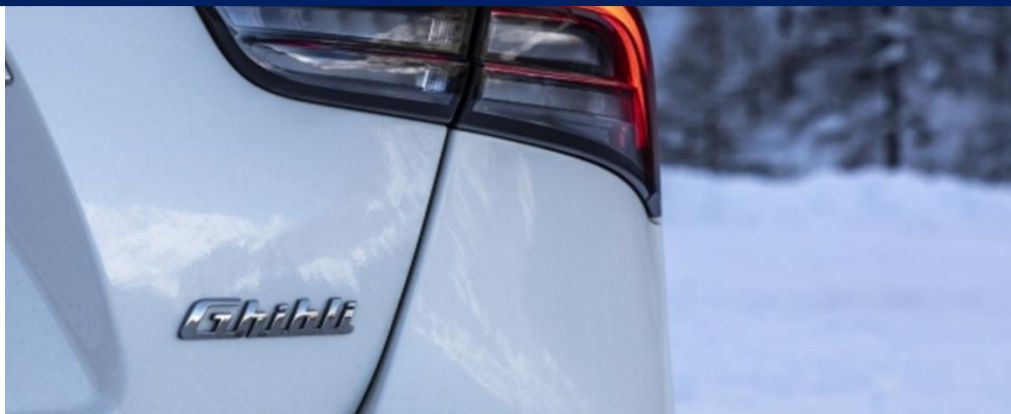
Certain Maserati Ghibli (M157) MY22 MY23 listed in MODISCS+ are involved in a Rapid Update to check the trunk lid bump stops.

On a limited number of vehicles, the bump stops may not have been correctly registered during the assembly phase.

The procedure consists of verifying the presence of movement of the mobile part of the pad and its eventual registration.
