Service Bulletin

Bulletin No.: 23-NA-177

Subject: Setting for Hands Free Liftgate (Open-Close) is Setting to 'Off' During Ignition Cycles

Brand:	Model:	Model Year:		Build Date:		Engine:	Transmission:
		from	to	from	to		
Cadillac	XT4	2024	2024	SOP	December 2, 2023

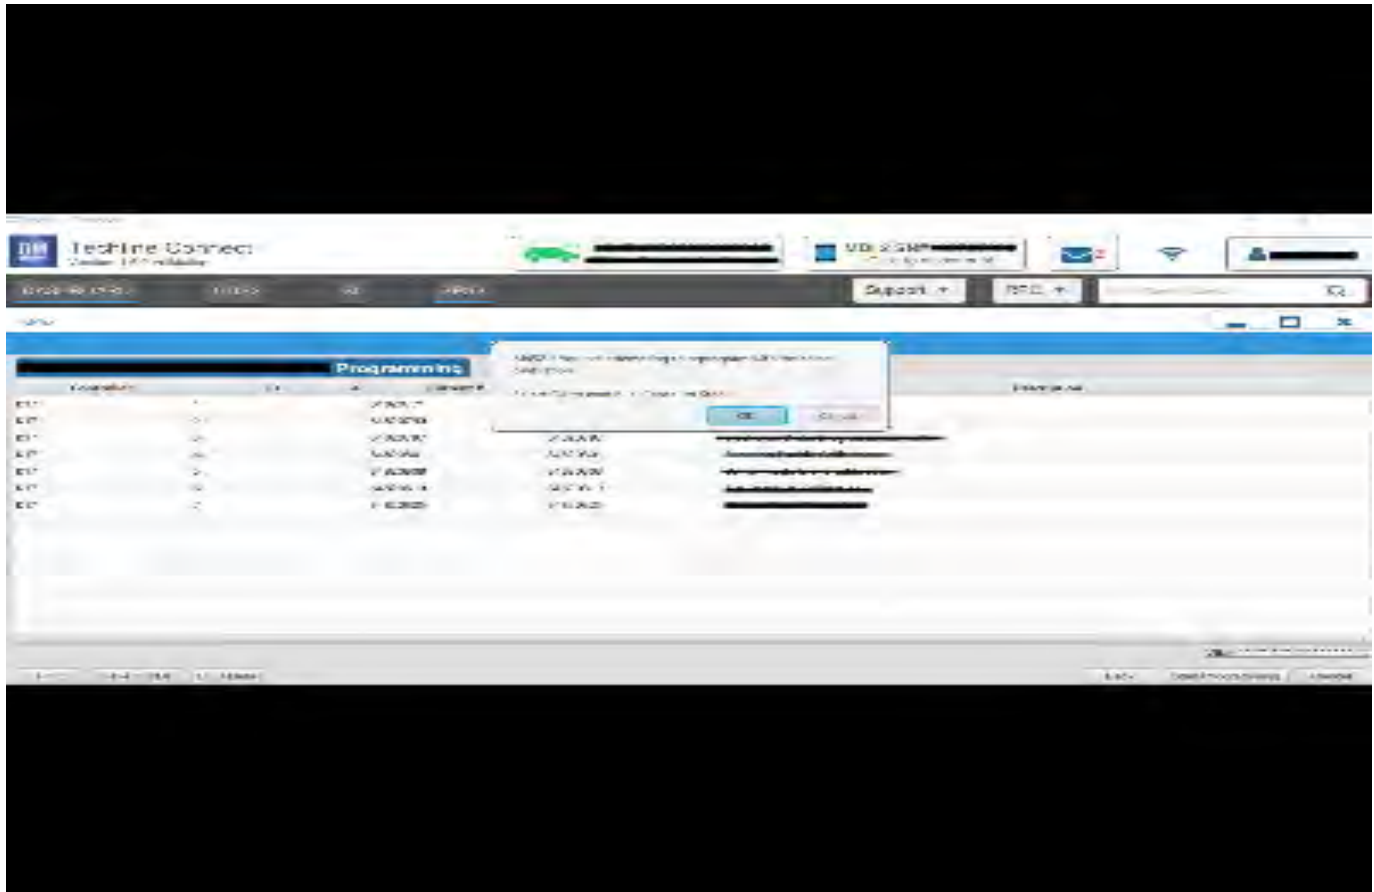
5644477

Important: Techline Connect screens shown above.

Important: If the same calibration/software warning is noted on the TLC Summary screen, select OK and follow screen instructions. After a successful programming event, the WCC is located in the Service
