# Service Bulletin

Bulletin No.: 24-NA-029

**Subject: HUMMER EV Water Leak Diagnostic Tips**

Brand:	Model:	Model Year:		VIN:		Engine:	Transmission:
		from	to	from	to		
GMC	HUMMER EV Pickup	2022	2024	-	-	All	All
	HUMMER EV SUV	2024	2024

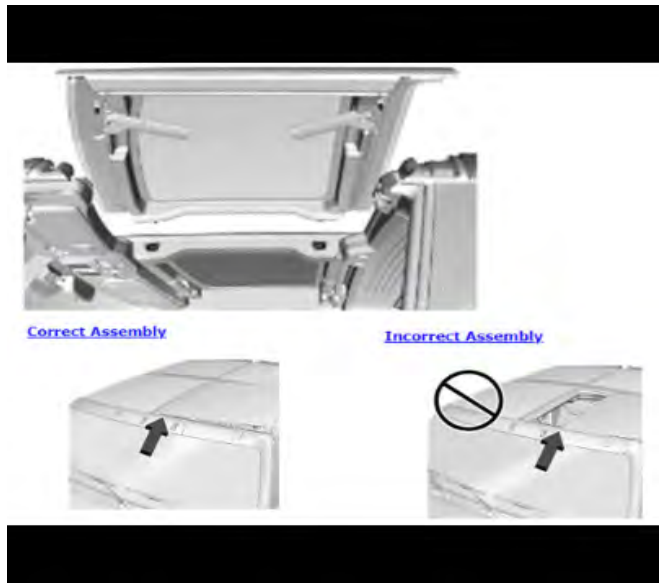
6542230

Carefully place the roof panel into its designated location. Position the inboard edge of the roof panel next to the weatherstrip on the I-Bar, then align and fit the horizontal pins into the receivers on the I-Bar.

When aligning the pins and receivers, make sure the inboard edge of the roof panel does not come in contact with the roof seals. Ensure that the inboard edge is far enough in that it clears the I-Bar weatherstrip. Ensure that the I-Bar weatherstrip is lying flush with the adjacent roof seals before fully engaging the pins into the receivers. Failure to do so may damage the weatherstrip or lead to an improper seal.
