GROUP	MODEL
GEN	2023-2024MY Forte (BDm)
NUMBER	DATE
099	February 2024

TECHNICAL SERVICE BULLETIN

SERVICE ACTION: TIRE MOBILITY KIT INSPECTION & REPLACEMENT/REPAIR (SA556)

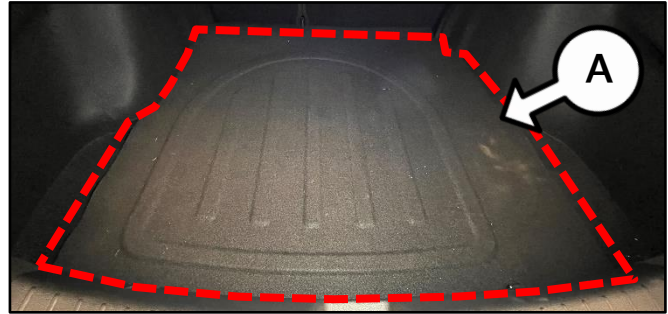
1. Open the trunk lid.
2. Remove the luggage board (A).

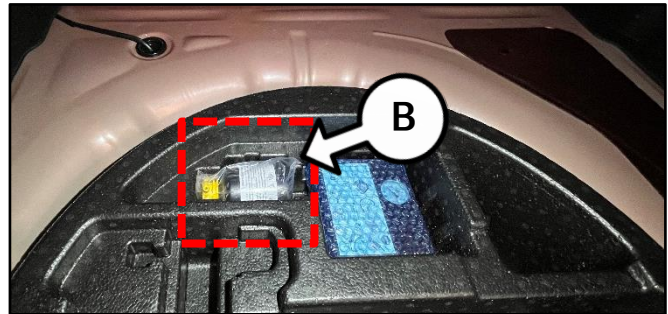
3. Remove the Tire Mobility Kit (TMK) sealant can (B).

- If sealant has not leaked from the TMK can (B) (OK), proceed to step 4.
