Subject: Information on Service Emissions System Displayed on Drivers Information Center (DIC), Malfunction Indicator Lamp (MIL) Illuminated - DTC P249C and/or P20E8 Set

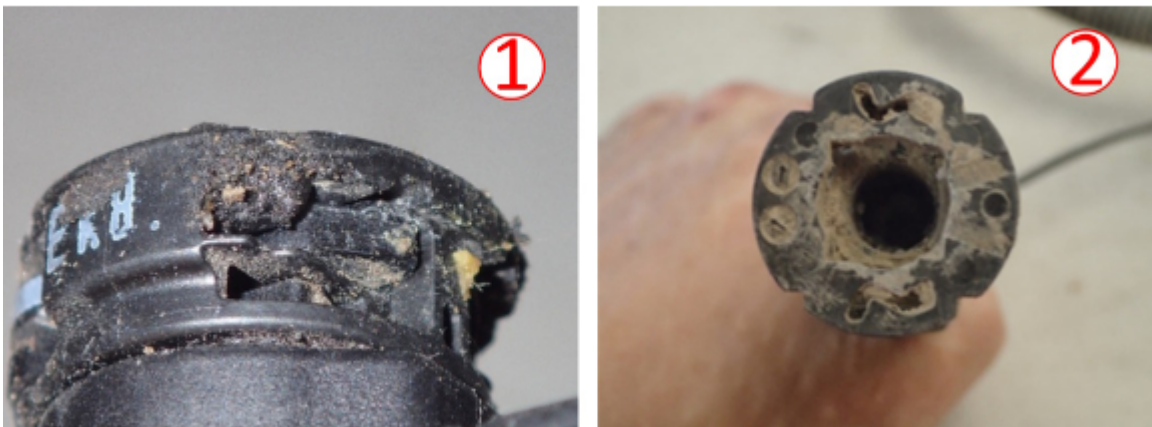
6531860

- Example of a DEF pipe with crystallized DEF. This can be cleaned using the procedure below.

The Emission Reduction Fluid Exhaust Front Pipe Injector Supply Pipe may be contaminated with crystallized DEF in or around the connector. This procedure outlines the correct cleaning procedure before attempting to re-connect the Emission Reduction Fluid Exhaust Front Pipe Injector Supply Pipe to the Reductant Fluid Injector or the Emission Reduction Fluid Pump Outlet Port.

Note: This procedure cannot be performed if the Emission Reduction Fluid Exhaust Front Pipe Injector Supply Pipe connector is contaminated with other forms of contaminants such as frame wax or dirt inside the connector. If this is the case, do not perform the cleaning procedure as the Emission Reduction Fluid Exhaust Front Pipe Injector Supply Pipe will need to be replaced.

1. Fill a clean container with fresh water.
2. Remove or pull back the heat protecting hood from the Emission Reduction Fluid Exhaust Front Pipe Injector Supply Pipe connector end if present.
