SERVICE BULLETIN

APPLICABILITY: 23-24MY Outback/Legacy Models (including Wilderness models)
 23-24MY Ascent Models
 24MY Impreza
 24MY Crosstrek
 24MY WRX

NUMBER: 15-305-22R
DATE: 11/15/22
REVISED: 02/26/24

SUBJECT: Reprogramming File Availability for Optimization of Gen 4.5 Denso CP1.5 Infotainment Systems

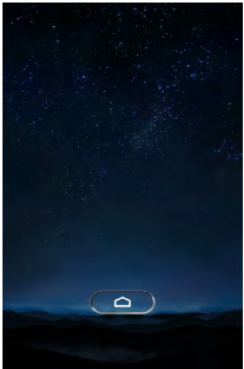
<p>-Right after starting up, the CID displays only background without icons and no further operation can be done (not applicable to WRX)</p>

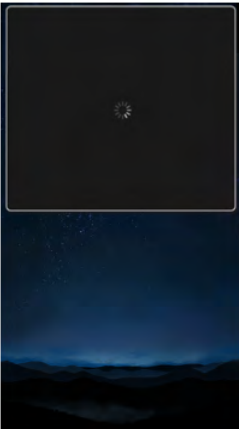
<p>After engine starts, only the black frame of the Caution screen display may remain on the CID screen. The rear view camera can be displayed by shifting to shift R.</p>

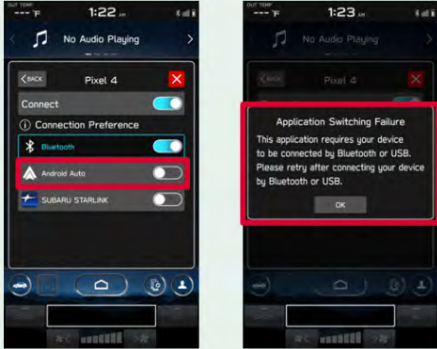
<p data-bbox="500 831 1484 936">- When you toggle on Android Auto from the Manage Device screen in CID while the Android device is not connected via USB, there may be a failure to start Wireless Android Auto (not applicable to BASE trim)</p>

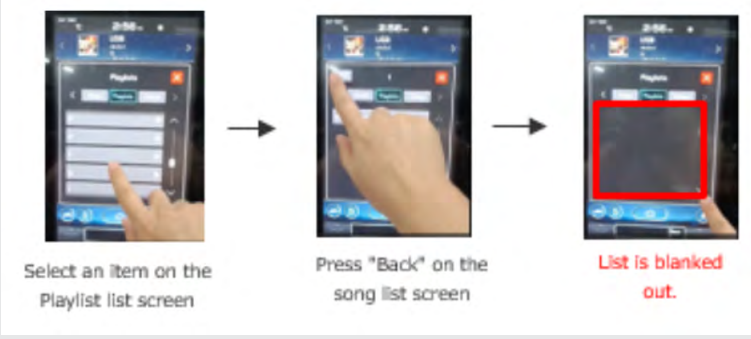
Number	Category	Symptoms to be Improved:
6	Audio	<p>- When returning to the Playlist List screen by pressing "Back" after selecting a Playlist on page 4 or later in the Playlist List screen, the Playlist List is displayed blank.</p>

<p>Select an item on the Playlist list screen → Press "Back" on the song list screen → List is blanked out.</p> <p>- After turning ignition ON, there is no audio sound.</p> <p>- The playback starts from the first song on the USB instead of resuming from the song that was played last time. (This is more likely to occur when the number of songs on the USB is 4000 or more.) The previous audio source was USB audio. Plug in the same USB as last time and audio playback starts automatically</p> <p>- The playback song and the displayed song title are mismatched. (Playback resumes from the same song, but the displayed song title is misplaced.) After USB audio playback, edit the folder structure and song order of that USB memory stick using a computer or other device. Restart USB audio on the same USB.</p>

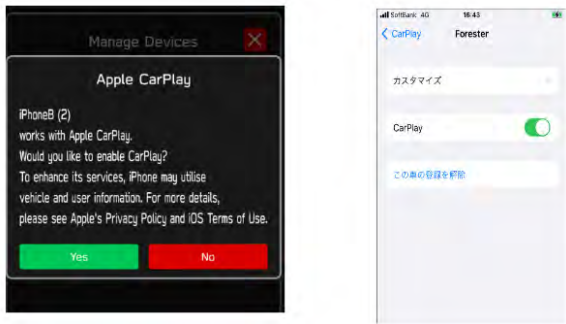
7	Bluetooth	<p>- Bluetooth connection may not become active, and it may become impossible to switch Bluetooth-connected devices, when following steps below (turning on/off the connection)(not applicable to WRX): With the CarPlay usage confirmation screen displayed on the CCU, press the 'Yes' button. Almost simultaneously, on the iPhone's settings screen, turn off the CarPlay toggle switch.</p>

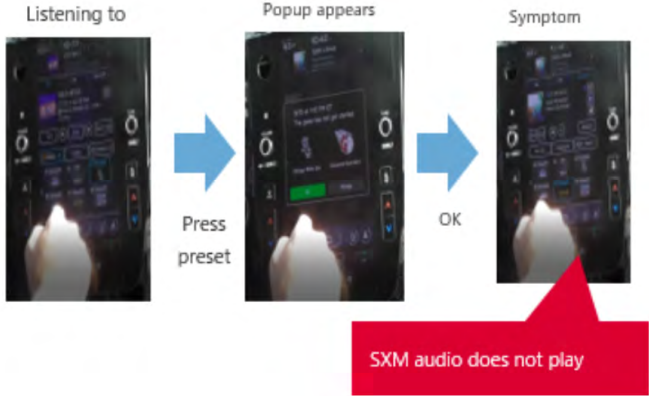
<p>- While listening to the radio (FM/AM) and attempting to select a sports team channel (SXM channel) from the presets, if the chosen team has a scheduled game on that day but it hasn't started yet a popup screen displaying the game schedule appears. However, after the popup screen appears, the system returns to the previously played channel, and the SXM audio does not play (not applicable to WRX).</p>

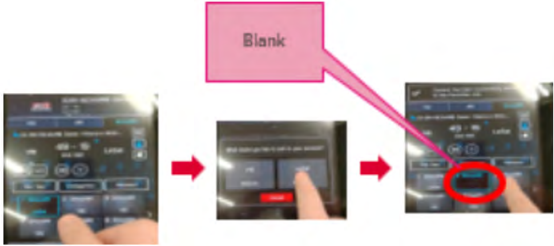
<p data-bbox="500 663 1498 814">- When registering SXM sports team channels to the radio preset buttons if a team for which logo image cannot be captured is registered, the channel short name will not be displayed on the registered button and the button will be blank (not applicable to BASE trim)</p>

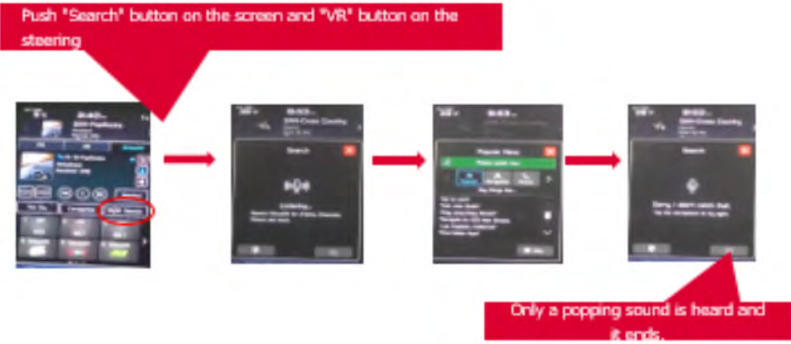
<p data-bbox="500 1430 1498 1541">- The voice recognition function encounters an error and ends, when initiating the SXM Search feature simultaneously with the activation of the CCU unit's voice recognition</p>

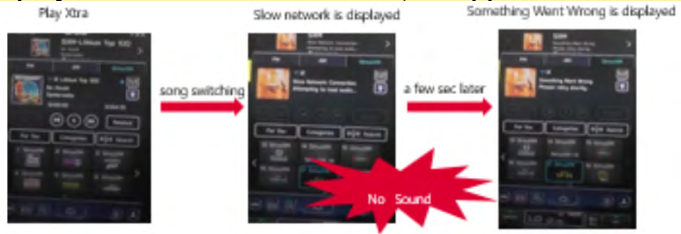
Number	Category	Symptoms to be Improved:
9	SXM	<p>- SXM sound stops sounding after conditions listed below:</p> <ol style="list-style-type: none"> 1. Register FM station A, an SXM sports channel that is not in the middle of a game, and FM station B in the order in which they are listed in the radio presets. 2. Use the steering wheel switch to switch from FM station A to FM station B, skipping the SXM sports channel that is not in the middle of a game. 3. Just before the playback of FM station B starts, operate the steering switch seek to return to the previous channel. <p>- While playing SXM's Xtra channel, "Slow Network" --> "Something Went Wrong" is displayed and no sound is heard (not applicable to BASE trim)</p>

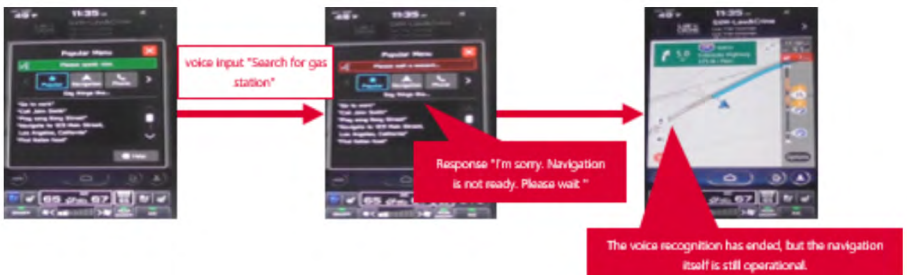
<p>- When searching for navigation POIs using voice recognition, the response is "Navigation is not ready" and POI search may not start (only applicable to HIGH trim)</p>

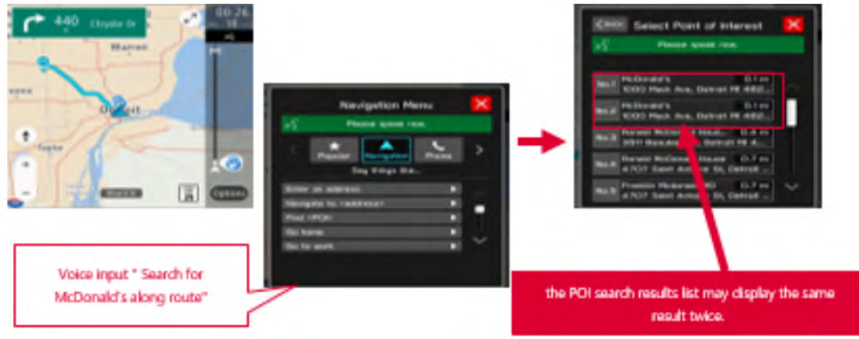
Number	Category	Symptoms to be Improved:
13	Navi Operation	<p>- When using voice recognition during navigation to say 'Search for **** along route,' the POI search results list may display the same result twice (only applicable to HIGH trim)</p>

<p>Voice input " Search for McDonald's along route"</p> <p>the POI search results list may display the same result twice.</p>
14	Audio/Voice Recognition	<p>- USB audio is activated by voice recognition command ""play artist xxx"" or ""play album xxx"". The last song played by USB audio is played, not the song commanded by voice. (only if the same USB is used) (not applicable to WRX)</p>
15	Voice Guidance	<p>- While driving with a navigation route set, there are instances where the voice guidance may not correctly pronounce "mile." It mispronounces "mile" as "me" (only applicable to HIGH trim)</p>
16	Voice Recognition	<p>- After setting a route in the navigation system and activating voice recognition function, the route guidance is not canceled even "Cancel Route" or "Delete Destination" is completed (only applicable to HIGH trim)</p> <p>- When you say ""Call ****"" using voice recognition, the meter display shows "Please wait a moment," but the call cannot be made (not applicable to WRX) (Note: ""****"" indicates an actual phone number or contact name you are trying to call)</p> <p>- Starting the CCU (Cockpit Control Unit) voice recognition while using the SXM Voice Search function results in an error and ends the voice recognition (not applicable to BASE trim)</p>

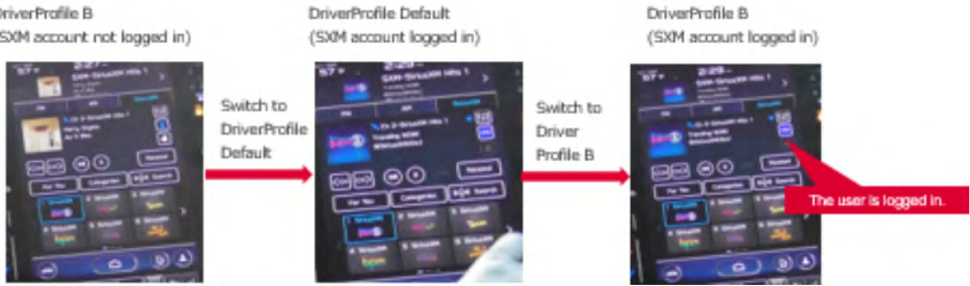
<p>- Switching the Driver Profile user causes the user to be logged into SXM even though he/she was not logged into the SXM account as the user after the switch</p>

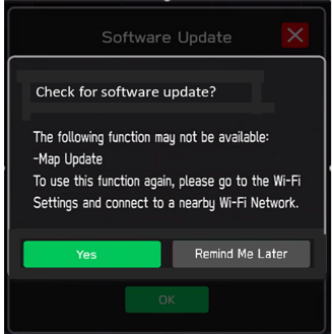
Number	Category	Symptoms to be Improved:
26	Software Update	<p>- To use FOTA (Firmware update Over The Air) for CCU software update via DCM (Data Communication Module) it is necessary to switch from the Wi-Fi communication settings for MapUpdate to the DCM communication settings. To notify the customer about this switching, the below message screen pops up a new CCU software becomes available from the server. (not applicable to BASE trim)</p>

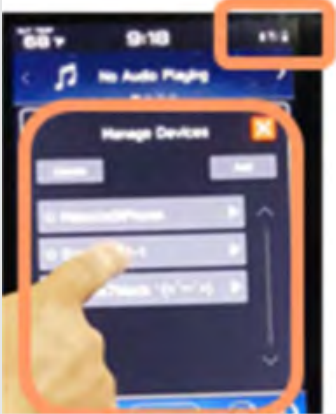
Number	Symptoms to be Improved:
7	<p>Bluetooth connection is disabled with a discrepancy in the display of status bar (showing Bluetooth devices being connected) and the “Manage Devices” screen (showing no Bluetooth devices being connected.)</p>

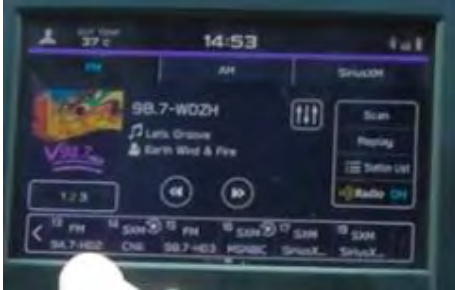
8	Android Auto Wireless (AAW) cannot be connected.
9	Android Auto Wireless (AAW) cannot be started from “Manage Devices” Screen.
10	Sound volume control does not work while using Android Auto. It is caused by data communication error between Android device and CCU.
11	Cyclic short noise like a drilling or vibration is heard from speakers.
12	<p>Sound is lost when changed to Subchannel 2 right after a preset HD radio channel has been selected.</p>

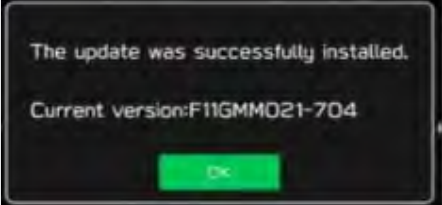
15	<p>Popup of “The update was successfully installed” is not displayed after reboot (IG-OFF and ON) operation of FOTA (Firmware Over The Air) update.</p>

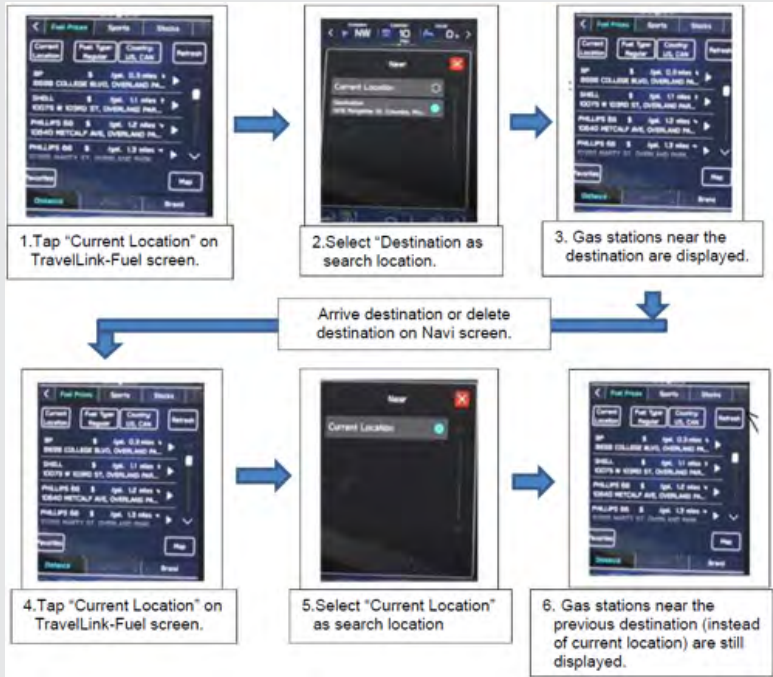
Number	Symptoms to be Improved:										
16	When tapping preset “Team Channel” on SMX, a popup of different game is displayed. It can occur under the following sequence of operations:										
17	<p>A wrong search location is used on TravelLink function. Example of the symptom.</p>

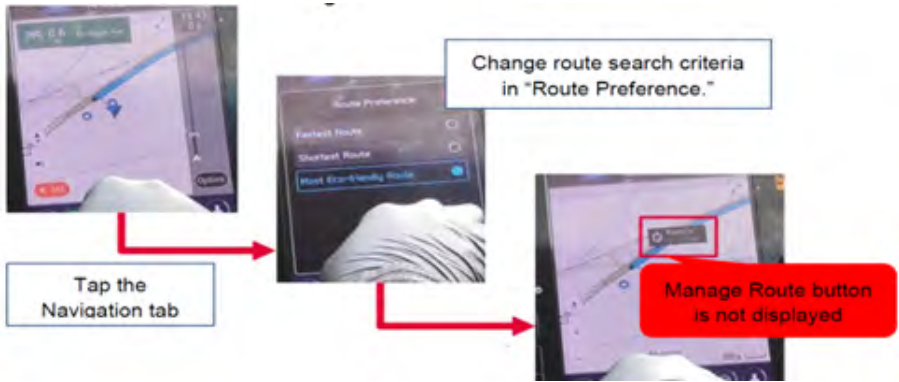
Number	Symptoms to be Improved:
10	Navigation restarts itself, when the letters are rashly entered or deleted using keyboard function to search destination.
11	<p>“Manage Route” button is not displayed when touching the route line on Navigation system, when the route search criteria got changed in the Route Preference Screen after a route had been searched.</p>

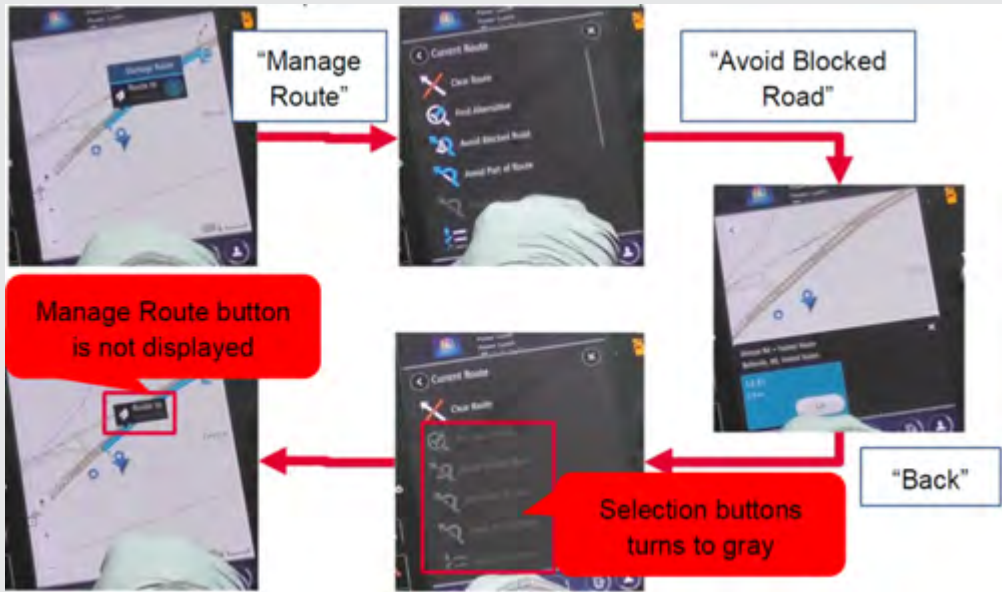
12	<p>“Manage Route” button is not displayed and buttons on the Current Route Screen become unselectable (turns to grayish fill) when the Navigation system is operated in the sequence of “Manage Route” > “Avoid Blocked Road” (in the Current Route Screen) > “Back.”</p>
