SERVICE BULLETIN

APPLICABILITY: 2016-18MY Legacy & Outback
 2016-18MY Impreza
 2016-18MY Crosstrek
 2016-18MY Forester
 2017-18MY WRX/STI

NUMBER: 15-316-24
DATE: 02/27/24

SUBJECT: Gen1 Telematics DCM Reprogramming for 3G Sunset

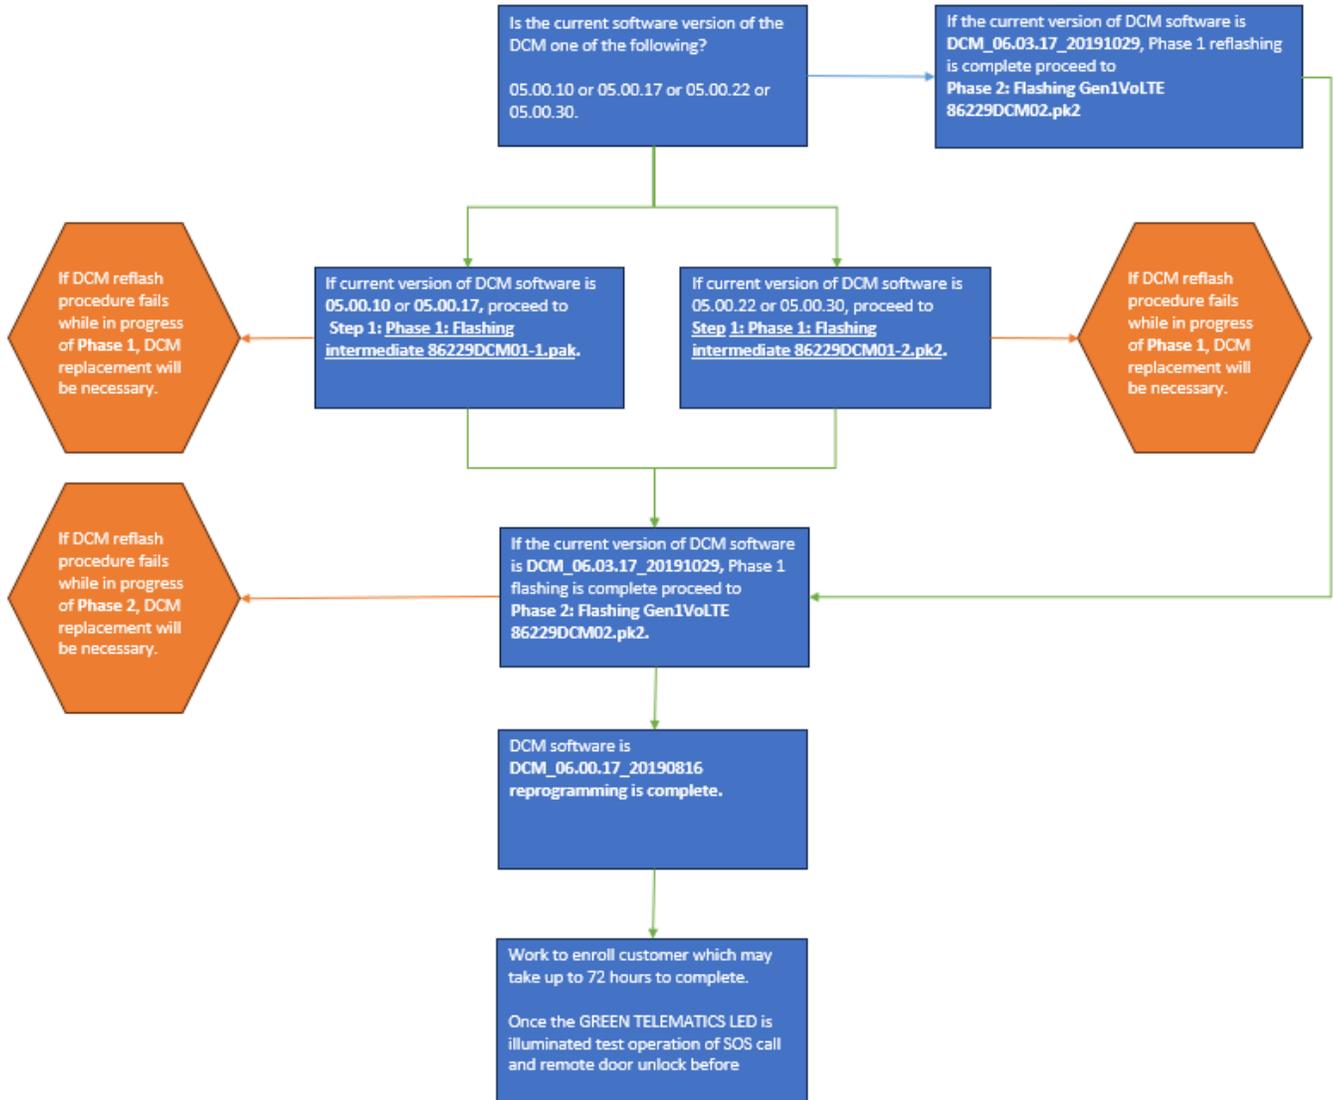
APPENDIX C (REPROGRAMMING FLOWCHART):

If the current version of DCM software is DCM_06.00.17_20190816, the vehicle has already received the reflash or the DCM was replaced and is equipped with the most recent version of software. Take no further action.
