Technical product information

Topic	V8 Kovomo - Engine MIL light on - DTC 'P04F000: EVAP system high pressure purge line performance' evident
Market area	Australia E04 Bentley rest Asia and Australia (6E04),China 723 Volkswagen (Anhui) Automotive CO (6723),China 796 VW Import Comp. Ltd (Vico), Beijing (6796),Germany E02 Bentley rest Europe (6E02),Japan E03 Bentley Japan (6E03),Korea, (South) E08 Bentley South Korea (6E08),United Arab Emirates E06 Bentley Middle East and Africa (6E06),United Kingdom E01 Bentley UK (6E01),United States E05 Bentley USA and rest America (6E05)
Brand	Bentley
Transaction No.	2065148/4
Level	EH
Status	Approval
Release date

V8 Kovomo

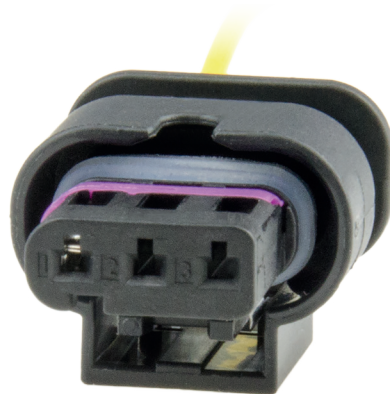
Detail Secondary lock

Secondary lock: 1

Primary lock: 1

Colour: black

Pins 3

Type female

Seal yes

Tool WEB-ENT-30-0002-98
